Fish Passage Culvert Assessment
for Cahilty Creek Watershed
FIA Project # 4602004

Weyerhaeuser Company Ltd.

ARC Environmental Ltd.
1326 McGill Road
Kamloops, B.C., Canada
V2C 6N6

November 24th, 2006

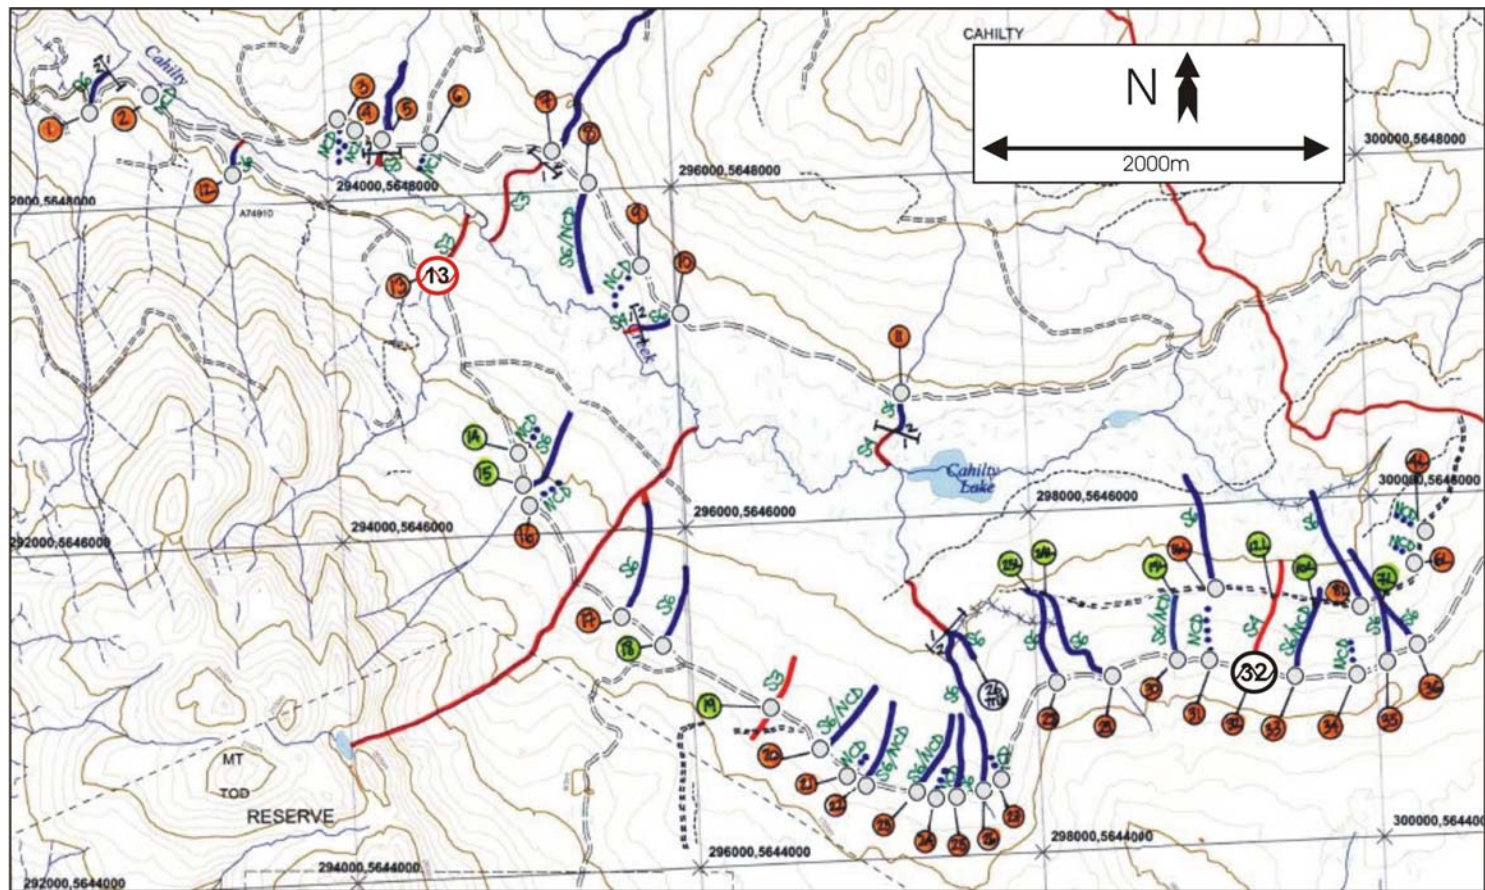
Figure 2: Cahilly Creek Fish Passage Culvert Inspection Results

All 40 sites investigated are located below in Figure 2 showing the site number, the channel crossing type with the FPCI result, and the stream classification. Sites 7L, 10L, 12L, 19L, 24L and 25L are all ford crossings and are presented on the map for reference, but were not part of the scope of work and are otherwise not part of the assessment report. Figures 3 and 4 provide insets of sites 13 and 32.

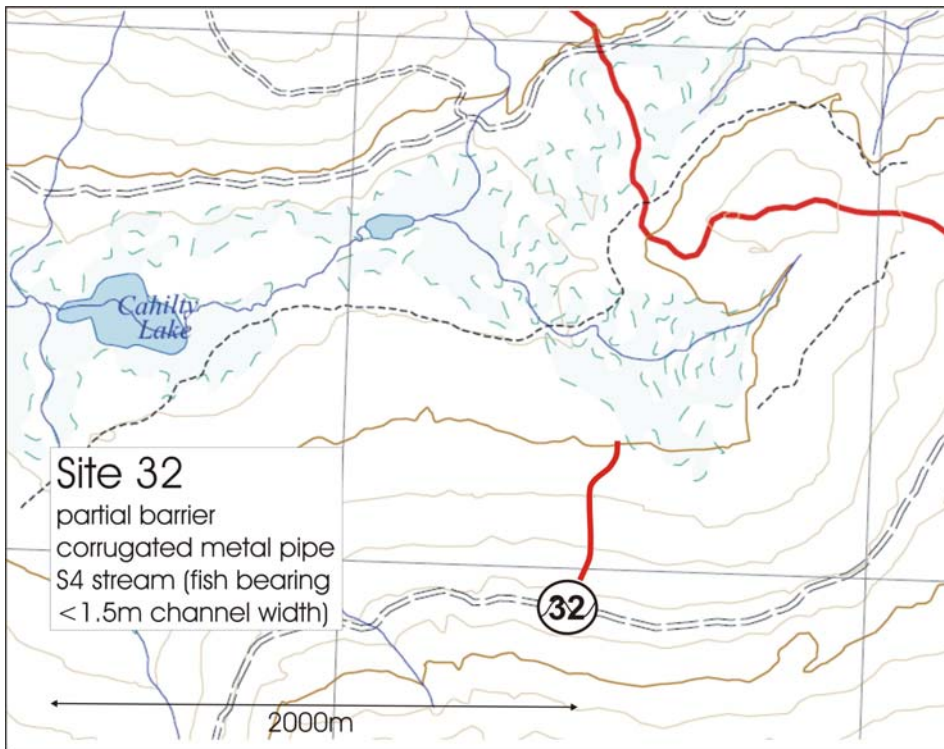
Figure 4: Site 32

The culvert at this site was determined to be a partial barrier that may allow passage of some age classes of rainbow trout at some times of the year. The culvert water velocity at the time of the assessment was 0.50m/s, more than 4 times the average channel velocity of 0.09m/s, and greater than the burst speed of juvenile rainbow trout <50mm FL. And the culvert water depth of 9cm was below the recommended 15cm for adult rainbow trout upstream passage. In addition, the culvert slope of 3.2% is greater than the recommended 1% for culverts without baffles and less than 24m in length (Parker 2000). However, the culvert plunge pool depth of 31cm is greater than 1.25 times the culvert outfall drop of 18cm and therefore juvenile to adult rainbow trout are able to access the culvert (Parker 2000). However, the vertical ditch wall immediately upstream of the culvert inlet is a full barrier to fish passage. Therefore the culvert acts presents a partial barrier to a short (<250m) and limited amount of habitat, which is likely not accessible due to the vertical ditch wall immediately upstream of the culvert.

Barrier	Partial
Barrier Type	Culvert slope of 3.2% is greater than the recommended 1% for culverts without baffles and less than 24m in length. Culvert diameter is 72% of channel width increasing velocity through the culvert. Culvert velocity in low flow period at 0.50m/s is more than 4 times the average channel velocity of 0.09m/s, and is greater than the burst speed of the 50mm juvenile class size. Velocity can be overcome by larger juveniles with a burst speed of 0.7 - .11m/s. Culvert water depth of 9cm is below the recommended 15cm for adult upstream passage. Culvert pool depth of 31cm is greater than 1.25 times the culvert outfall drop of 18cm so jump height and pool depth are adequate for all age classes of rainbow trout, but culvert
