2010 Fish Passage Culvert Assessments in Gold River Watershed

FIA Project Number: 7008001

Prepared for:
Western Forest Products Inc.
118-1334 Island Hwy
Campbell River, BC, V9W 8C9

Prepared by:
Mac Jedrzejczyk, M.Sc., RPBio.
FINS Consulting Ltd.
4809 Hamer Ave.
Terrace, BC, V8G 2E5

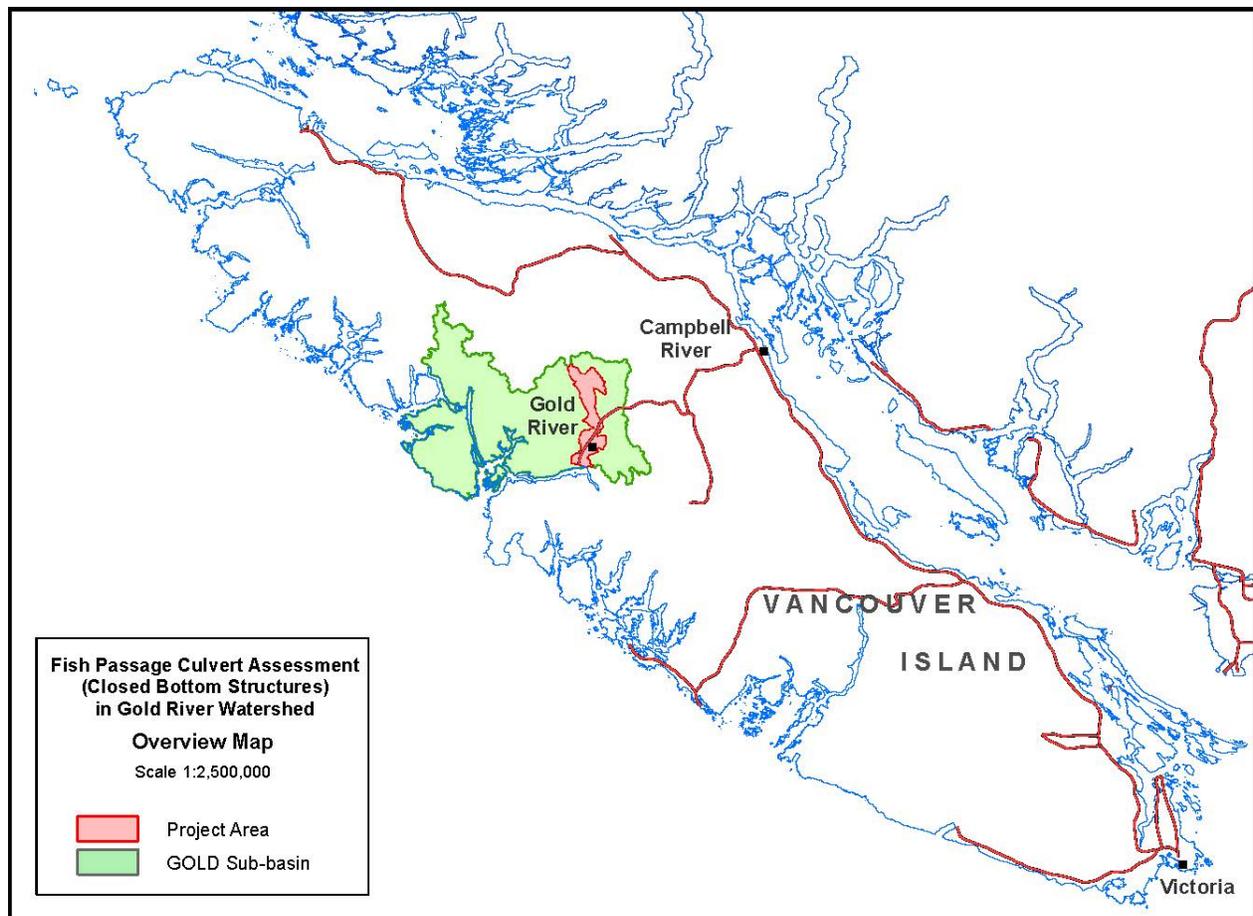
Figure 1. Study Area

The study area includes the main stem of the Gold River basin located west of Strathcona Provincial Park and 10 smaller polygons covering 217.2 km² (Figure 1). Watersheds within the project area are listed in Table 1 below.
