PROOF OF WATER FOR THE PROPOSED SUBDIVISION
OF DISTRICT LOT 5682 AND PART OF DISTRICT LOT 6091,
NORTH OF HALFMOON BAY ON THE SECHELT PENINSULA

PACIFIC HYDROLOGY CONSULTANTS LTD.
204 - 1929 West Broadway
VANCOUVER, B.C. V6J 1Z3

JUNE 23, 1992

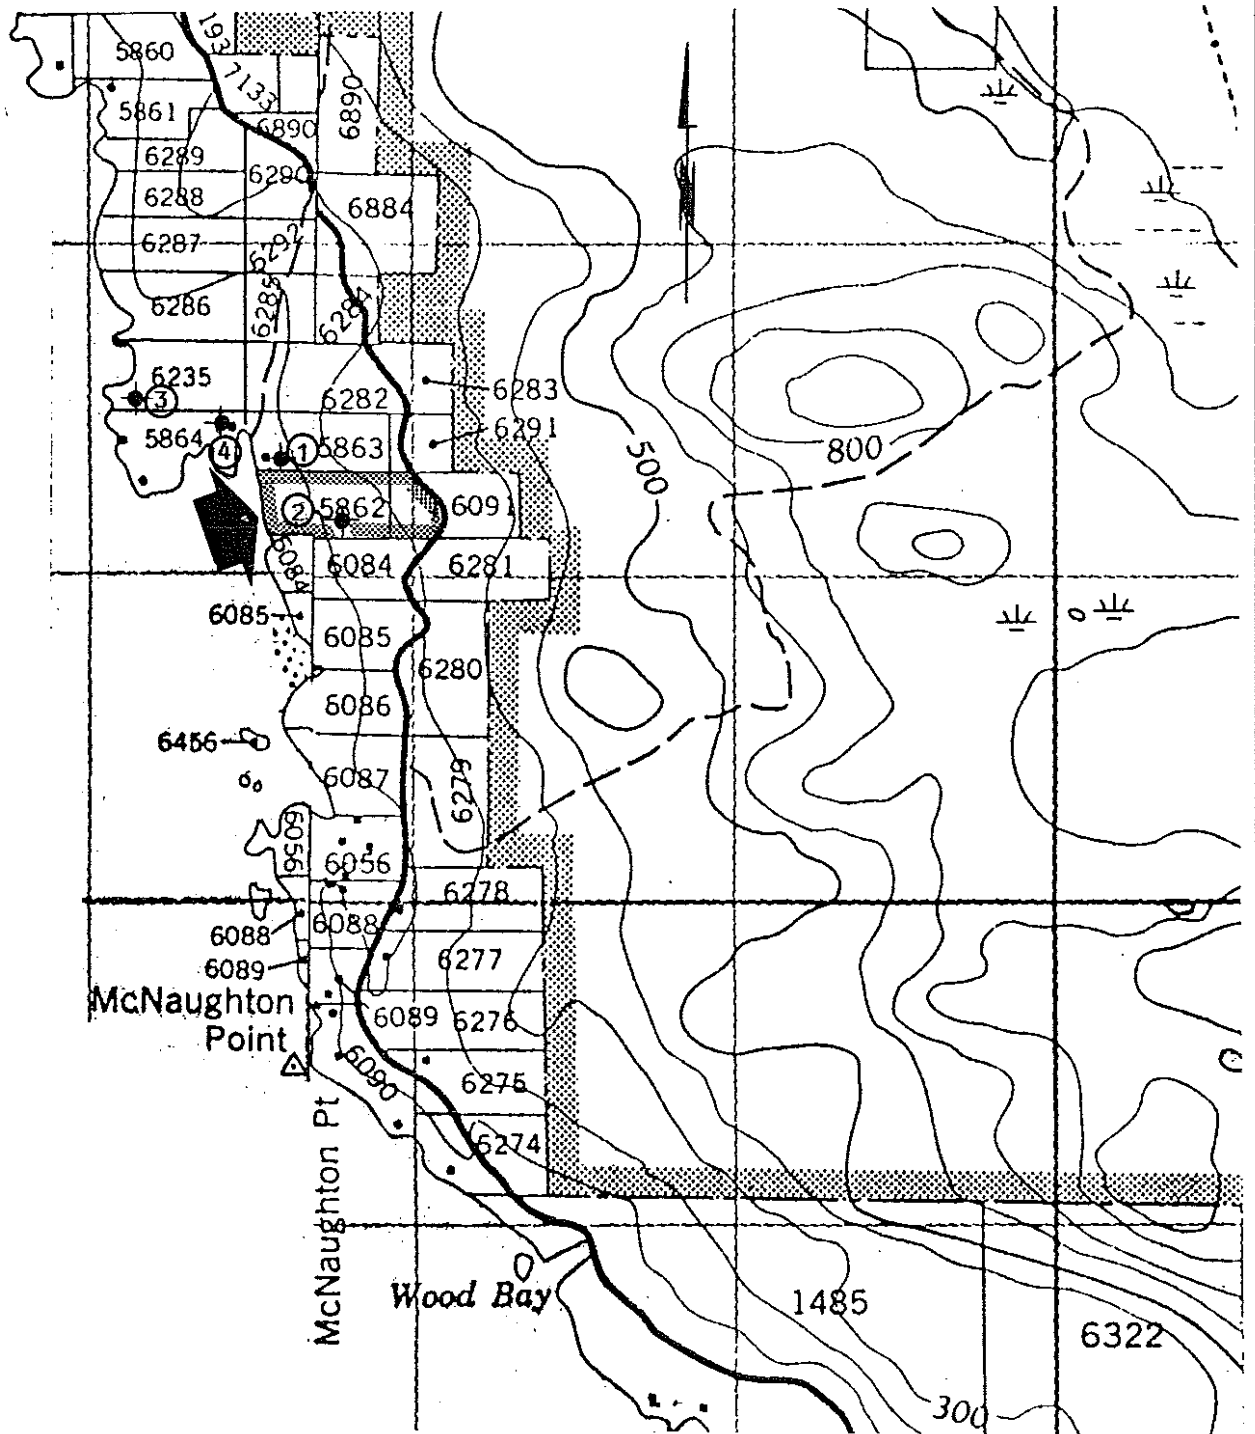
FIGURE 1

PROPOSED SUBDIVISION OF STRAIGHT PROPERTY
NORTH OF HALFMOON BAY ON SECHELT PENINSULA

1. The base map is prepared from 1:50,000 scale topographic maps 92F/9, Texada Island, and 92G/12, Sechart Inlet, enlarged to an approximate scale of 1:23,000.
2.

outlines location of proposed Straight Subdivision (see Figure 2, Page A - 2).
3.

indicates approximate location of a water well (see Table 1 in Appendix B).

Figure 1 in Appendix A is an area and water well location map; Figure 2 shows the layout and other features of the proposed Straight Subdivision. Appendix B contains a summary table of water wells in the subject area for which records are on file with B.C. Environment.
