Re: Gabriola Island Community Plan, Fault Zones

As requested by Mr. G. Tonn, Planner with the Islands Trust, a review has been undertaken of available hydrogeologic information pertaining to four "fault zones" designated in the map accompanying the Gabriola Island Community Plan (1978). These linear zones (700-foot wide strip) have been included in the community plan under Resource Protection Areas (20-acre minimum lot size), as "linear areas of rock fracture which allow surface and sub-surface water to penetrate to underground water sources known as aquifers". Available well log data, existing geology and groundwater reports and air photographs were examined in conjunction with a field visit of the area on May 30, 1979 to assess the hydrologic significance of these "fault" designated zones. For purposes of discussion the four linear zones have been arbitrarily designated areas A, B, C and D (Figure 1). A brief description of each zone is given below following a general discussion on fault terminology.

| <p>Province of British Columbia Ministry of the Environment ENVIRONMENTAL AND ENGINEERING SERVICE WATER INVESTIGATIONS BRANCH</p> | <p>TO ACCOMPANY REPORT ON GABRIOLA ISLAND COMM

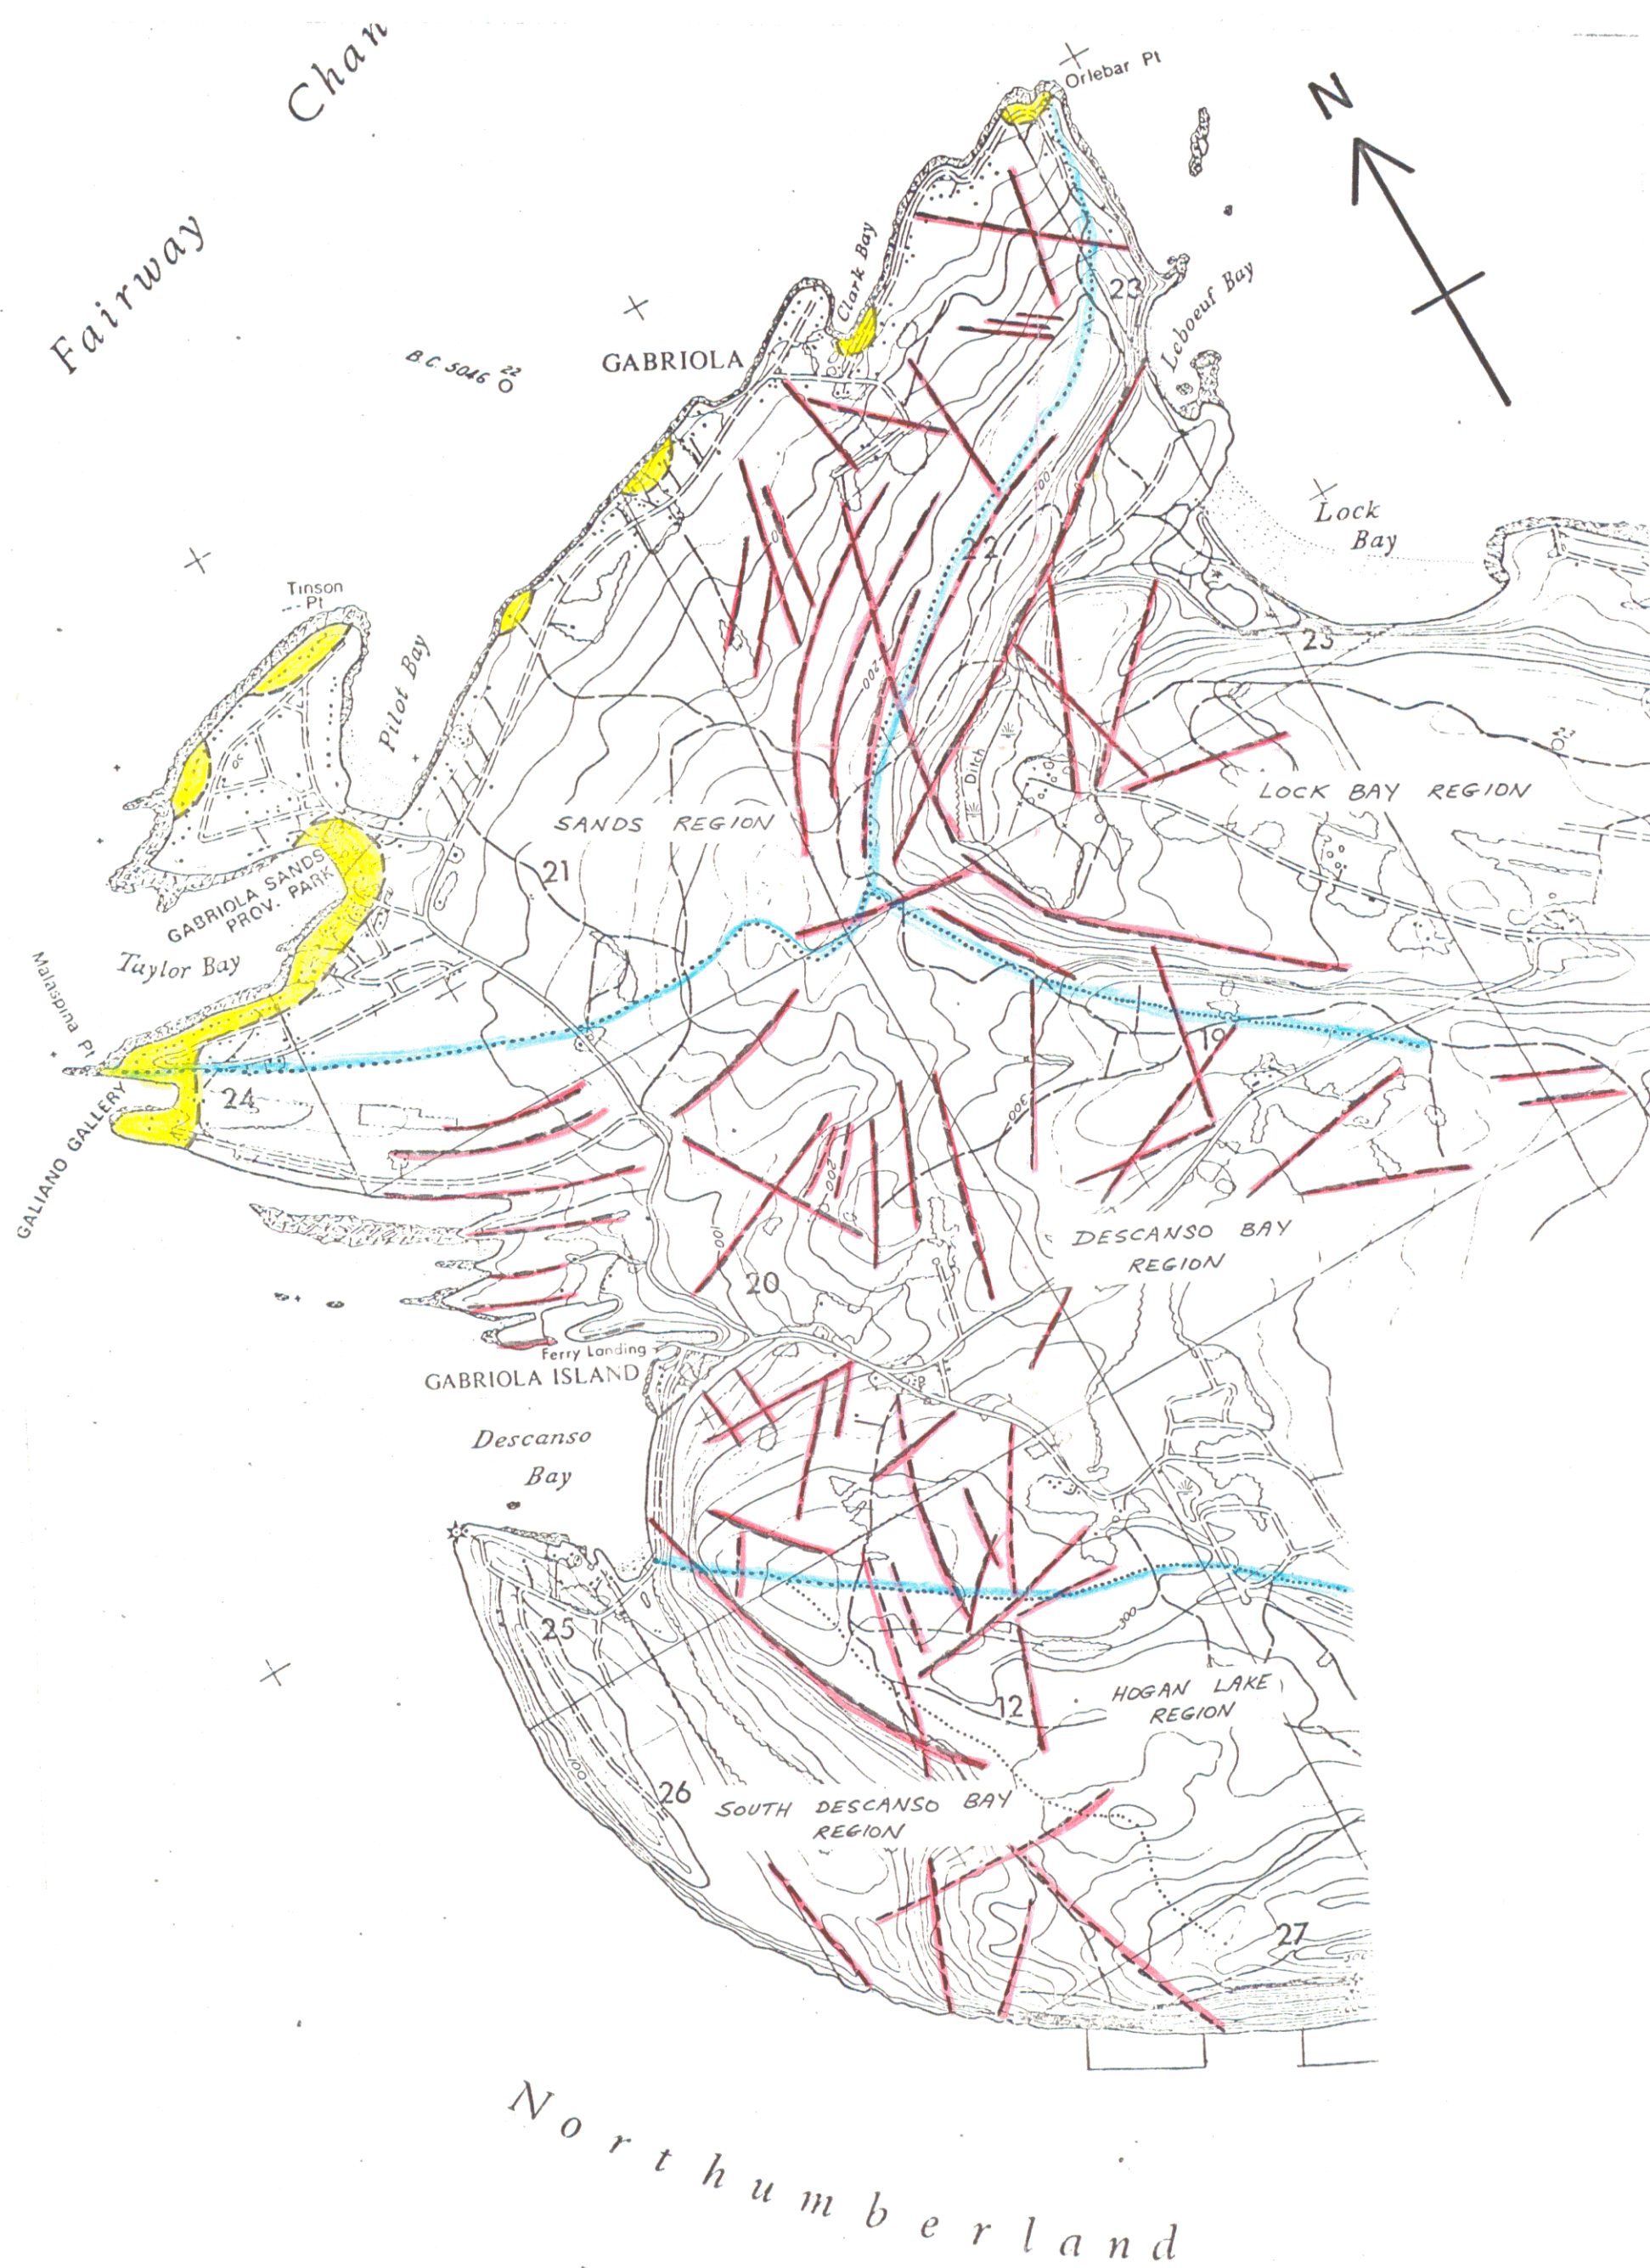
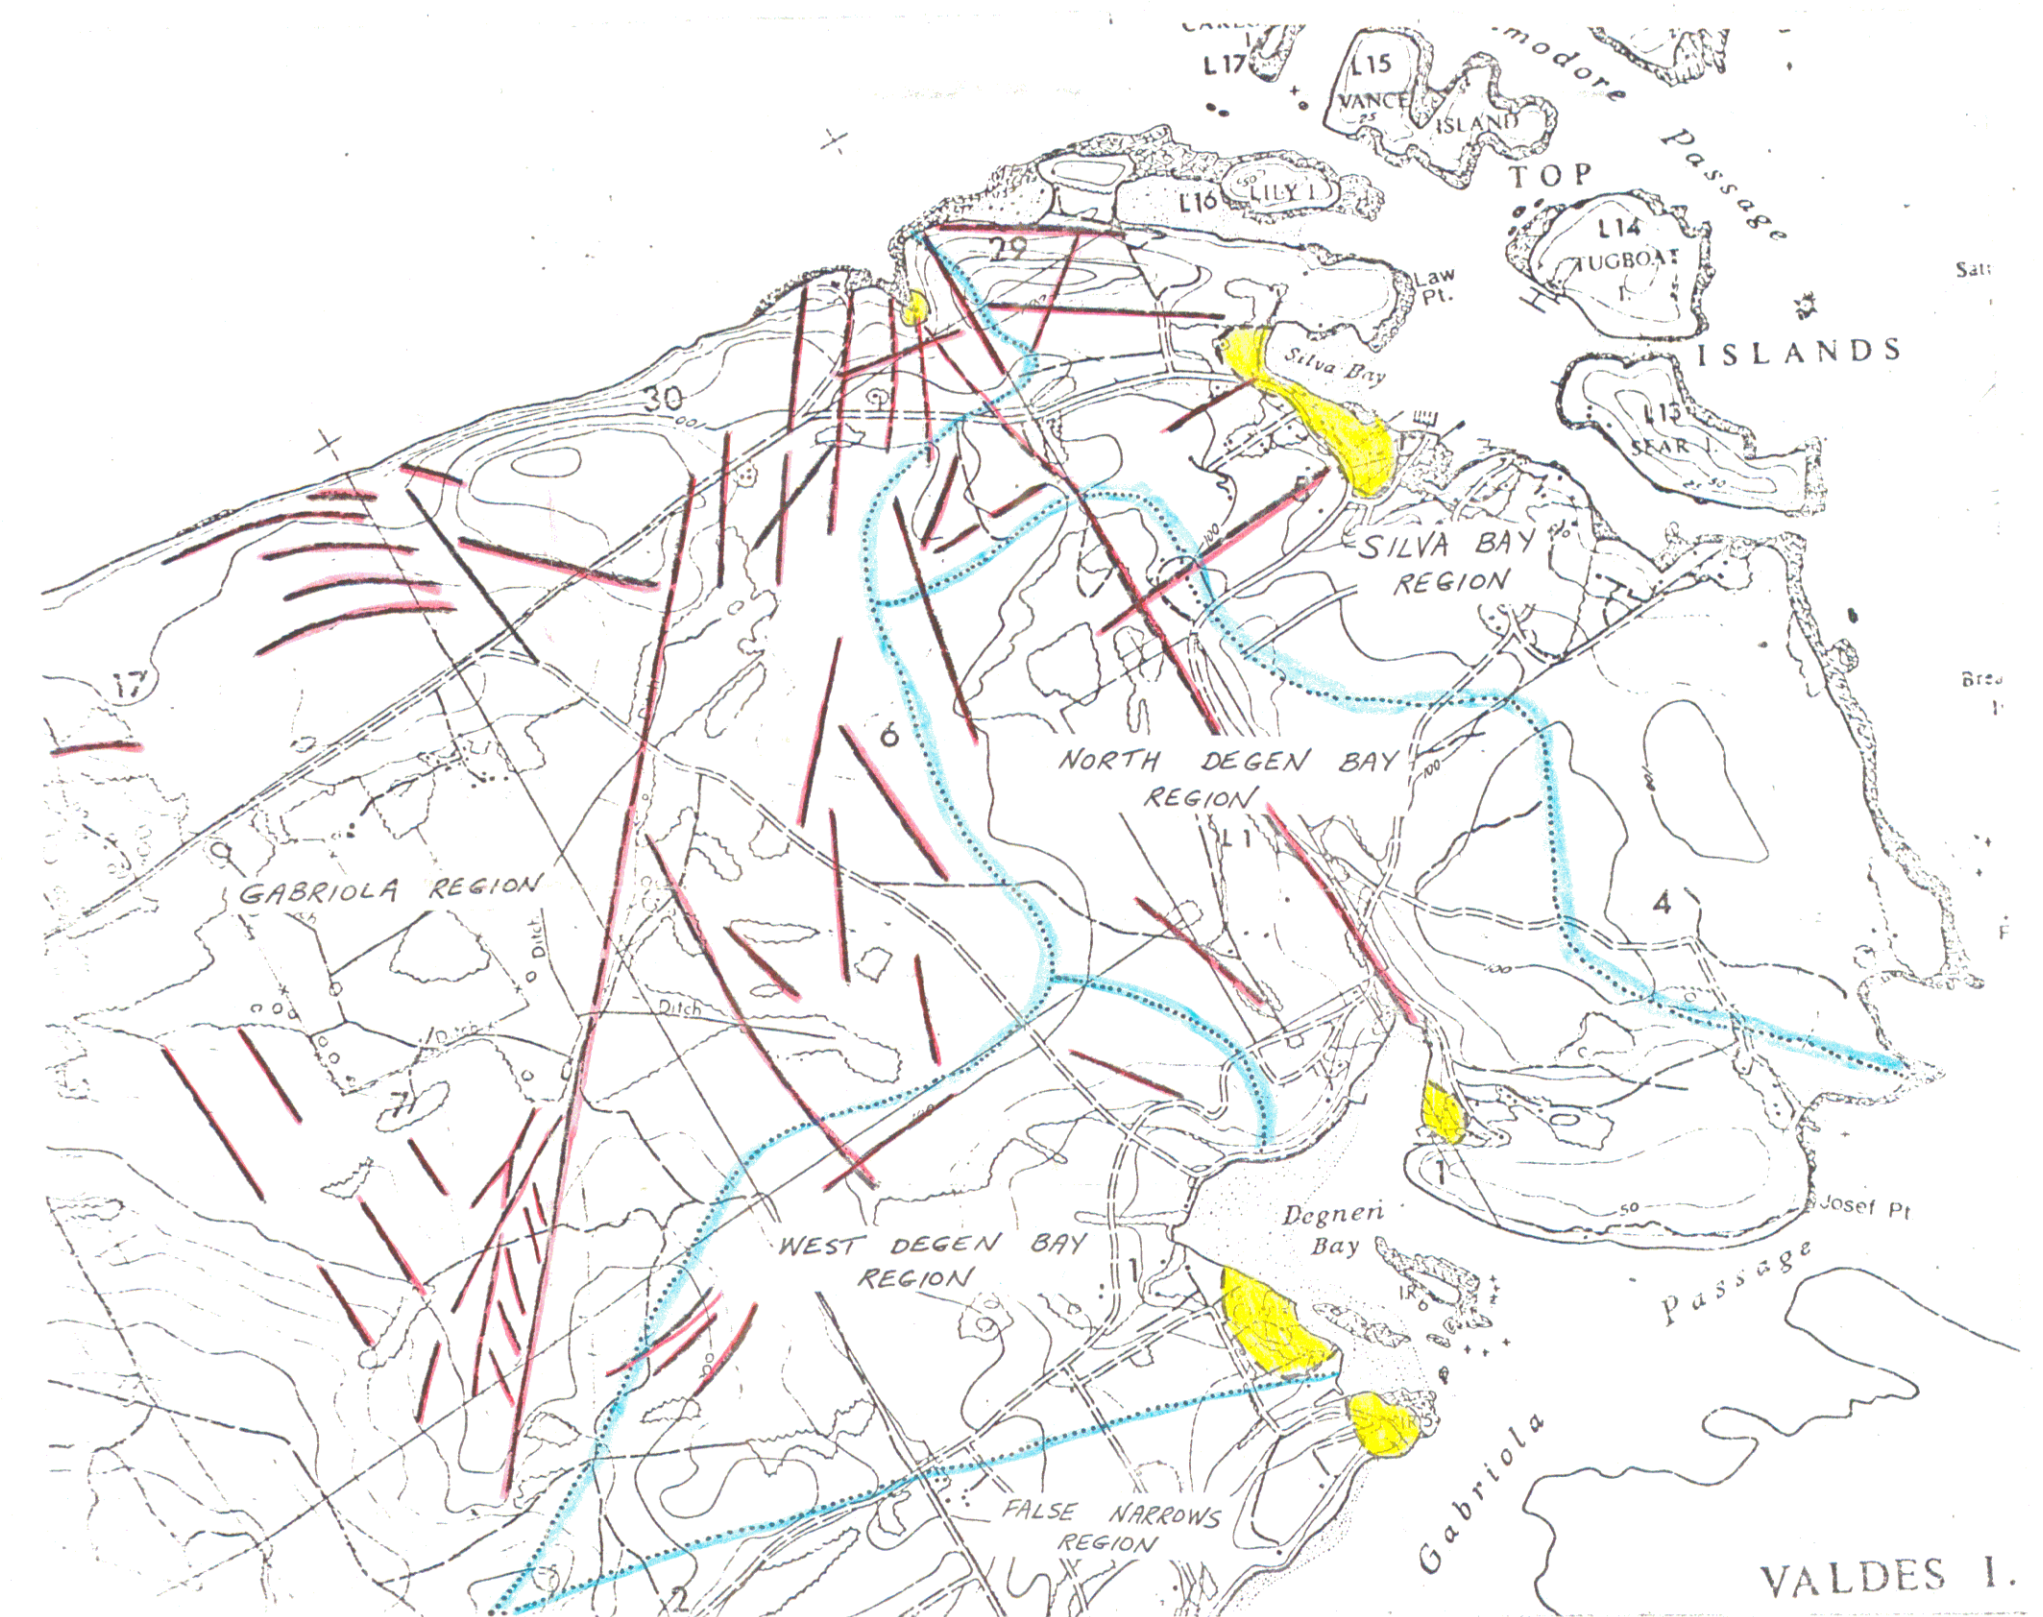
- STRUCTURAL LINEAMENT (includes faults, joints and bedding traces)
- WATERSHED BOUNDARY
- AREAS WHERE CHLORIDE CONCENTRATIONS IN GROUNDWATER EXCEED 100 MG/L

This northeasterly striking zone forms the northern extension of a major structural lineament clearly evident in air photographs of the island. The lineament has been mapped as a major transverse fault by Muller and Jeletzky (1970). In the northeastern part of Section 6 the zone occupies a topographic low (saddle) between two ridges. A few shallow wells (less than 110 feet) have been completed in the zone, showing moderate well yields up to 5 gpm, with water levels ranging from 30 to 50 feet below ground surface. Flowing artesian conditions have been encountered north of the fault zone where it intersects Peterson Road. Where the fault zone intersects the coastline, several parallel embayments occupied by shear joints were observed during the field examination. These zones which parallel the fault trend do not appear particularly permeable (clay gouge observed on shear planes), although the zones are lithologically weaker and more susceptible to erosion than adjacent rock masses. Some saline groundwater having a specific conductance of 4 000 micromhos/cm and chloride concentration of 1 300 mg/L has been delineated along the coast near the fault zone (Figure 2).

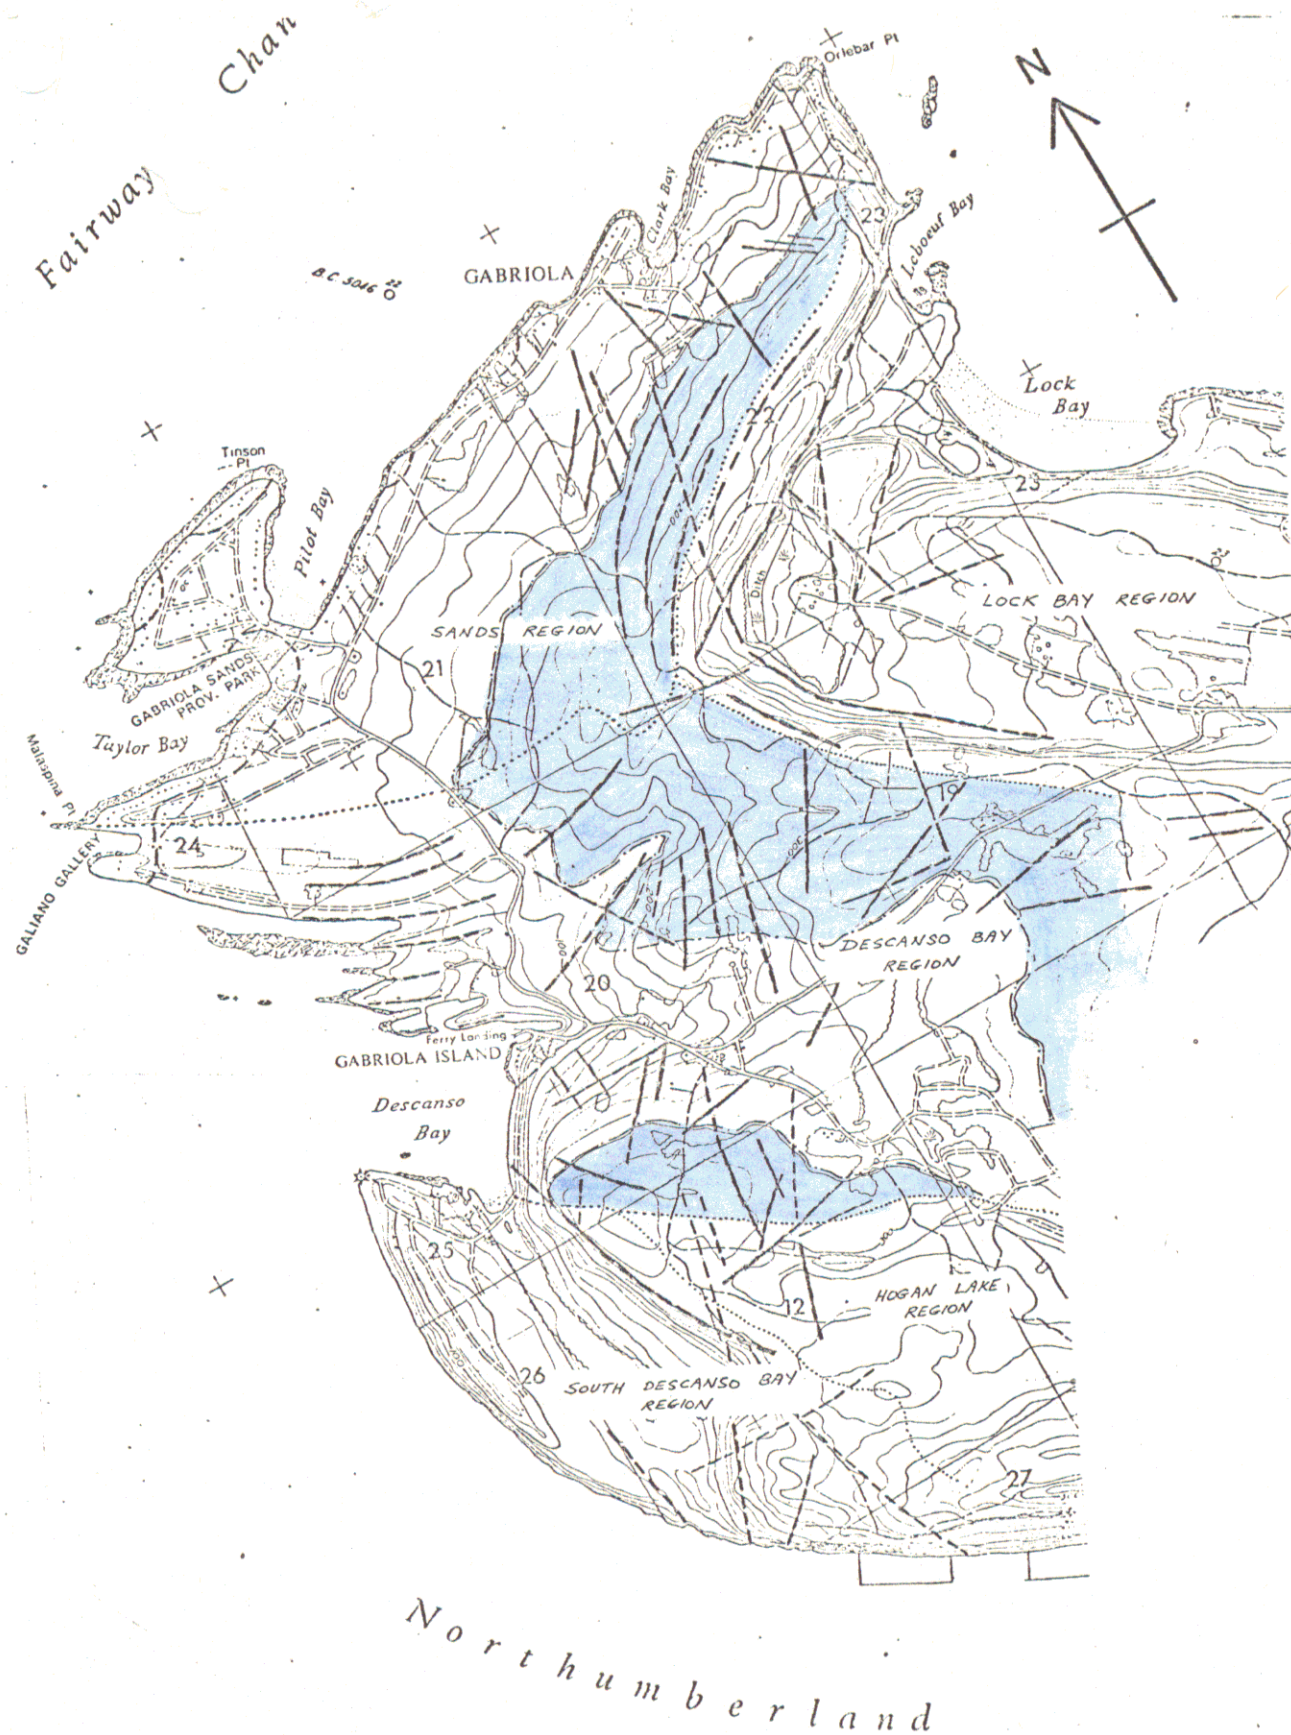
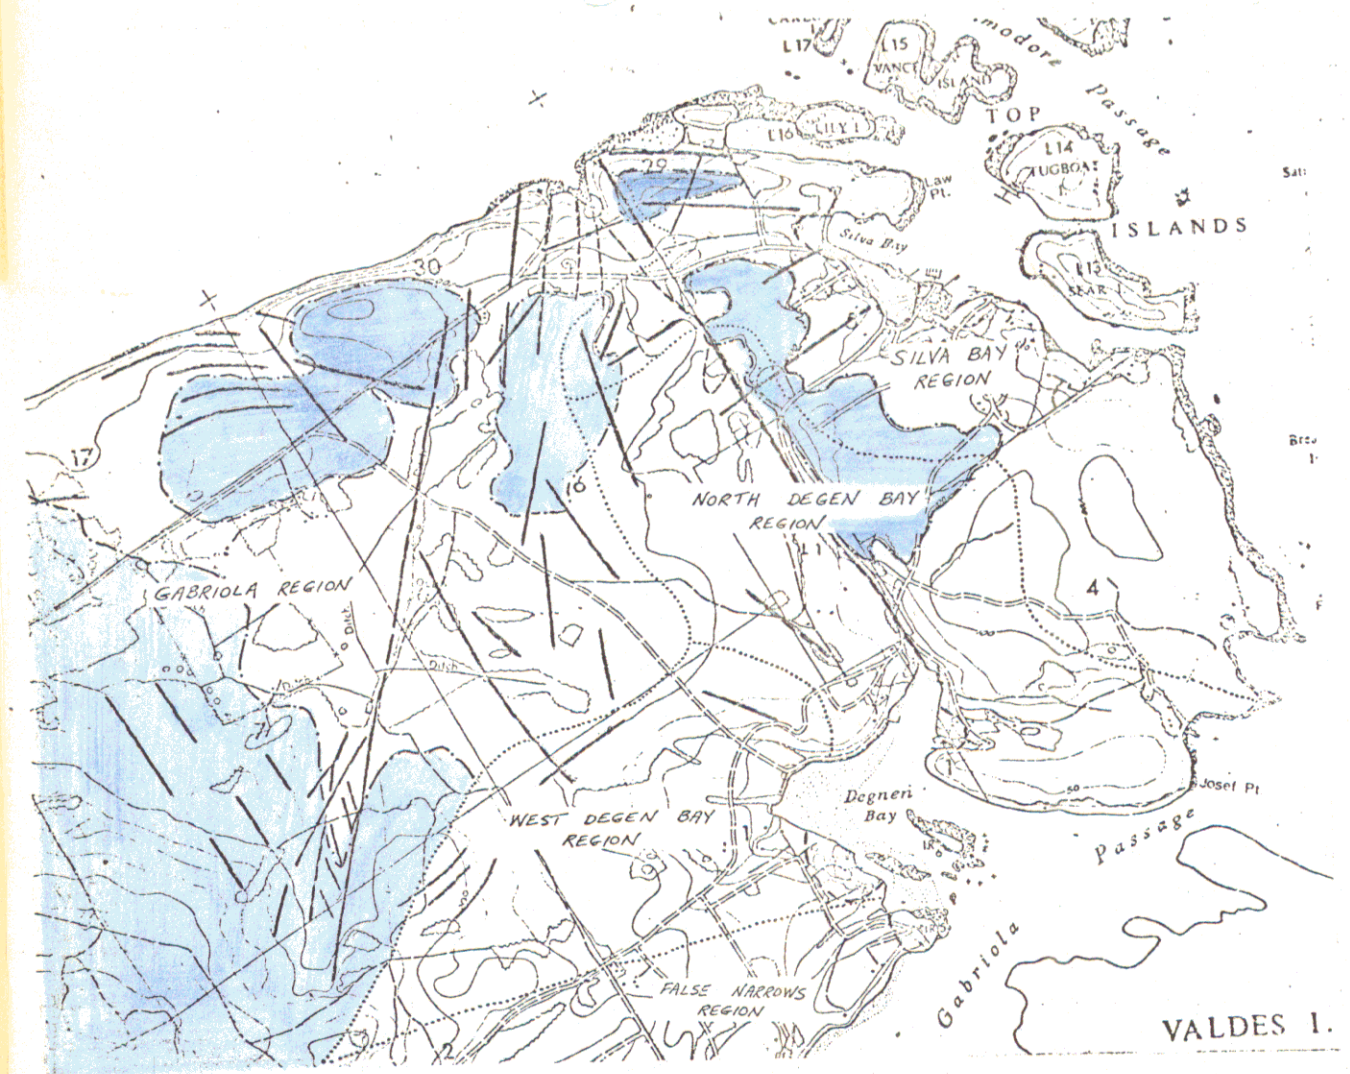
SUGGESTED WATERSHED PROTECTION AREAS
FOR GROUNDWATER RECHARGE IN THE
SANDS, DESCANSO BAY, GABRIOLA AND SILVA BAY REGIONS
