FINAL REPORT

Interior Watershed Assessment Procedure & Reconnaissance Stability Assessment of Structure Locations

Glade Creek

January, 2001

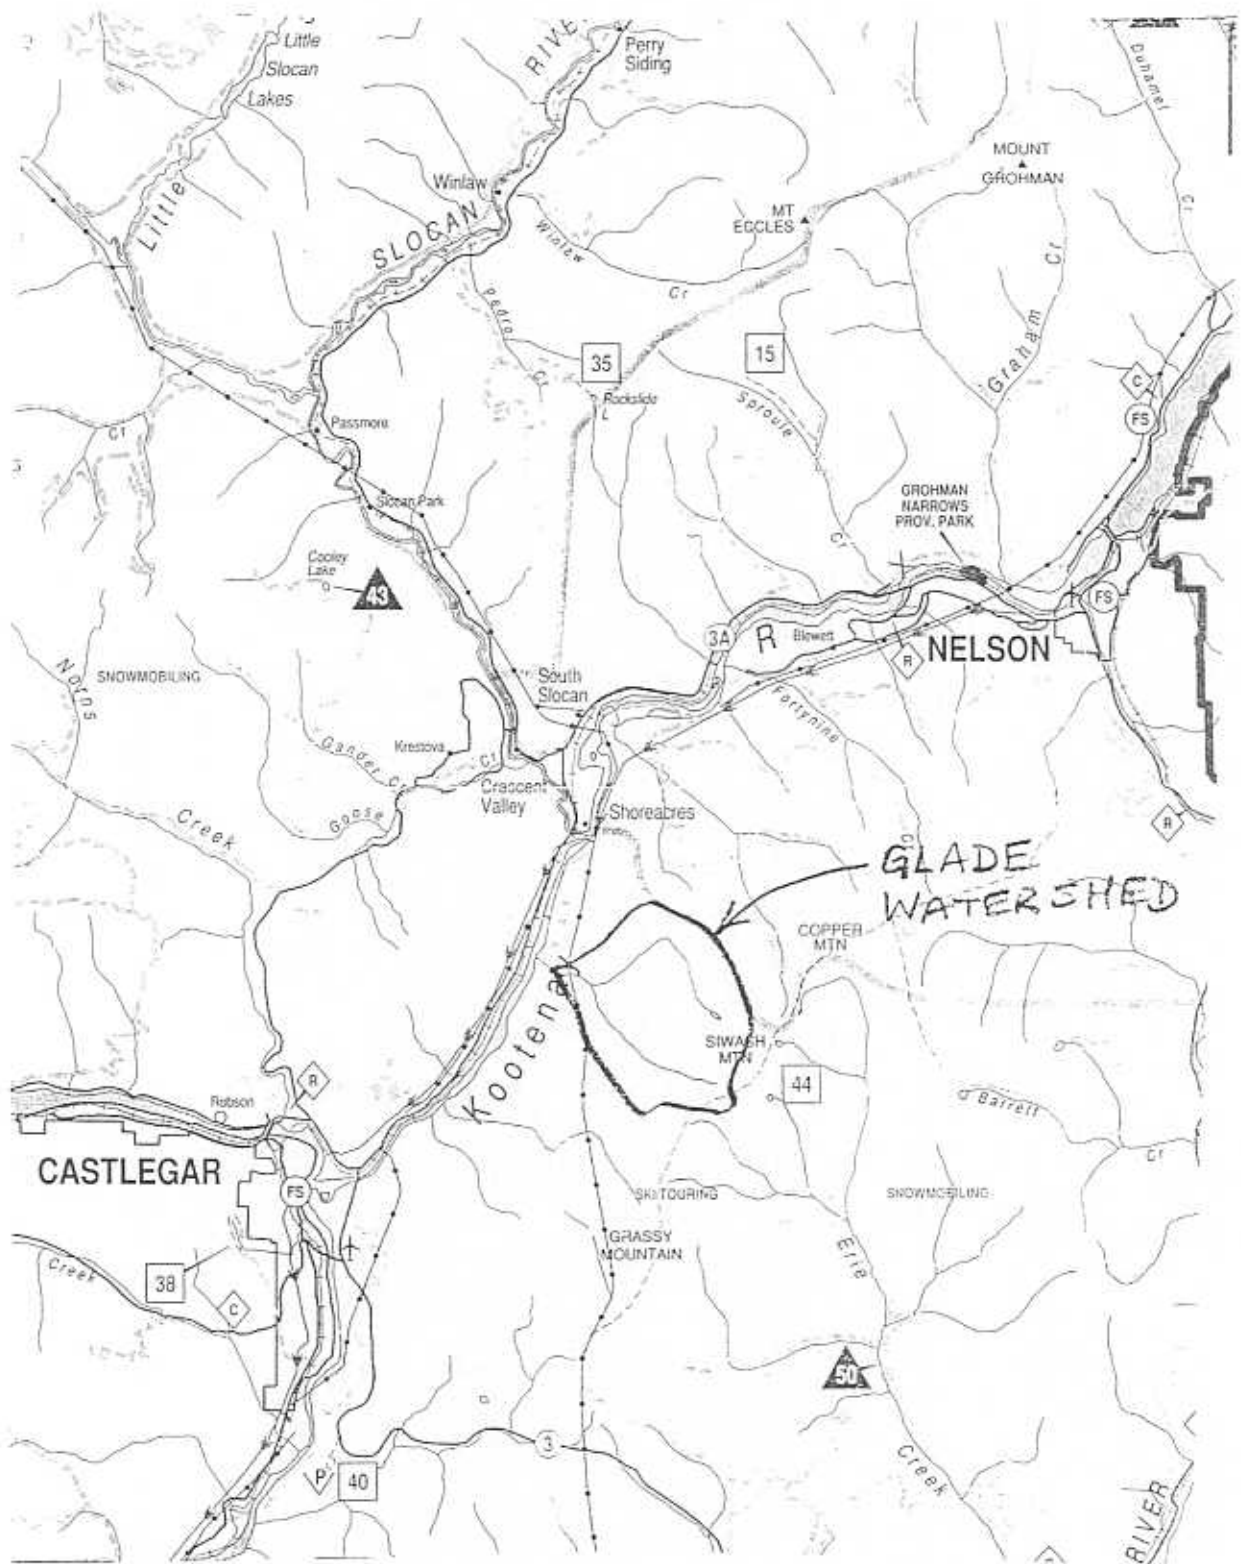
Figure 2.1. Study area location.

The Glade Creek study area is shown in Figure 2.1. The watershed is 29.6 km² in area and is located 15-20 km west of Nelson, B.C.

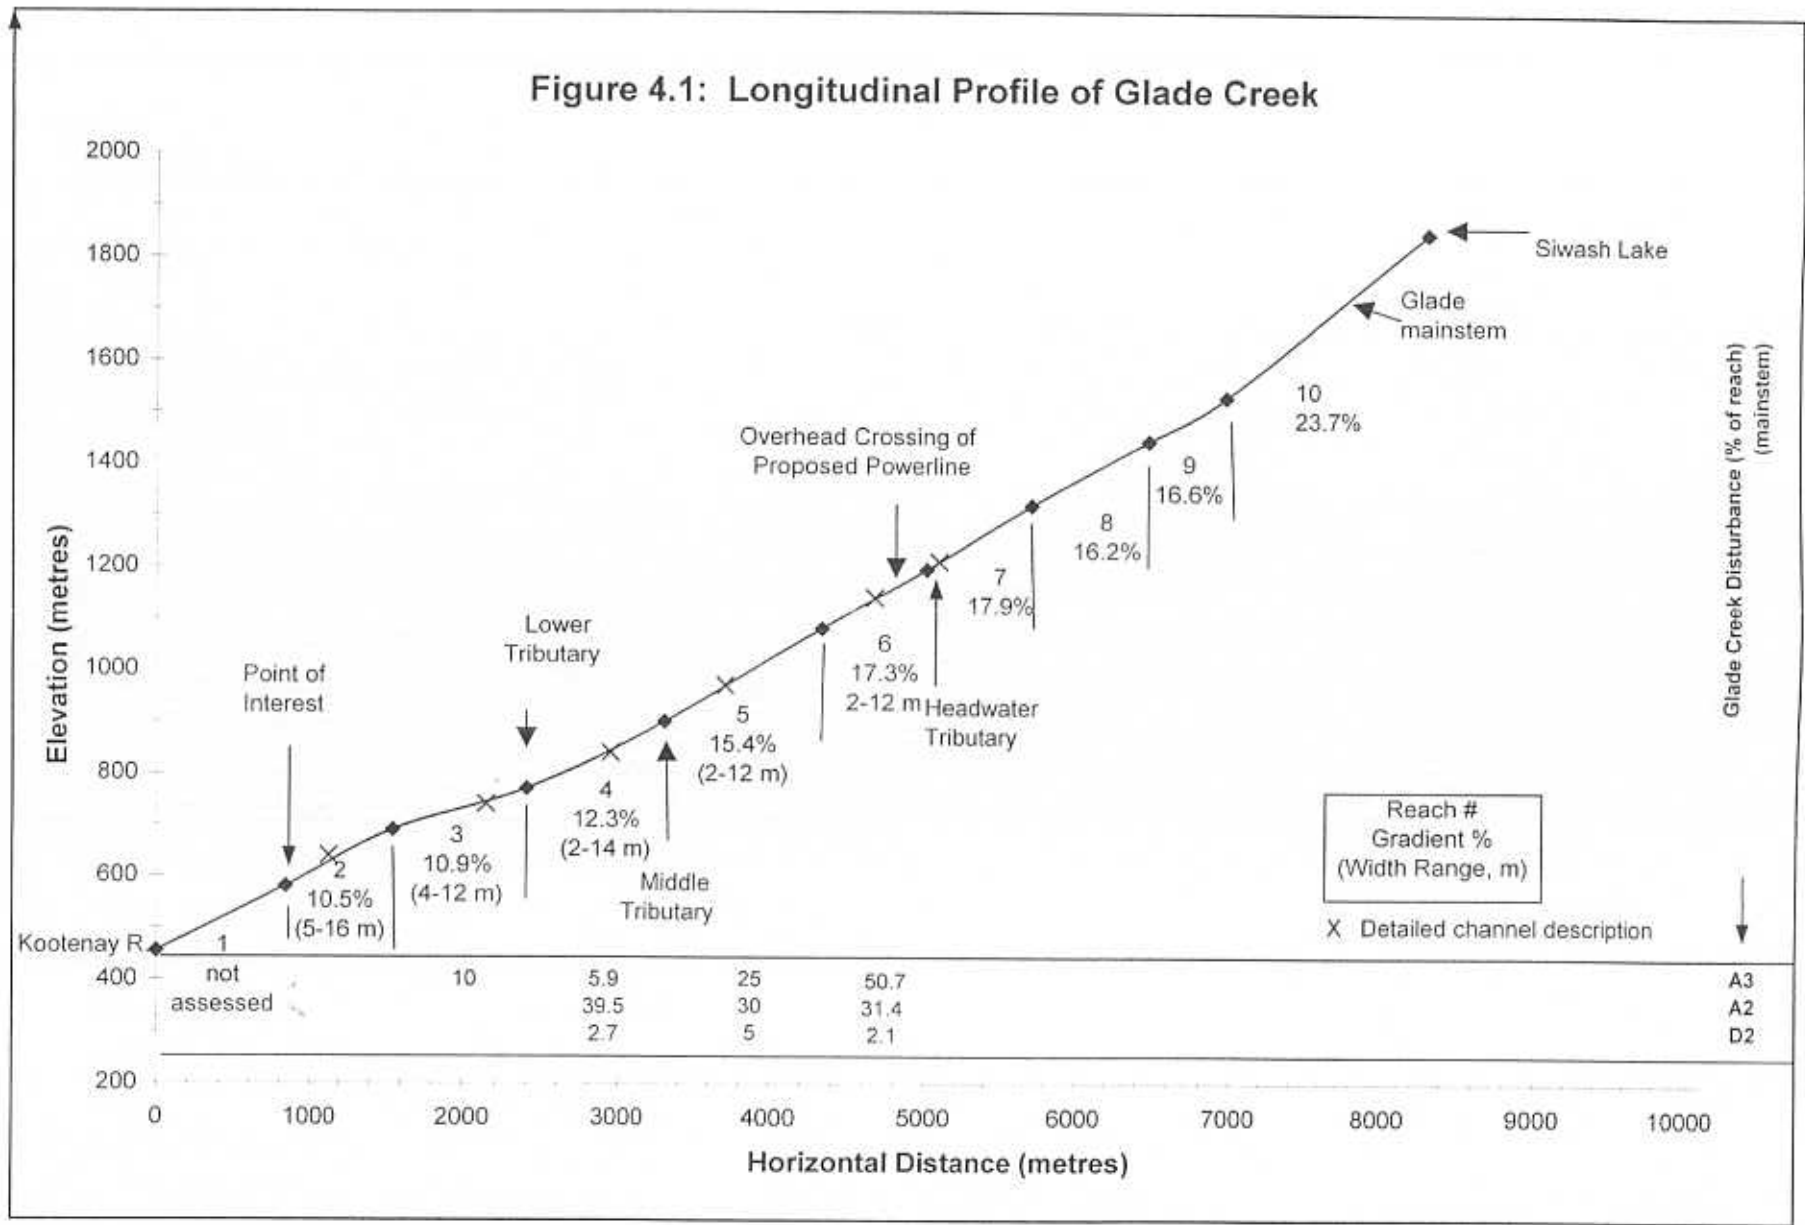
Figure 4.1: Longitudinal Profile of Glade Creek

As shown in longitudinal profile in Figure 4.1, the Mainstem of Glade Creek originates in Siwash Lake in the northeastern part of the watershed and flows north to a minor confluence with a headwater tributary. As the channel then flows southwest/west trend to its mouth at 455 m (at the Kootenay River), two significant tributaries flow into Glade Creek ("Upper Mainstem"). The confluence with the Middle Tributaries at 900 m contributes a minor increase to the total flow. The addition of the Lower Tributary at 775 m almost doubles the flow and creates a distinctly different channel in this lower section of the Mainstem ("Lower Mainstem").

Ten reaches were identified between Kootenay River and the basin headwaters. Physical characteristics of each reach are provided in Table 4.2 along with their disturbance ratings. Figure 4.1 provides this information on a longitudinal profile of Glade Creek. These results show that 40% of surveyed reaches are moderately or severely aggraded/degraded. The majority of these disturbed sections were in reaches 4 through 6. Table A2.1b provides details on the presence/absence of disturbance indicators as recorded in the field. The channel was observed to have very high width-to-depth ratios (10 to 50) indicative of a lack of storage capacity due to aggradation. The stream is expected to have SPb-w and CPb-w morphology though functioning wood was severely reduced in the upper mainstem channel (reaches 4-6).
