Upper Adams Watershed Risk Analysis

Prepared for:

Gilbert Smith Forest Products Ltd.
Box 689 Barriere, BC, V0E 1E0

Forsite Consultants Ltd.
#330 42nd St SW
Salmon Arm, BC
V1E 4R1

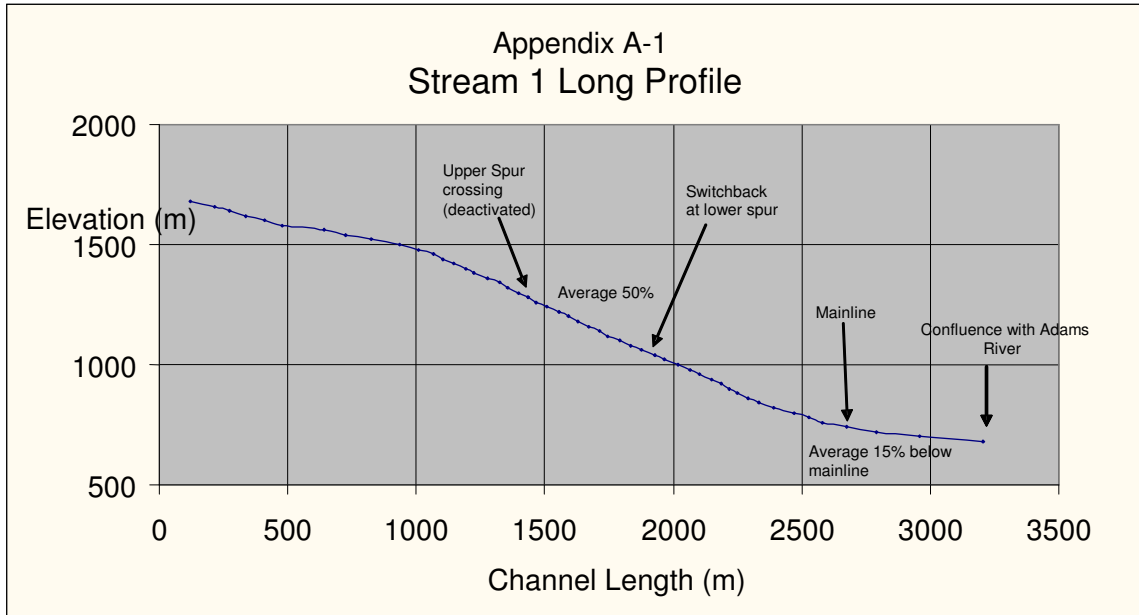
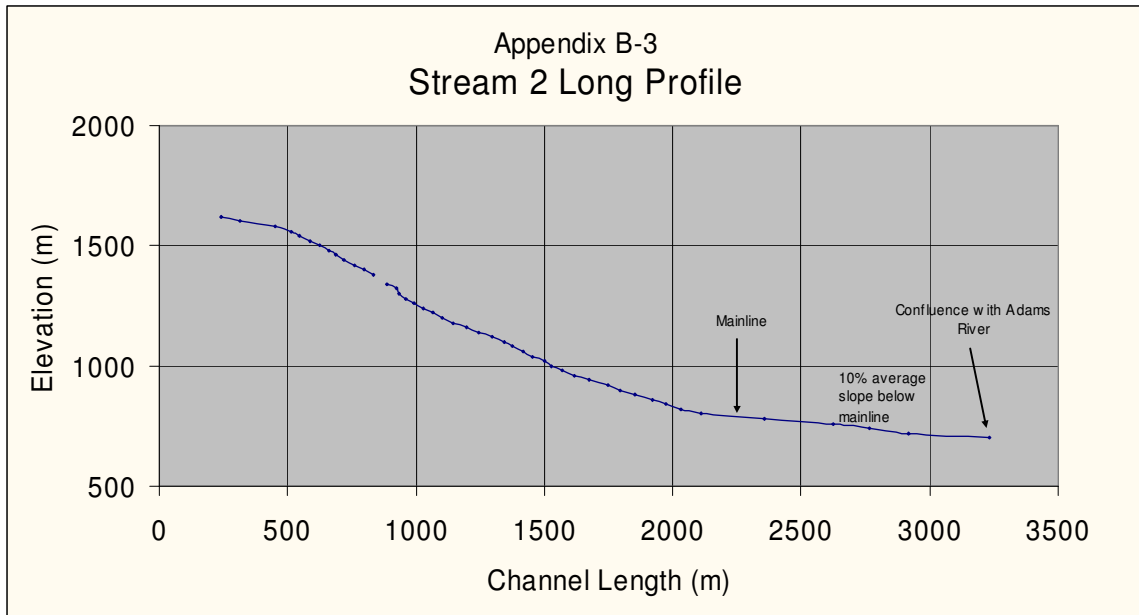
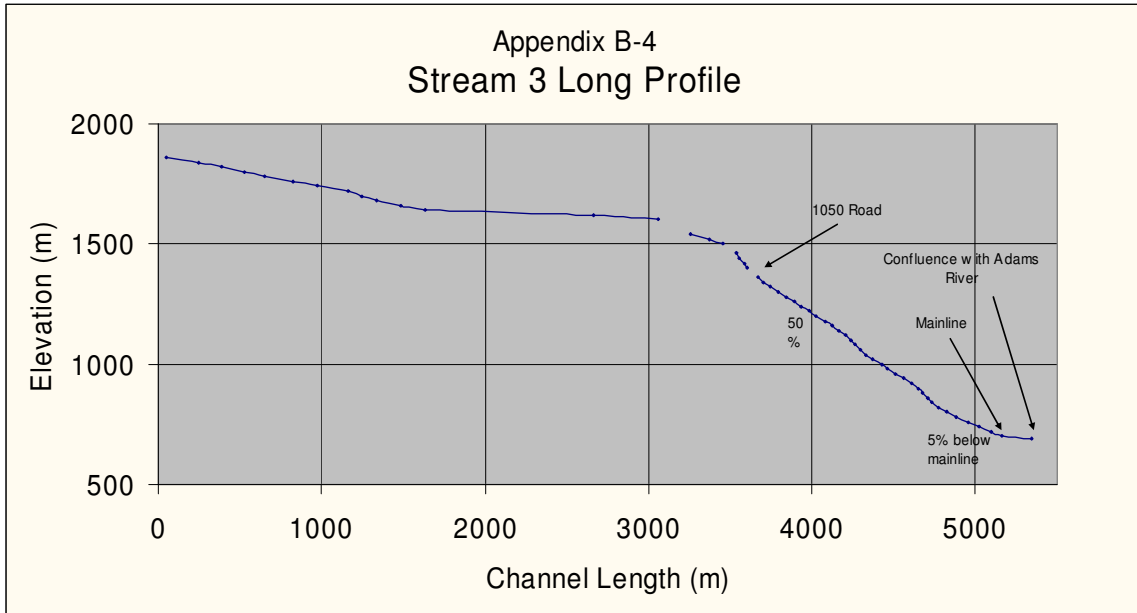
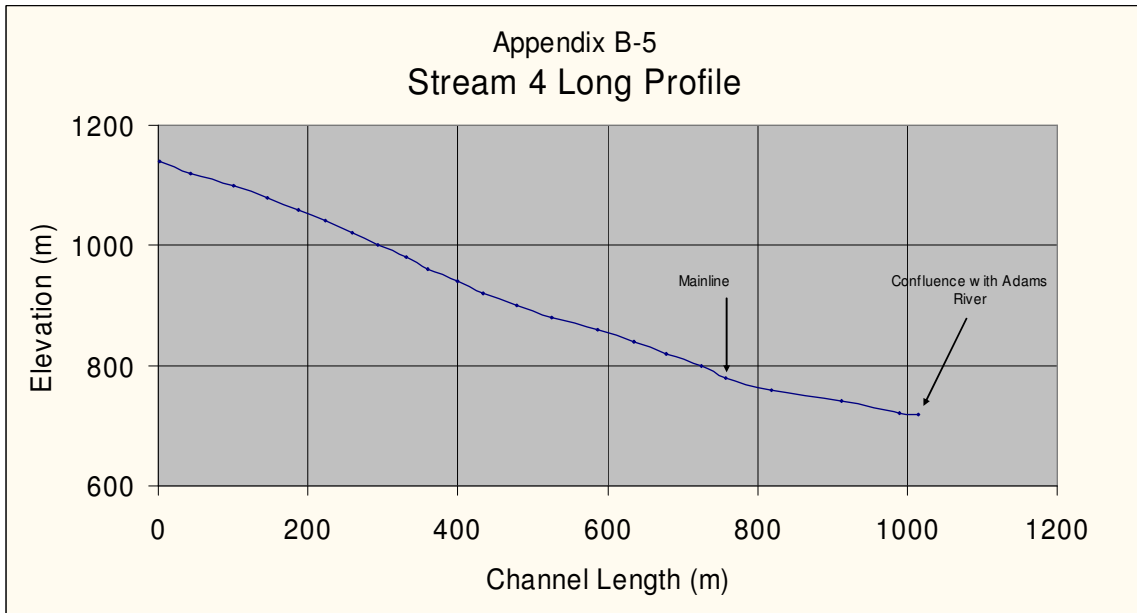
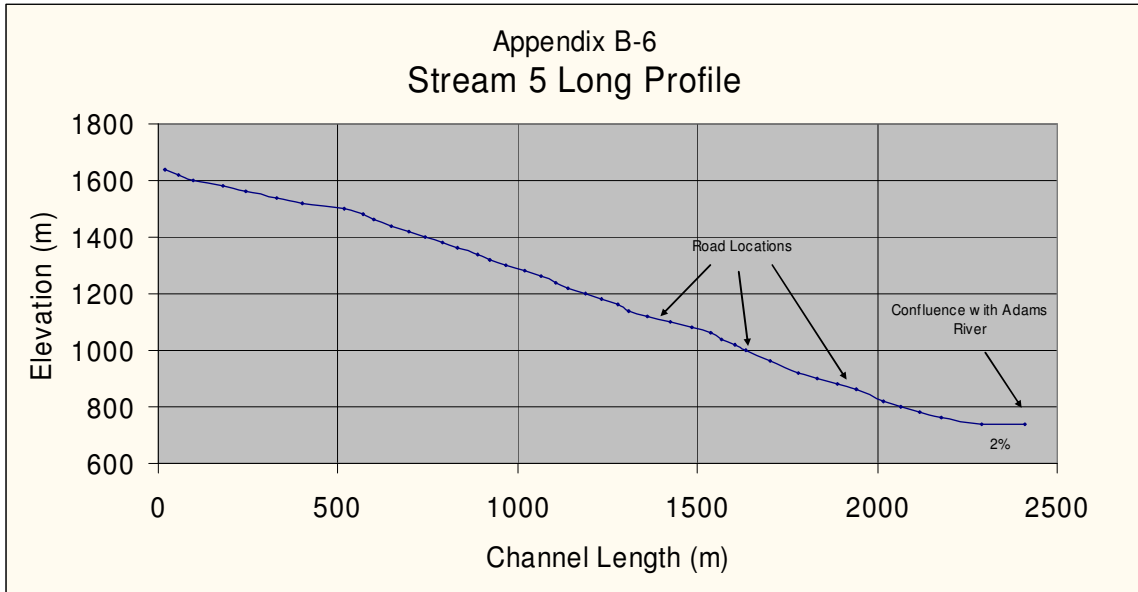
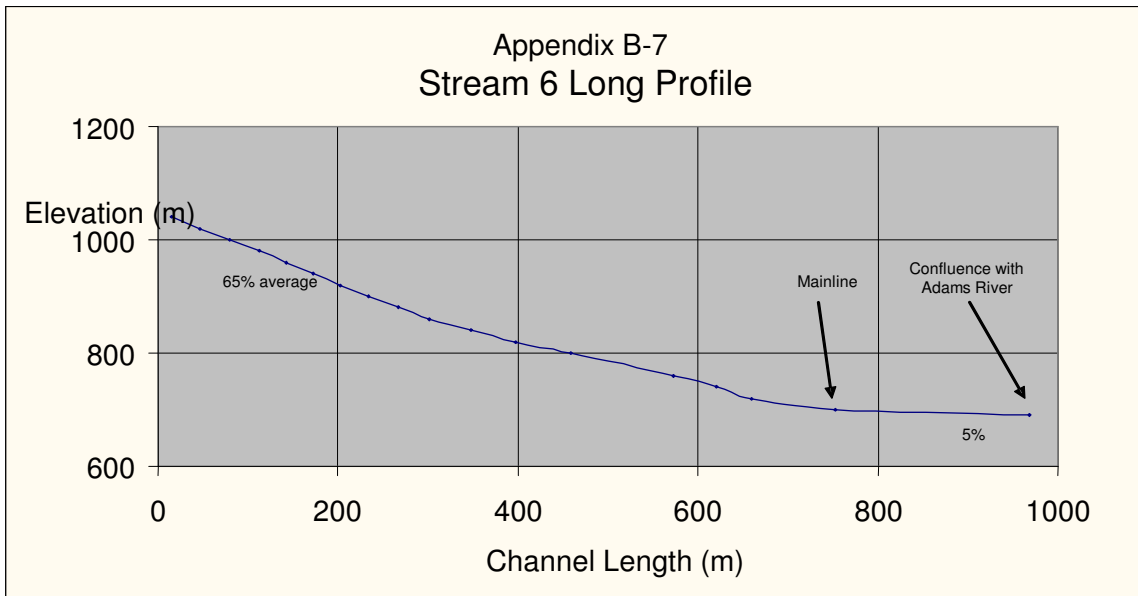
Appendix A	GPS locations of assessment sites.....	attached
Appendix B	Long Profiles of selected streams.....	attached
