ALBRED A / ROBIN A

TERRAIN STABILITY INTERPRETIVE MAP

BCGS Mapsheet 83D.045, 83D.055, 83D.065

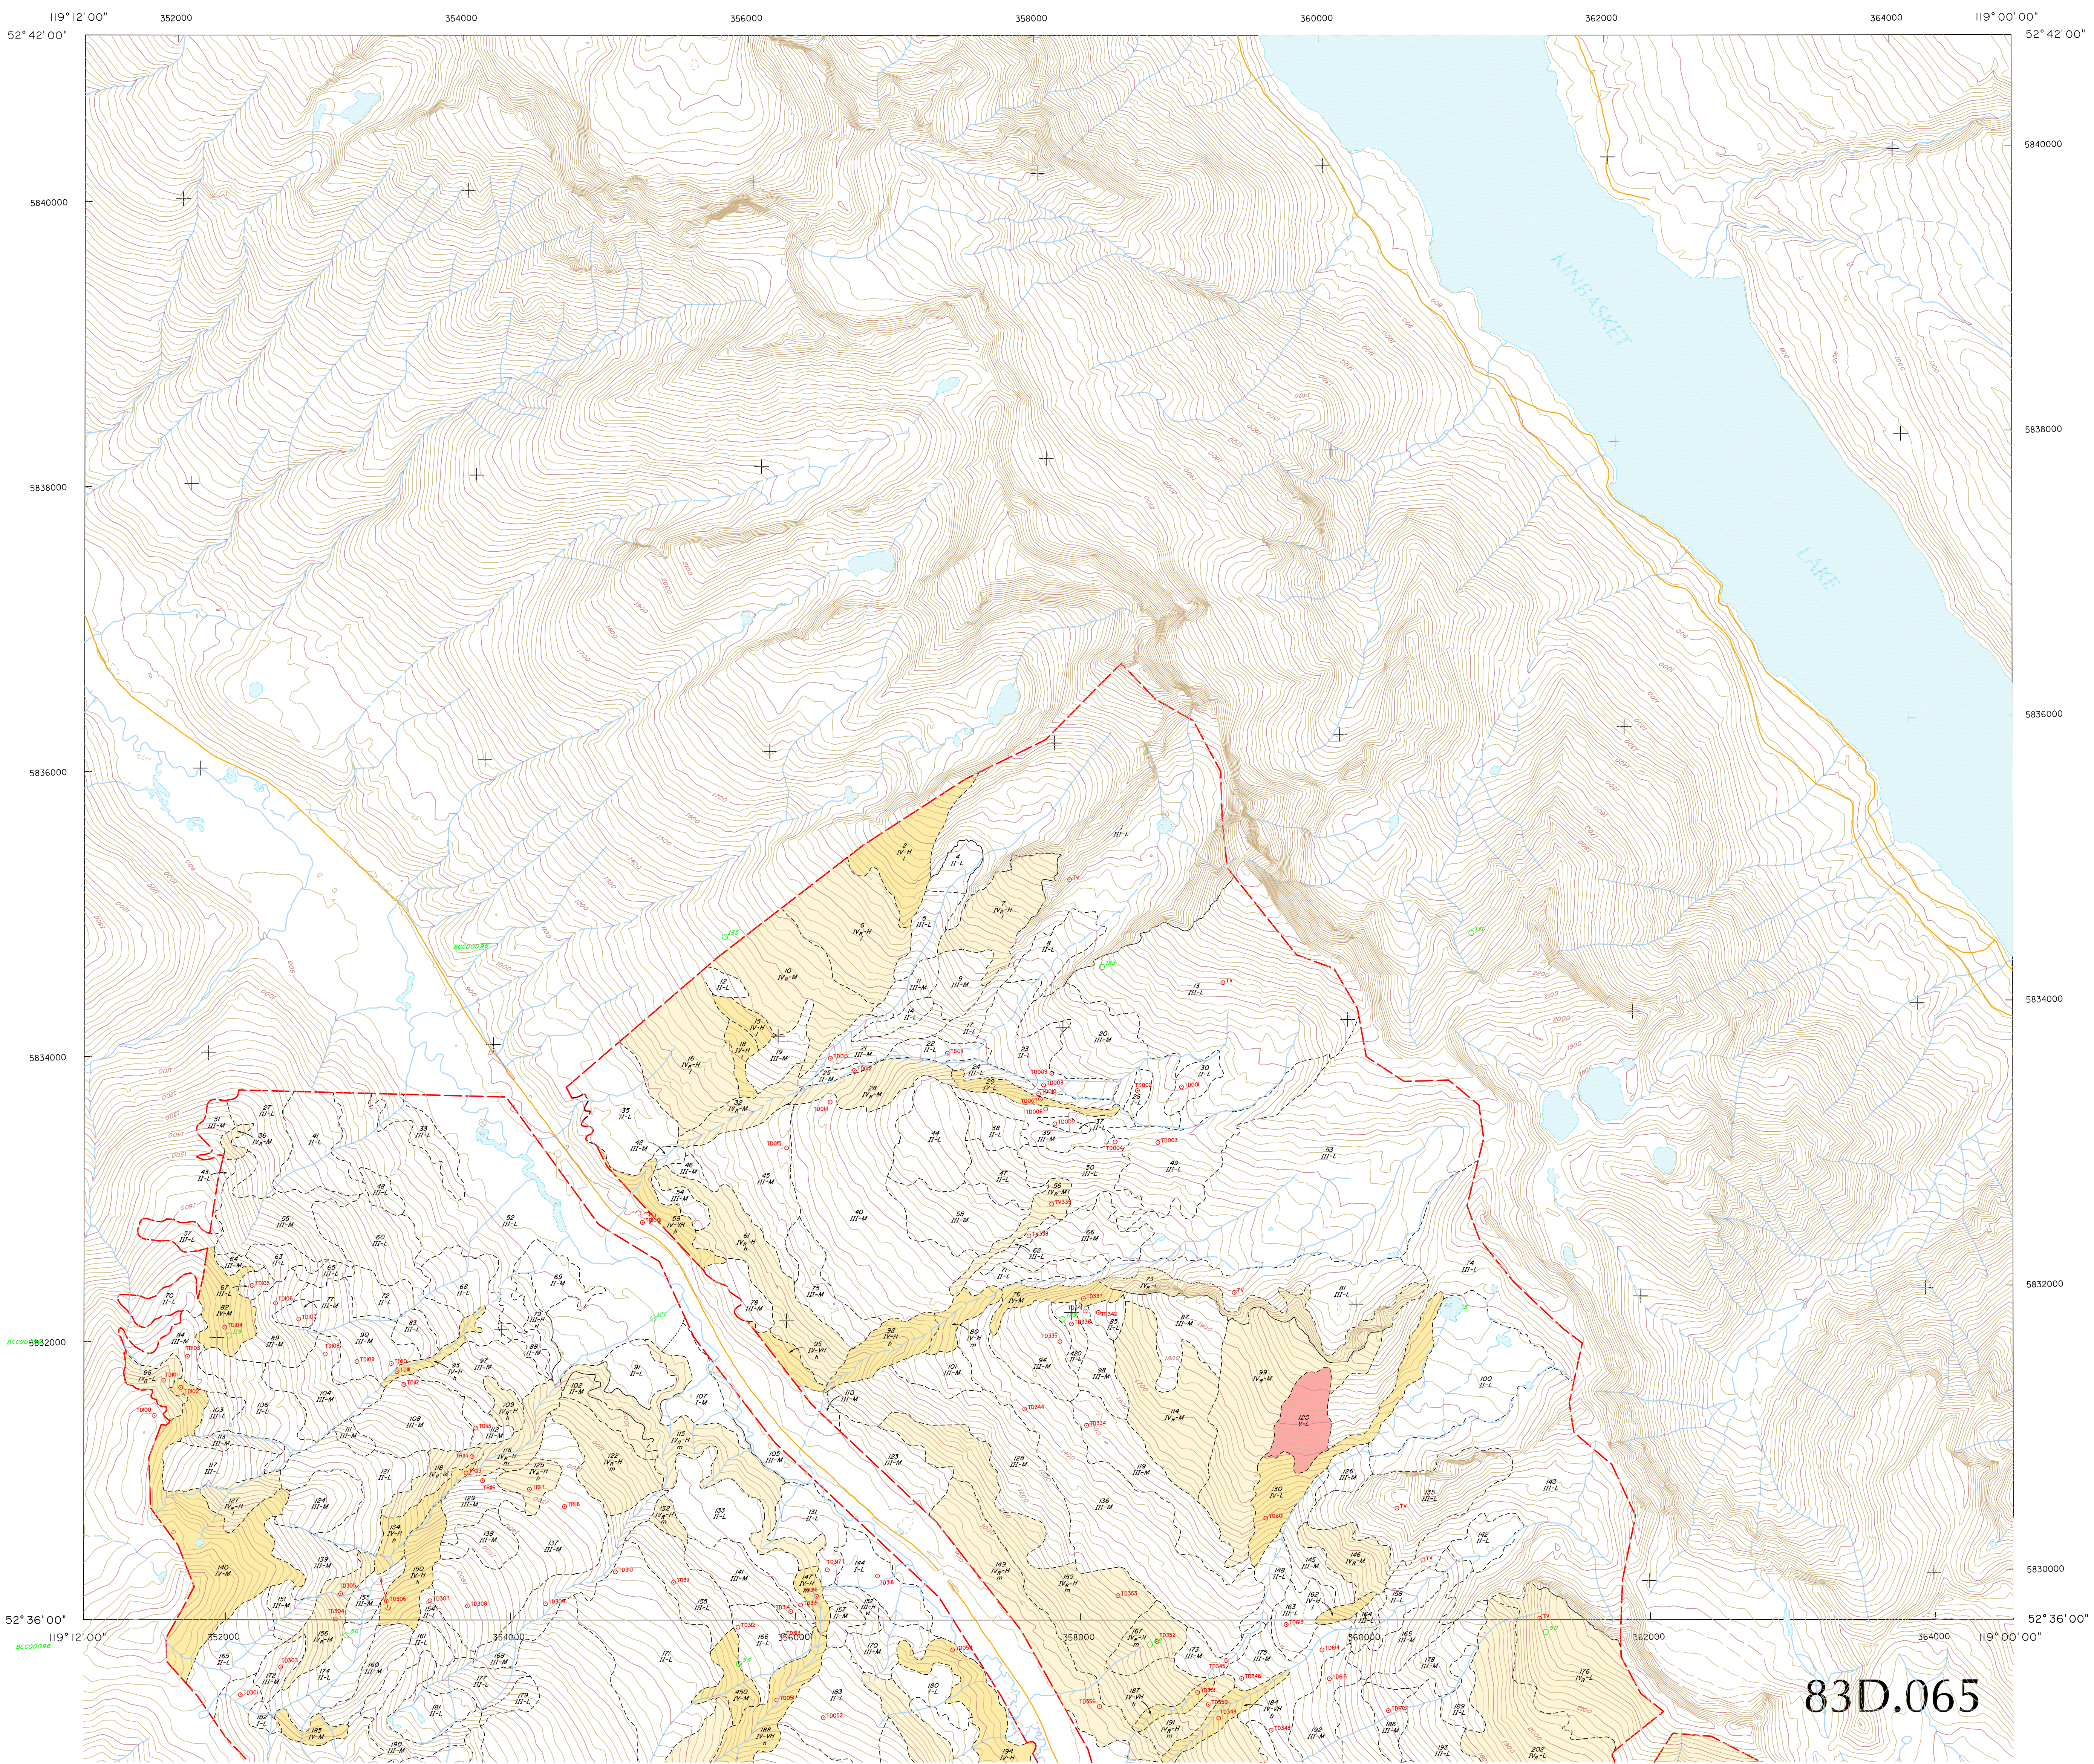
EXAMPLE OF MAP SYMBOLS

polygon number

terrain stability class

surface erosion potential

potential for sediment delivery from surface erosion sources
