MESSITER / AVOLA / McMURPHY
TERRAIN STABILITY INTERPRETIVE MAP
BCGS mapsheet 82M.063, 82M.064, 82M.073, 82M.074,
82M.083, 82M.084, 82M.093, 82M.094
Scale 1:20,000

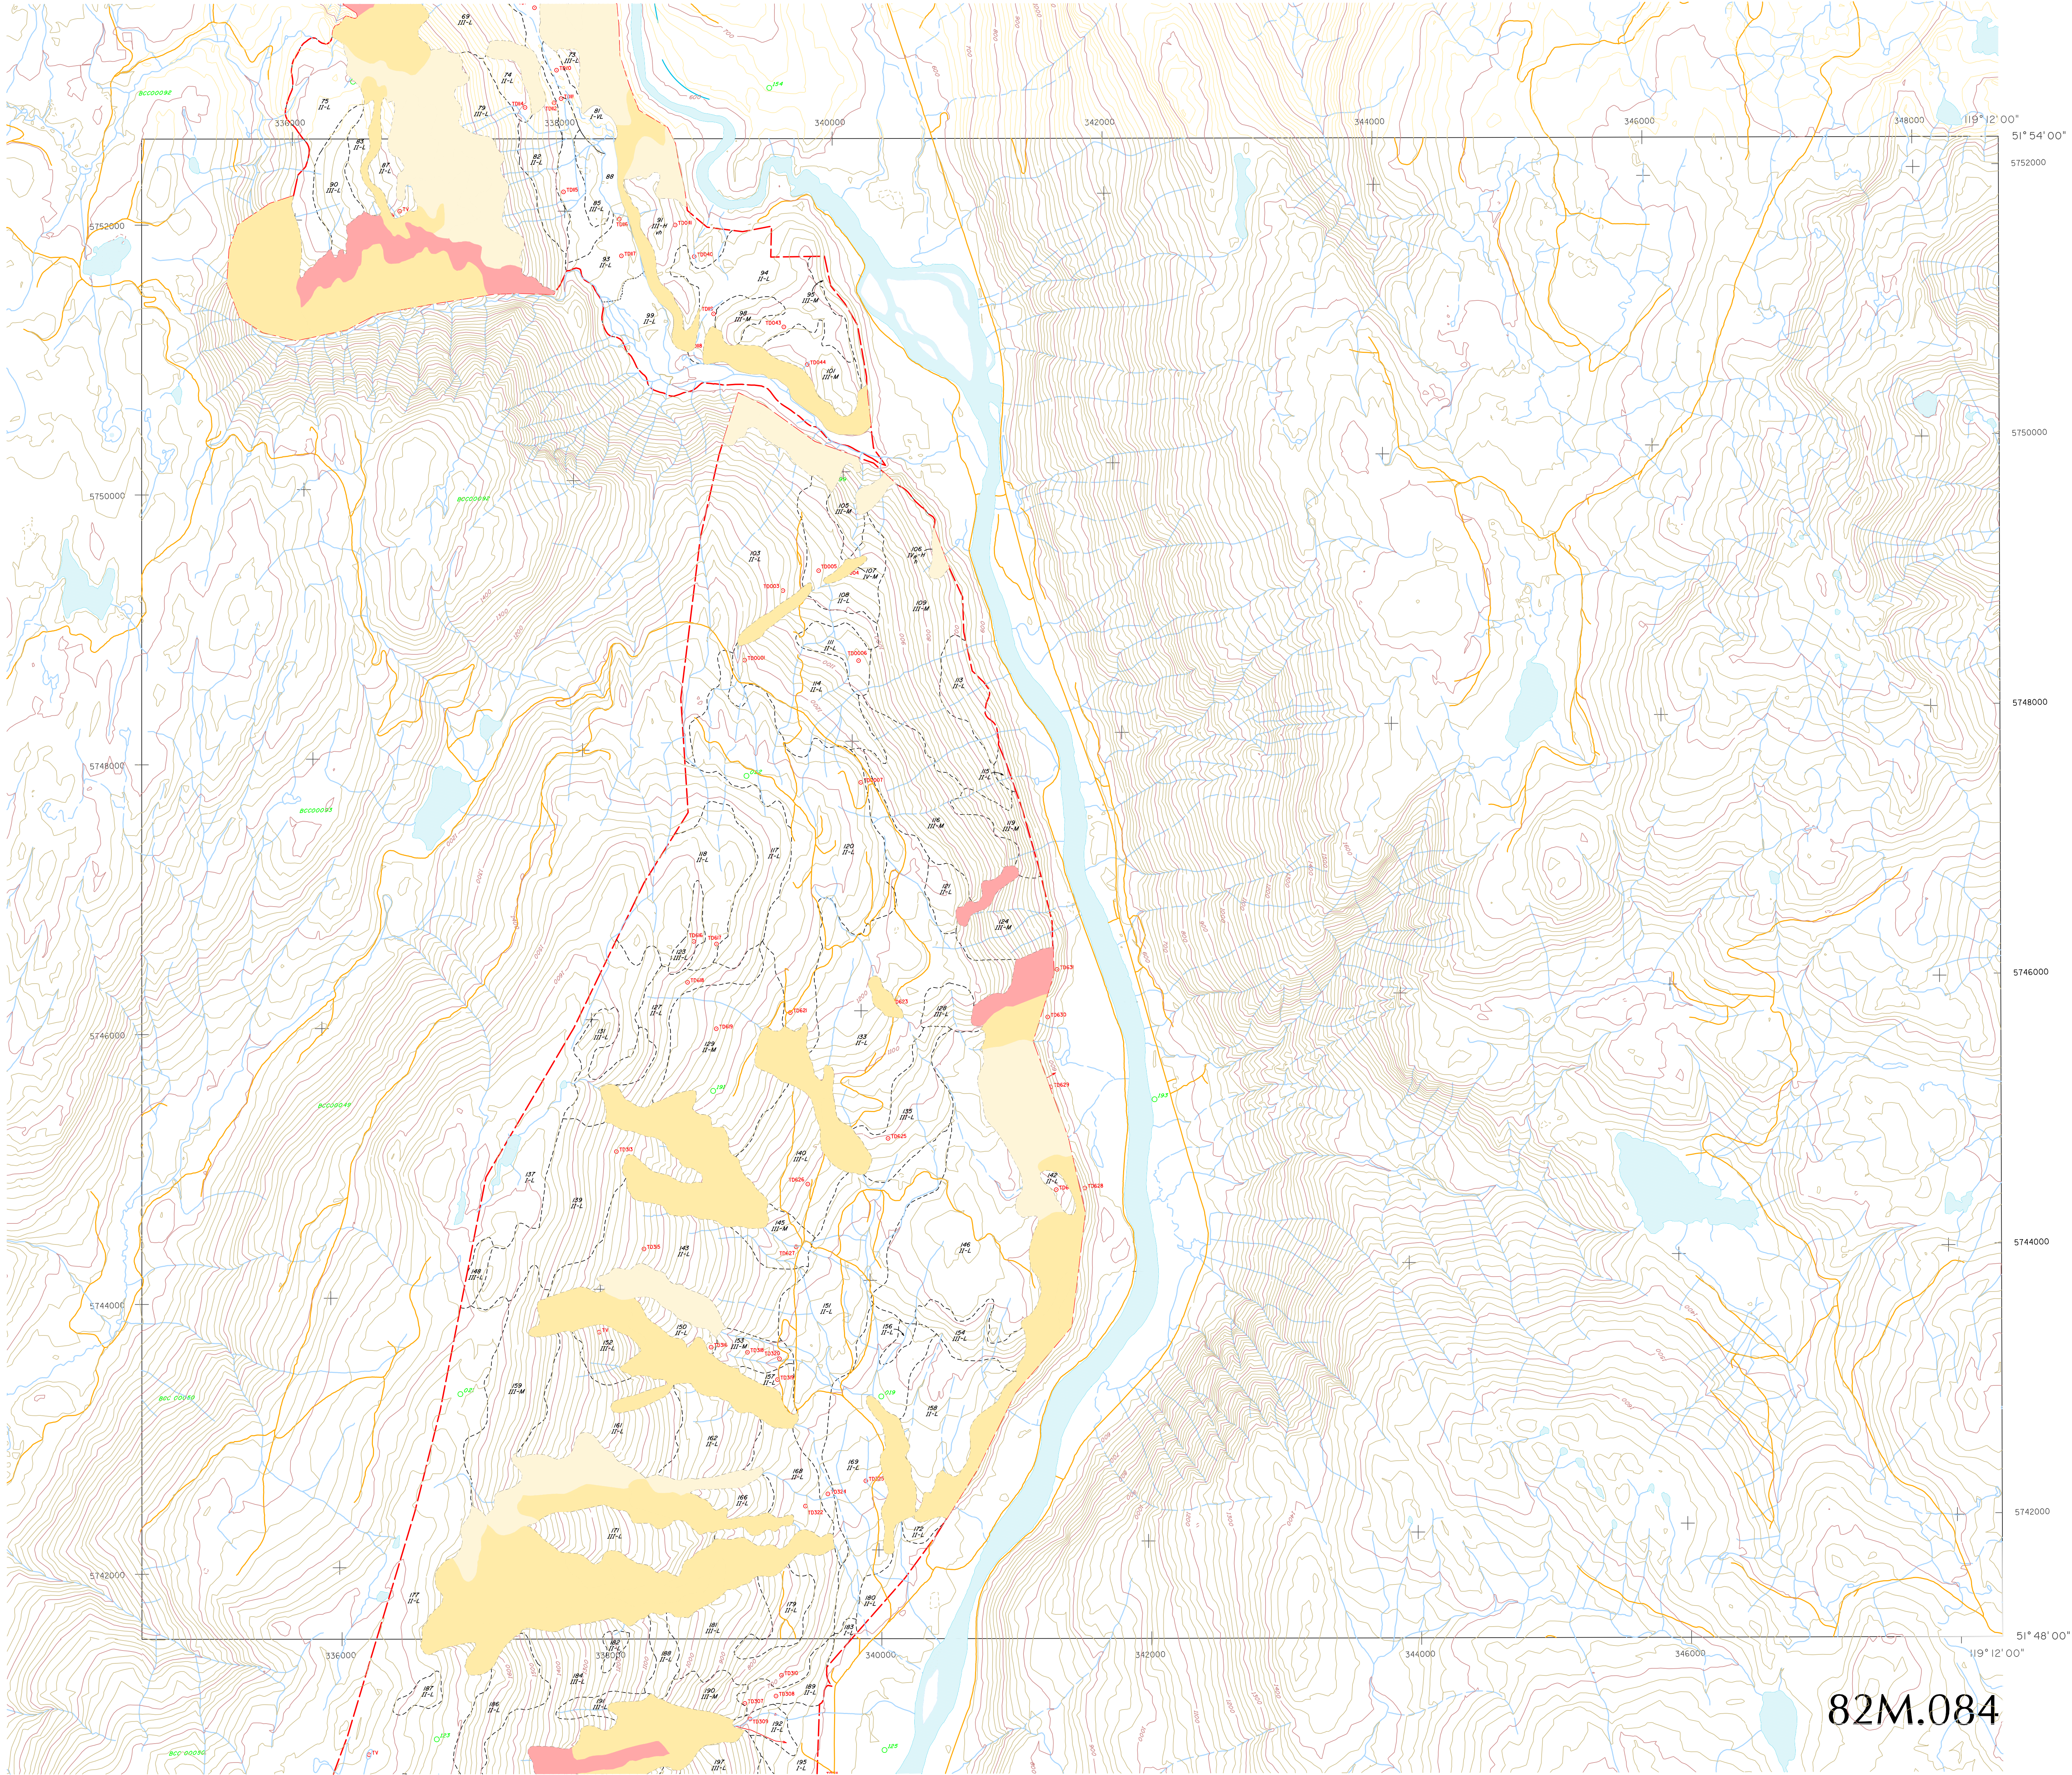
polygon number
terrain stability class
surface erosion potential
potential for sediment delivery from surface erosion sources

—	Define polygon boundary	Scarp in surficial materials
- - -	Indefinite polygon boundary	Recent or recurrent landslide scar
.....	Arbitrary polygon boundary	Headwall scar
—	Study area boundary	Gully
○	Ground Observation	Terrain Stability Class IV _a
A	Visual Observation	Terrain Stability Class IV
+++++	Meltwater channel; small	Terrain Stability Class V
	Meltwater channel; large
