**MESSITER / AVOLA / McMURPHY**  
**TERRAIN STABILITY INTERPRETIVE MAP**  
BCGS mapsheet 82M.063, 82M.064, 82M.073, 82M.074, 82M.083, 82M.084, 82M.093, 82M.094  
Scale 1:20,000

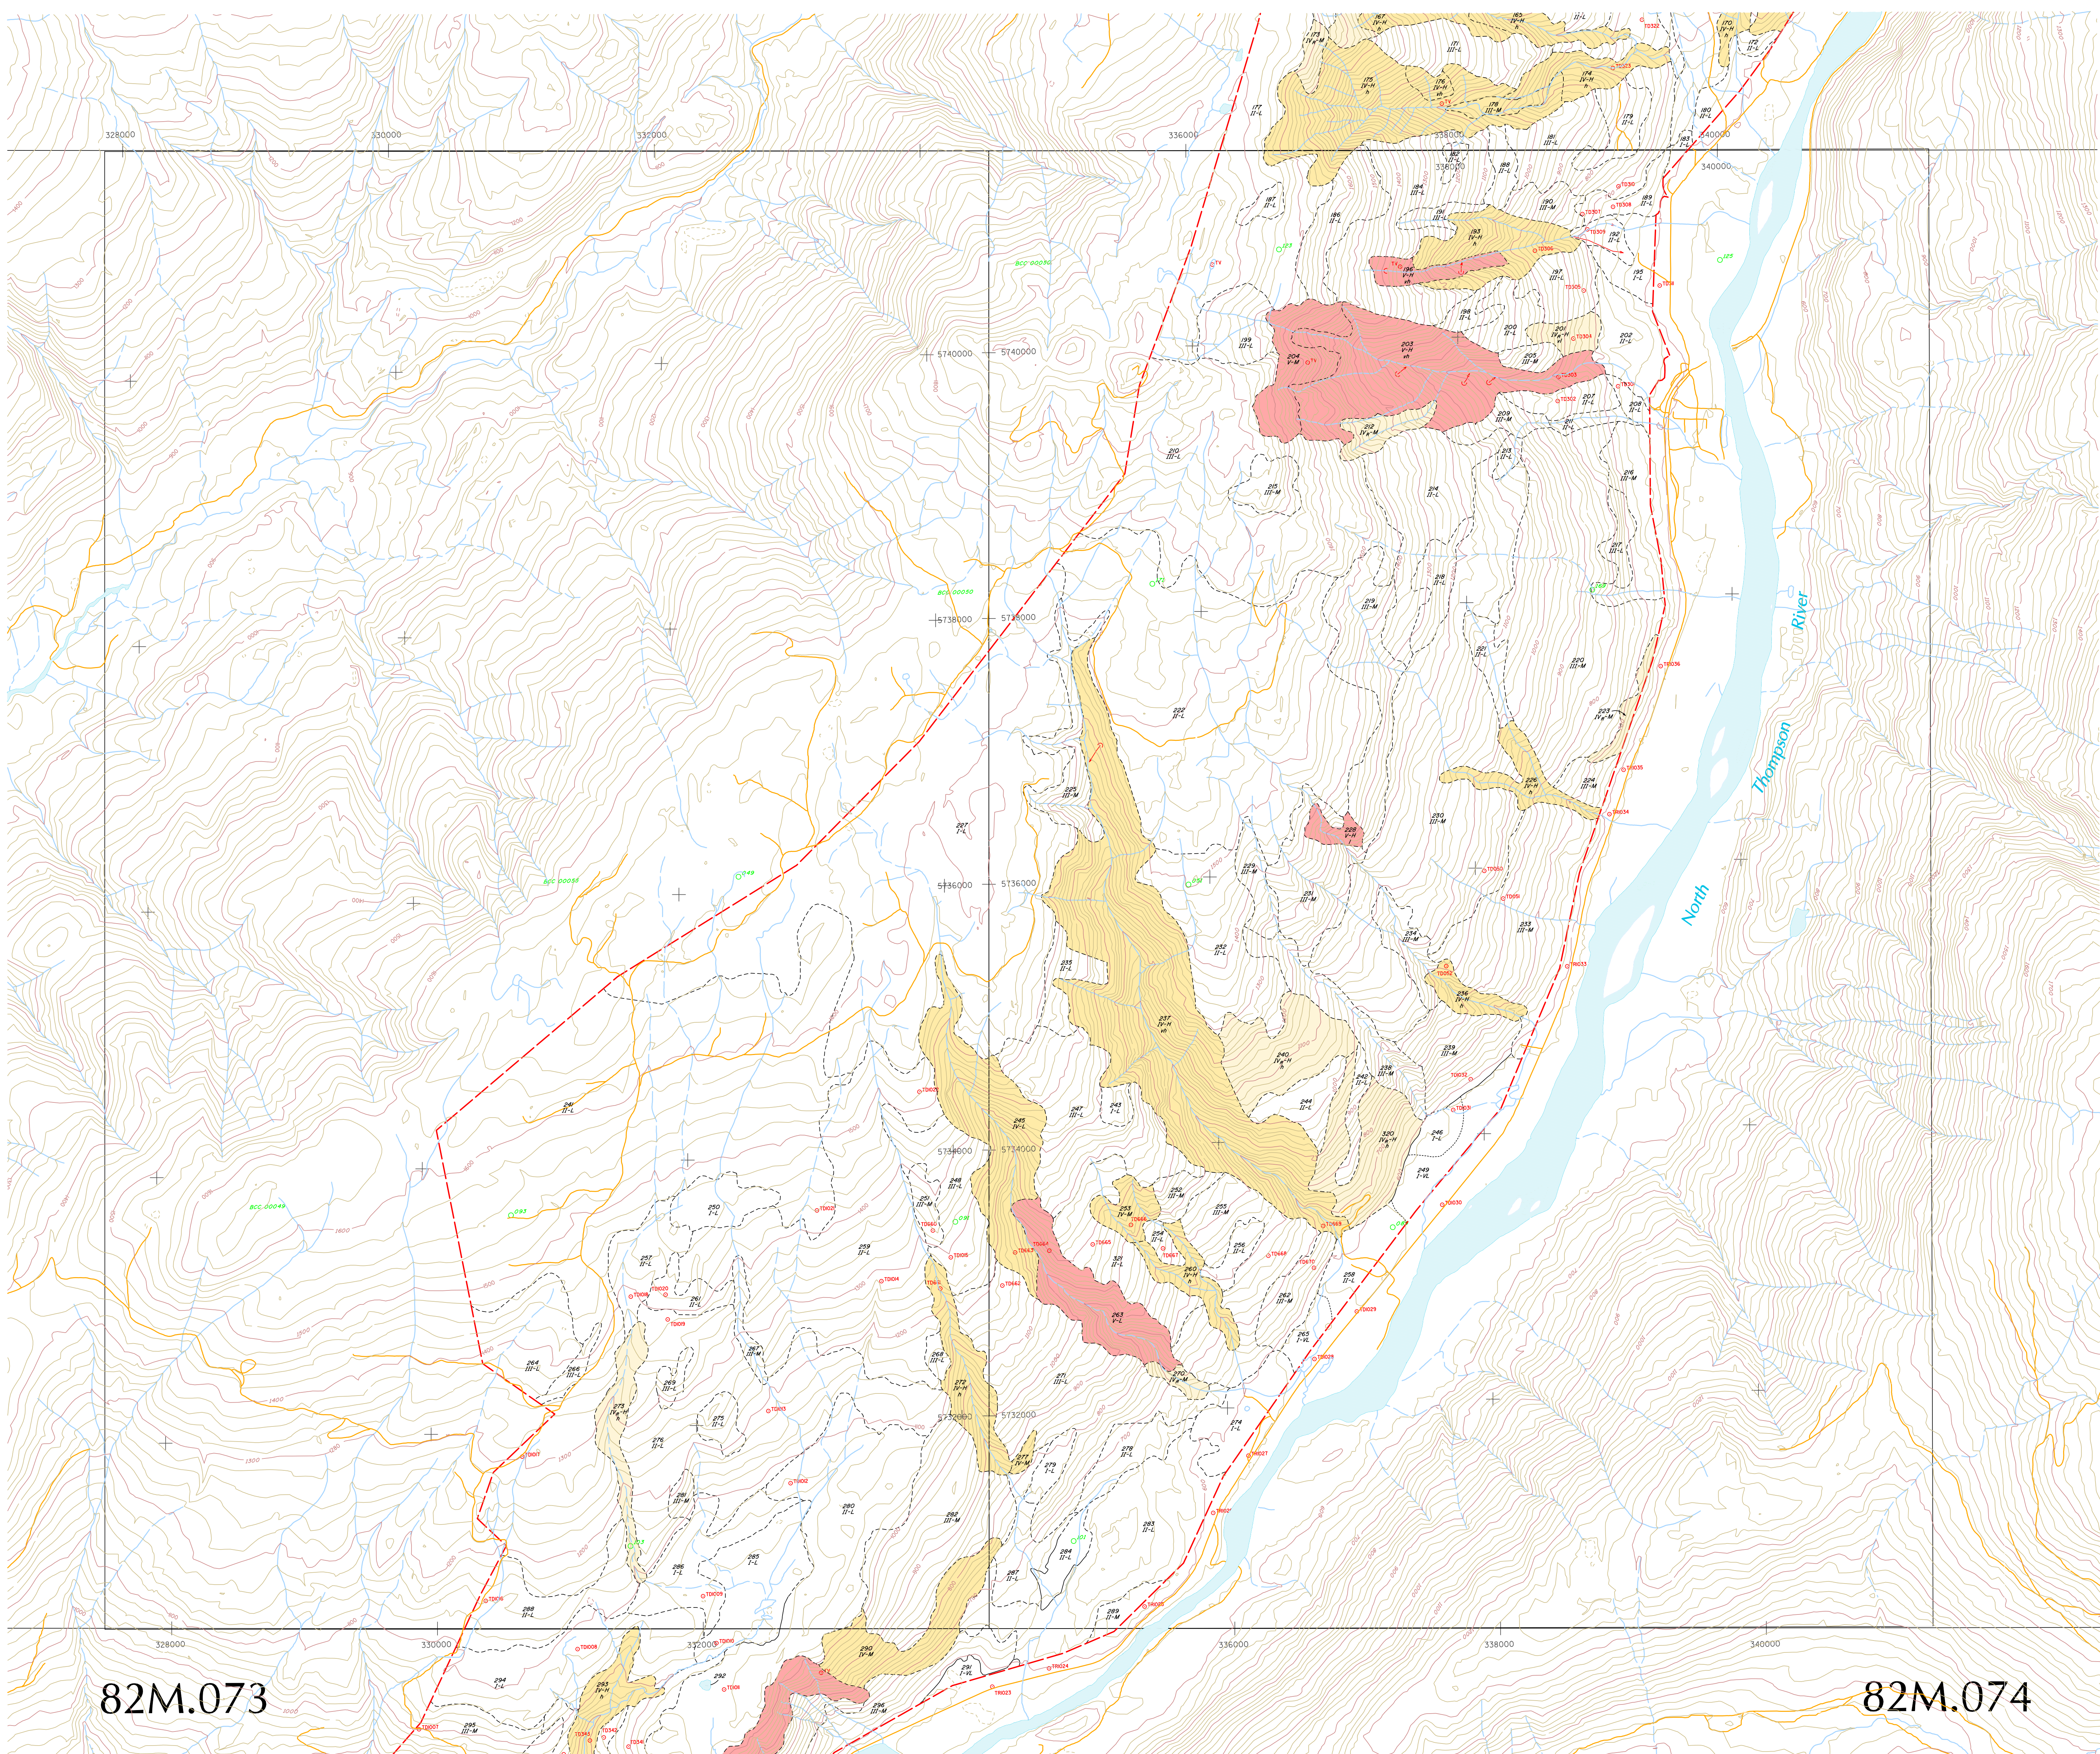
**EXAMPLE OF MAP SYMBOLS**

polygon number  
terrain stability class  
surface erosion potential  
potential for sediment delivery from surface erosion sources
