# 2008

## Fish Passage Culvert Inspection Planning

Enclosed is the Fish Passage Culvert Inspection 2008 for portions of the St. Mary's River Watershed, Findlay River Watershed and Skookumchuck River Watershed. This document contains a signed and sealed report outlining the recommendations for restoration on 23 FPCI locations. This report details the procedures and rationale used to develop the recommendations. The report also provides text regarding the assessment procedure and possible changes to the procedure for future FPCI work. The primary focus of this report is to provide recommendations in restoring fish passage at culverted sites within portions of the Cranbrook and Invermere TSA's using the procedures outlined in the *Fish Passage Protocol for Culverted Sites (June 2008)* and the *Field Assessment for Fish Passage Determination of Closed Bottom Structures (May 2008)*.

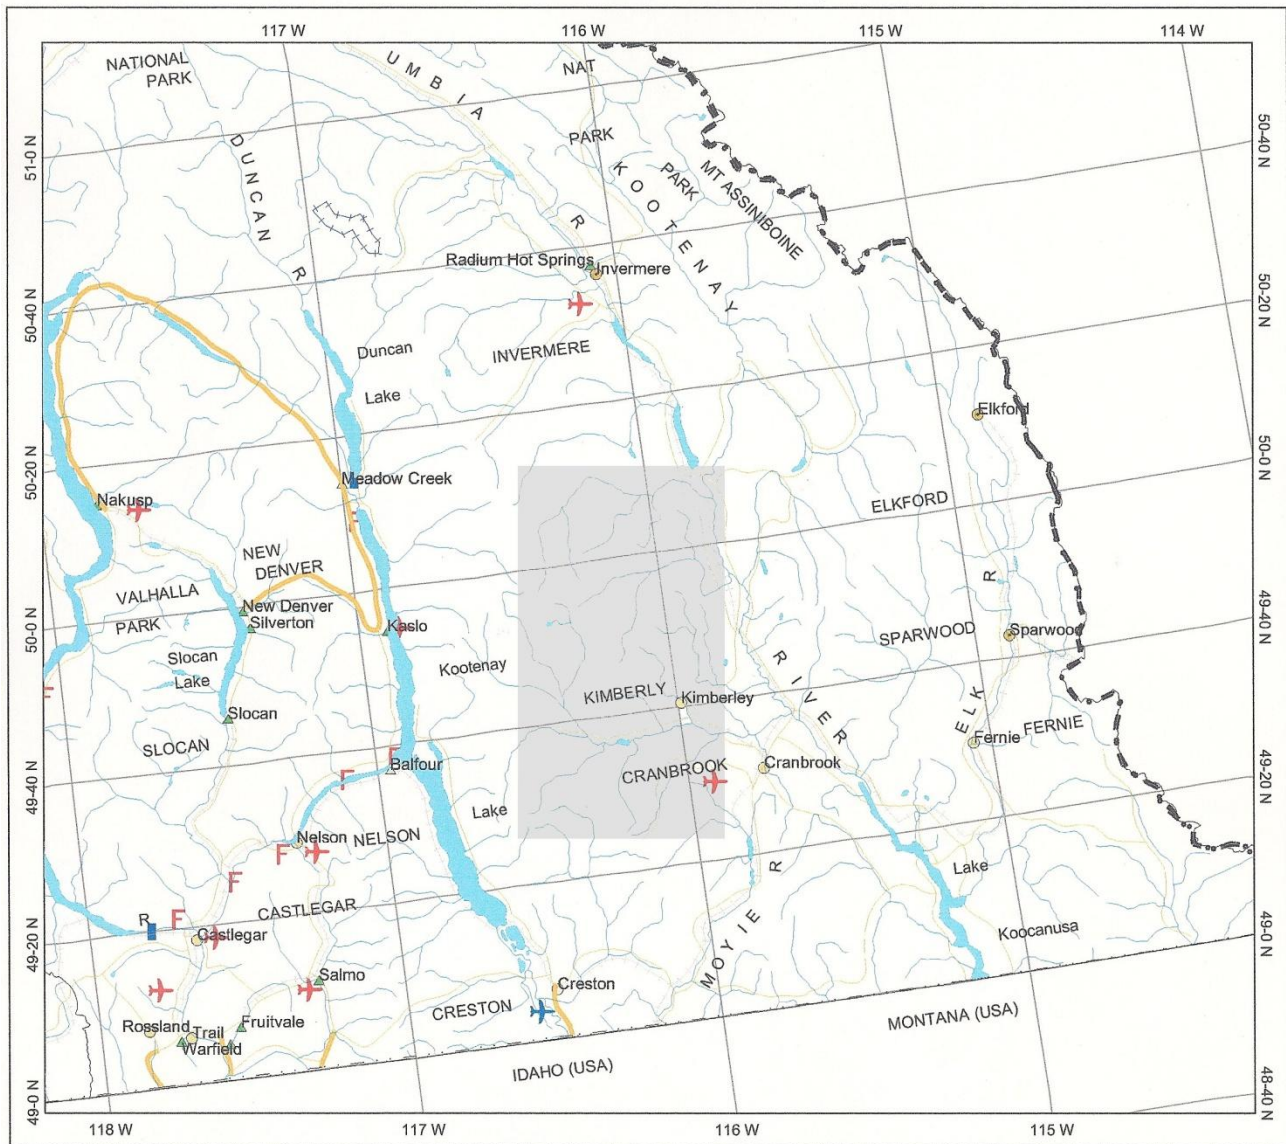
**Figure 3  
Study Area Overview Map**

A funding request was made by Tembec for a review / assessment of all groups within both TSAs. Funding approval was provided for the SMAR in Cranbrook and Invermere and for the Columbia River in Invermere. After a preliminary review, the SMAR Watershed Group became the primary study area. It includes the watersheds of the Findlay and Skookumchuck rivers (Figure 3) in the Invermere TSA and the St. Mary watershed in the Cranbrook TSA (Figure 3).
