2010 Fish Passage Evaluations for Closed Bottom Structures

Performed under FIA Contract:

Project # 4031505

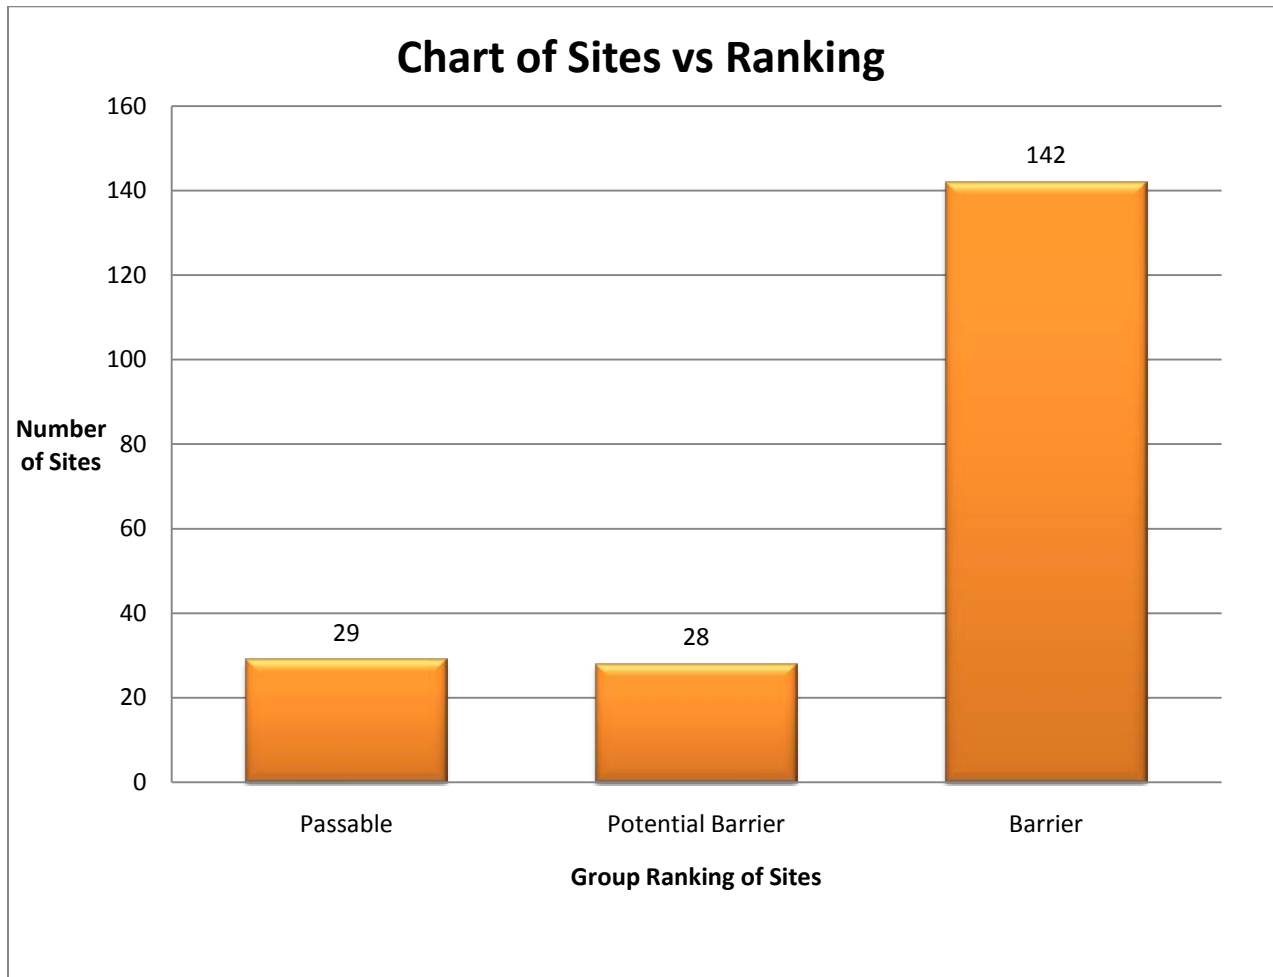
Figure 3 – Fish Passage rating for 199 Fish Streams in Copper River Watershed.

A total of 636 sites in the Copper River watershed were fully assessed for fish passage using the assessment for closed bottom structures. Sites of passable ranking were found at 29 sites. Sites which rated as having a potential barrier were found at 28 sites. Sites which rated as having a definite barrier were found at 142 sites (See Tables 1 and Figures 3).

Figure 3 show that there is a high proportion of 'Barrier' sites. Much of the forest development in the Copper River drainage occurred over 30 years ago. Since that time, many of the roads and areas have over grown and self-stabilized. While the heavily over-grown roads created access problems for much of the project, they have effectively stabilized the cut and fill slopes along the roads. As well, many of the streams have stabilized into their new channels and any fine sediment has long since eroded away.

Old roads were found to have streams which in many cases cut through and around old drainage structures and re-established a stream channel through the old road. It is also worth noting and will explain further the reason for so many 'Barrier' sites, is that many roads are built at the toe of slope on hill/mountainsides. This results in a much lower gradient on the downstream side than on the upstream side. Roads are often built using this 'cut and fill' method as the steep upslope provides the material for the 'fill' on the lower. The product of this method as outlined above is that the down slope stream channel is of low gradient while the upslope stream channel is often steep or gullied. Many of the "Barrier" sites exhibited this character and even though they were classed as being "Barrier" upgrading or converting the structure would provide very little if any additional upstream fish habitat. Some will be improved by upgrading the structures and they have been identified to how much habitat would be improved in Table 1.
