MABEL LAKE

RECONNAISSANCE TERRAIN STABILITY REPORT

(T.S.I. LEVEL 'D')

Terrain Stability Maps
82L.046; 047; 056; 057; 058; 067; 068; 077; 078; 088

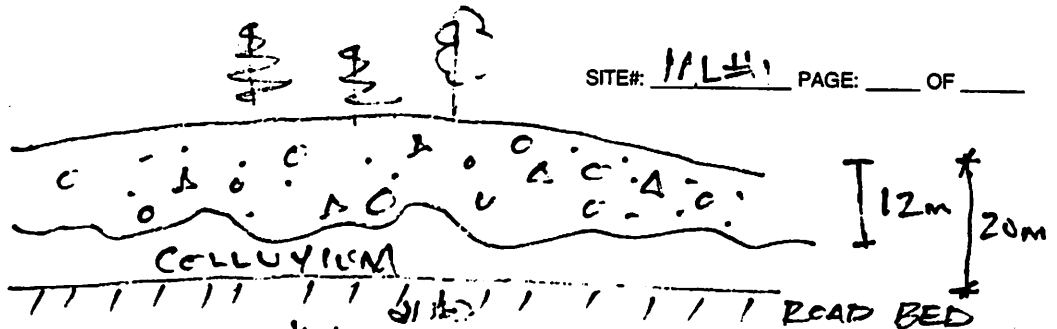
SITE#: 11L#1 PAGE: OF

Section Sketch:

Materials/Facies Description:

Unit of Thickness: 12 m Sample Taken: Yes / (No) #:
