ROBINSON, ROBERTS & BROWN LTD.

**Groundwater Development
for
SIDNEY WATERWORKS DISTRICT
Well No. 12
Sidney, British Columbia**

November, 1968

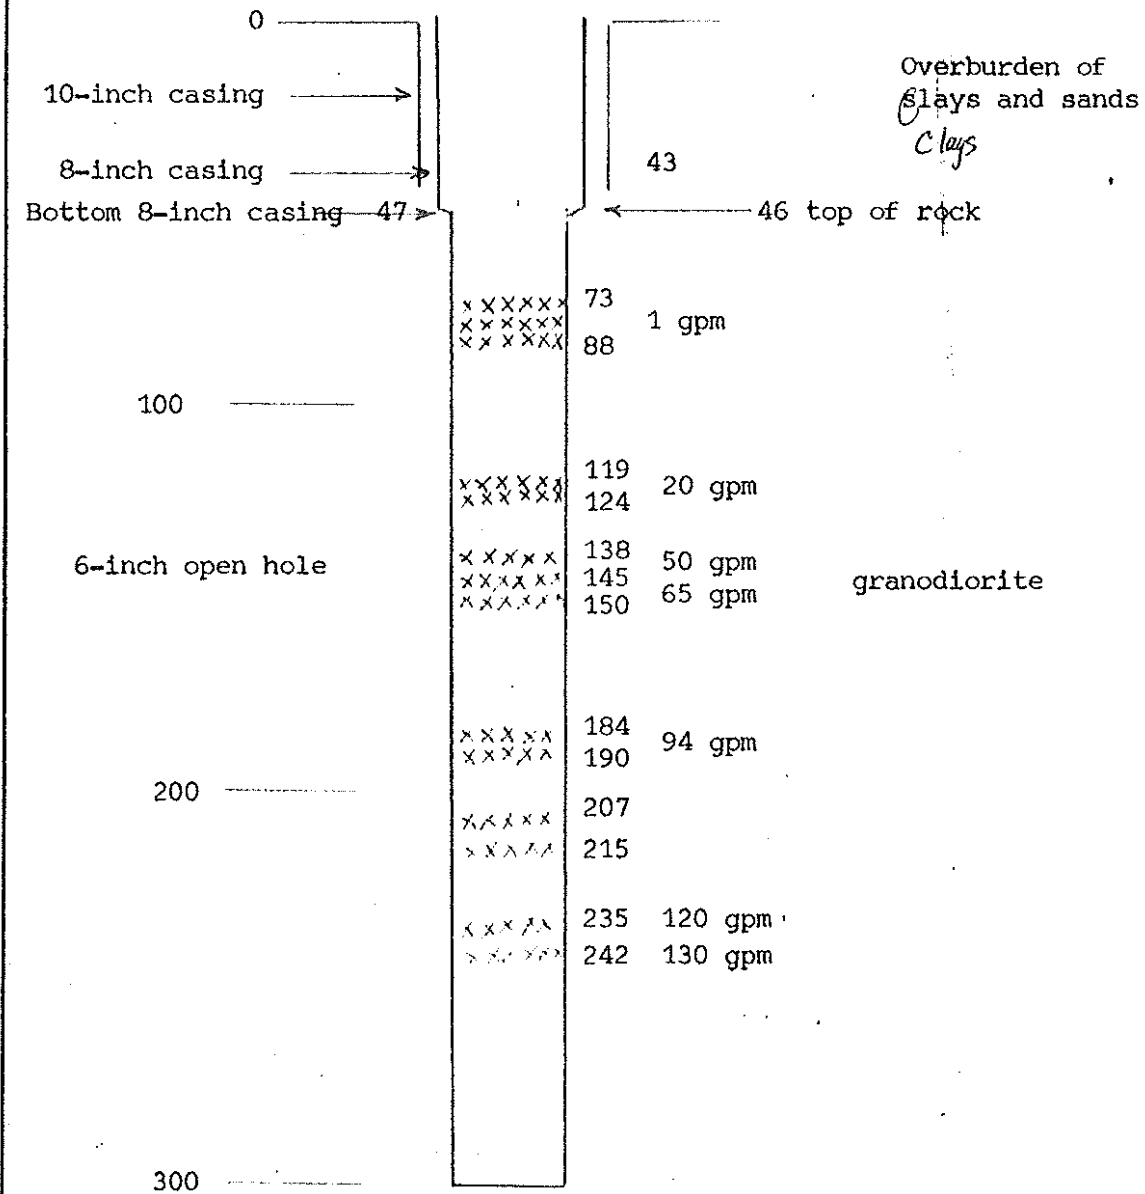
SIDNEY WATERWORKS DISTRICT	Lithologic Log	ROBINSON, ROBERTS & BROWN LTD. CONSULTING GROUNDWATER GEOLOGISTS NORTH VANCOUVER, CANADA
Sidney British Columbia	Well No.12	September 1968

Note: Flows measured on water blown out of hole by air

The enclosed log of Well No. 12 shows the salient features of the well. The sizes and amounts of casing, the top of bedrock at 46 feet and the location of the various fractures.
