MEMORANDUM

SUBJECT: Well Interference in Campbell River Lowland

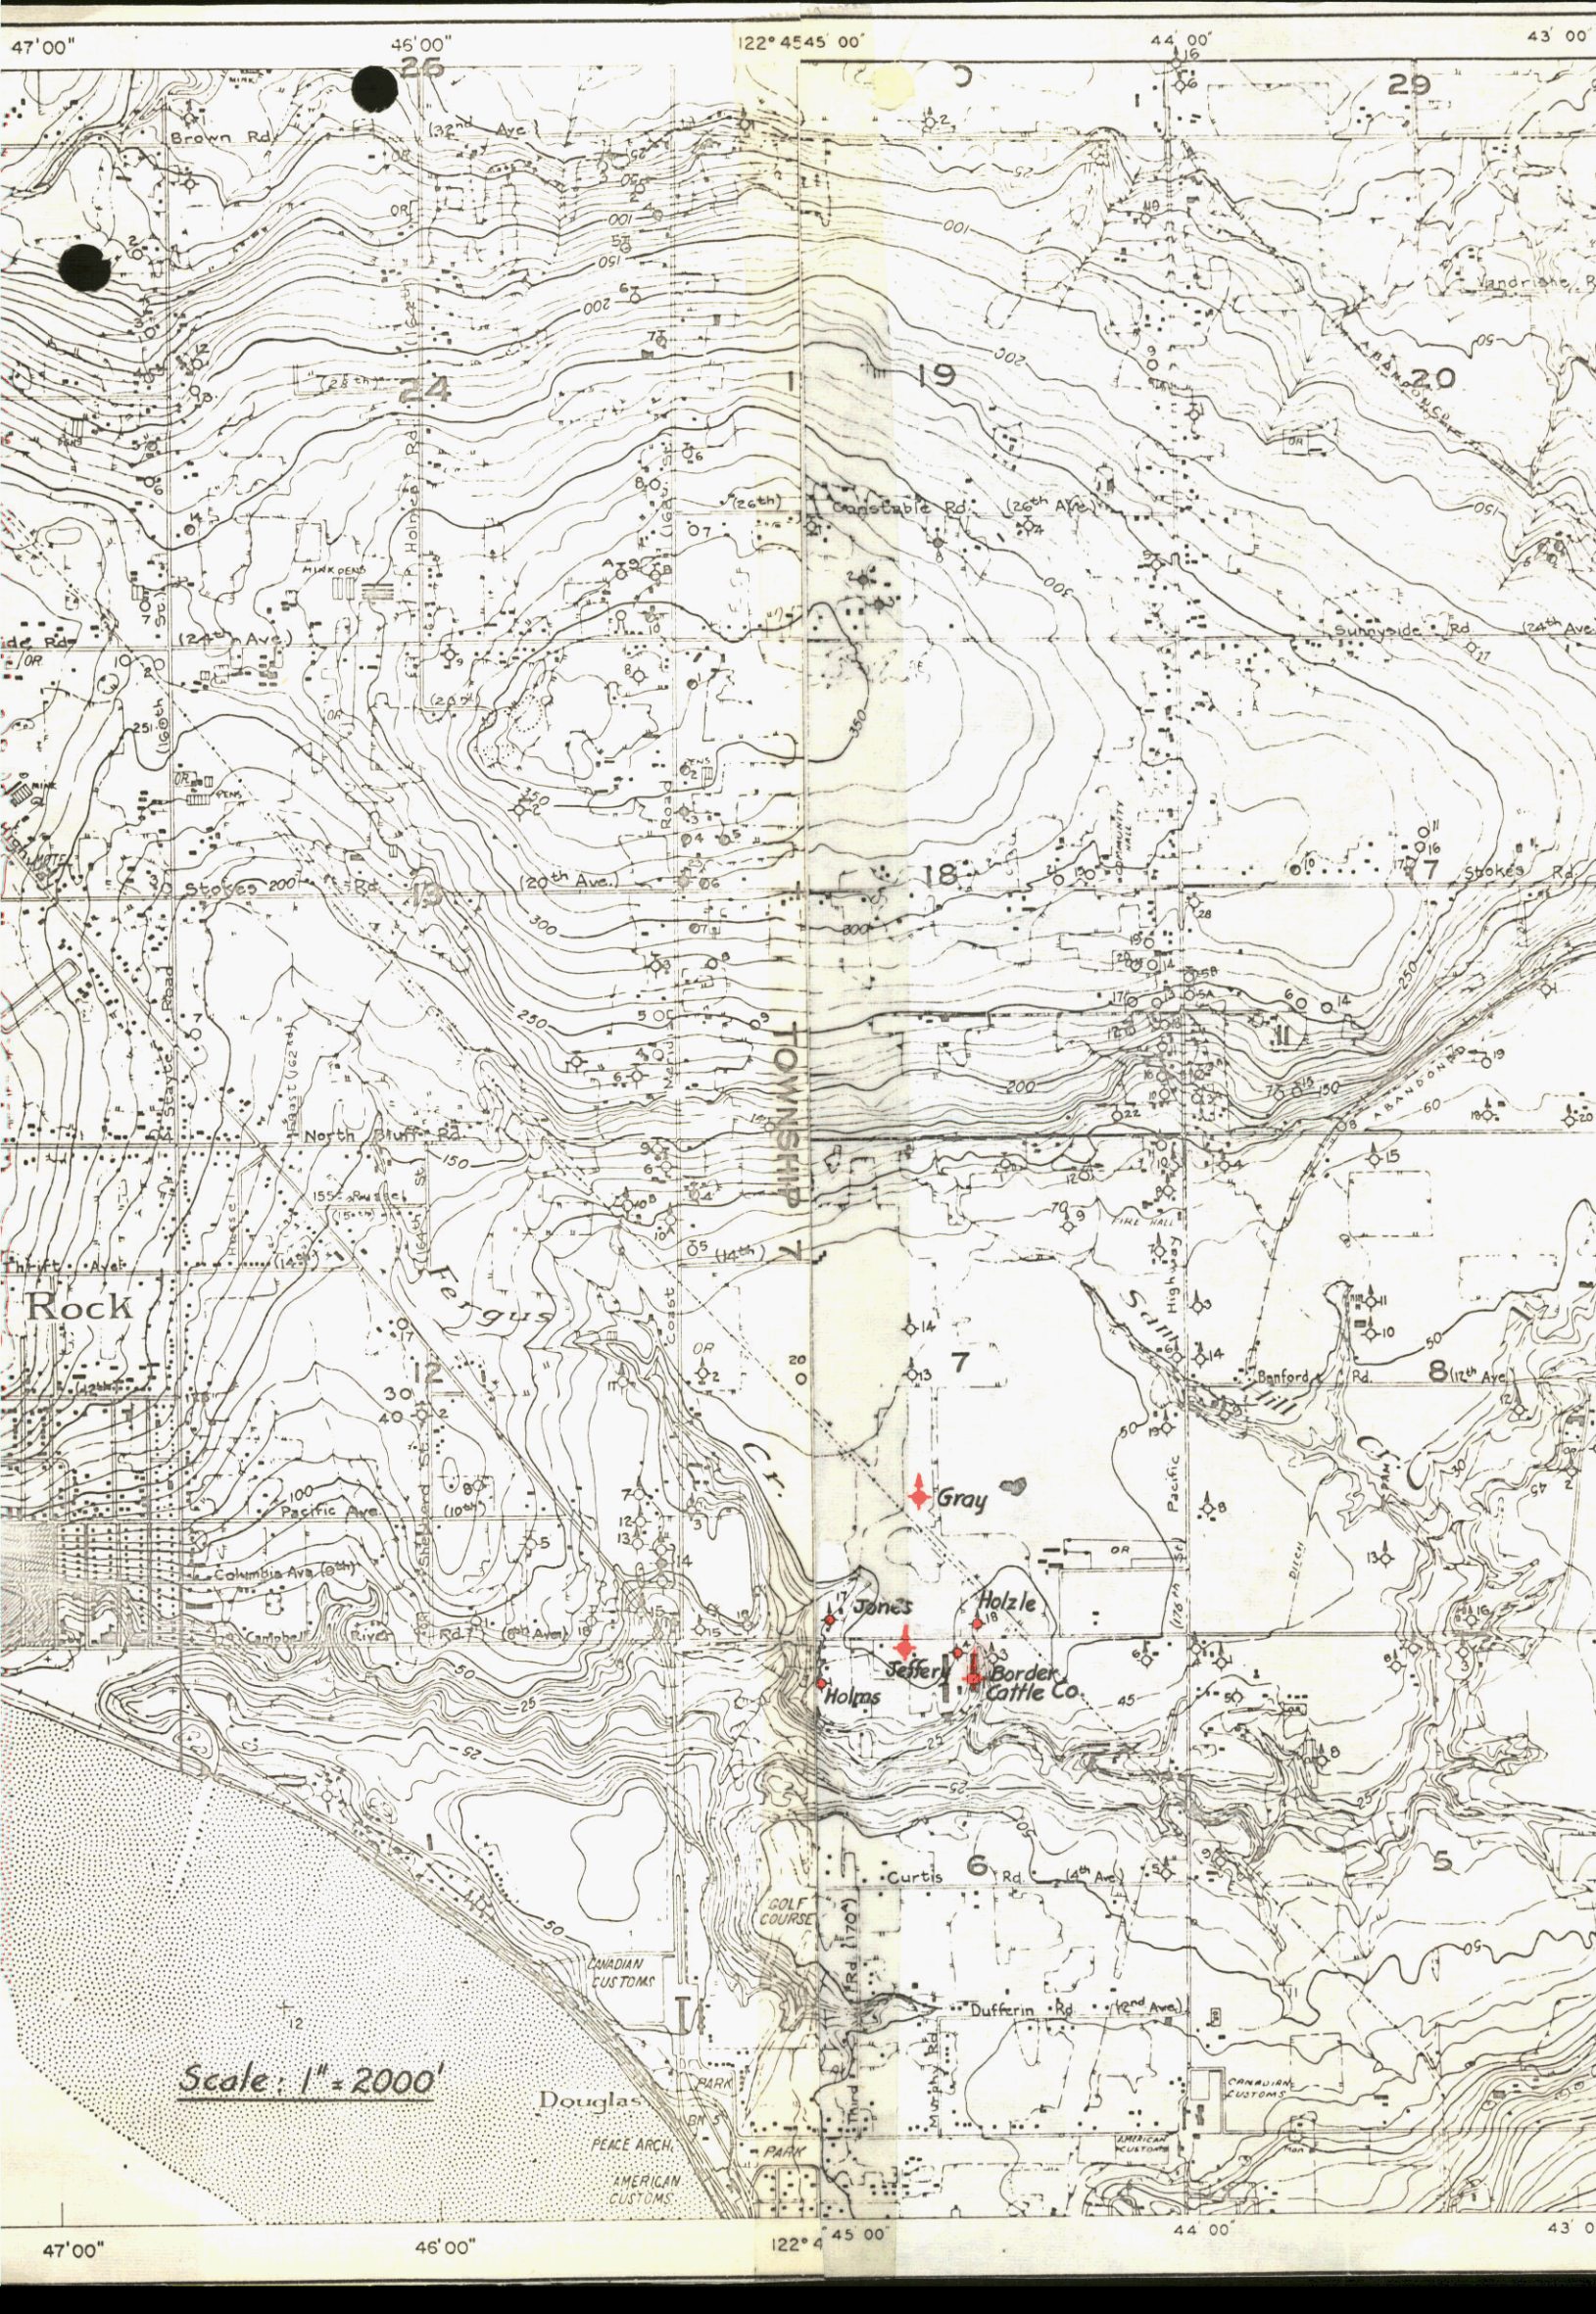
Enclosed is a map showing the area where all these wells are located. The various wells mentioned below are designated by the owners' names.
