## City of Merritt

### Source Water Assessment and Protection Plan

**August 2017**

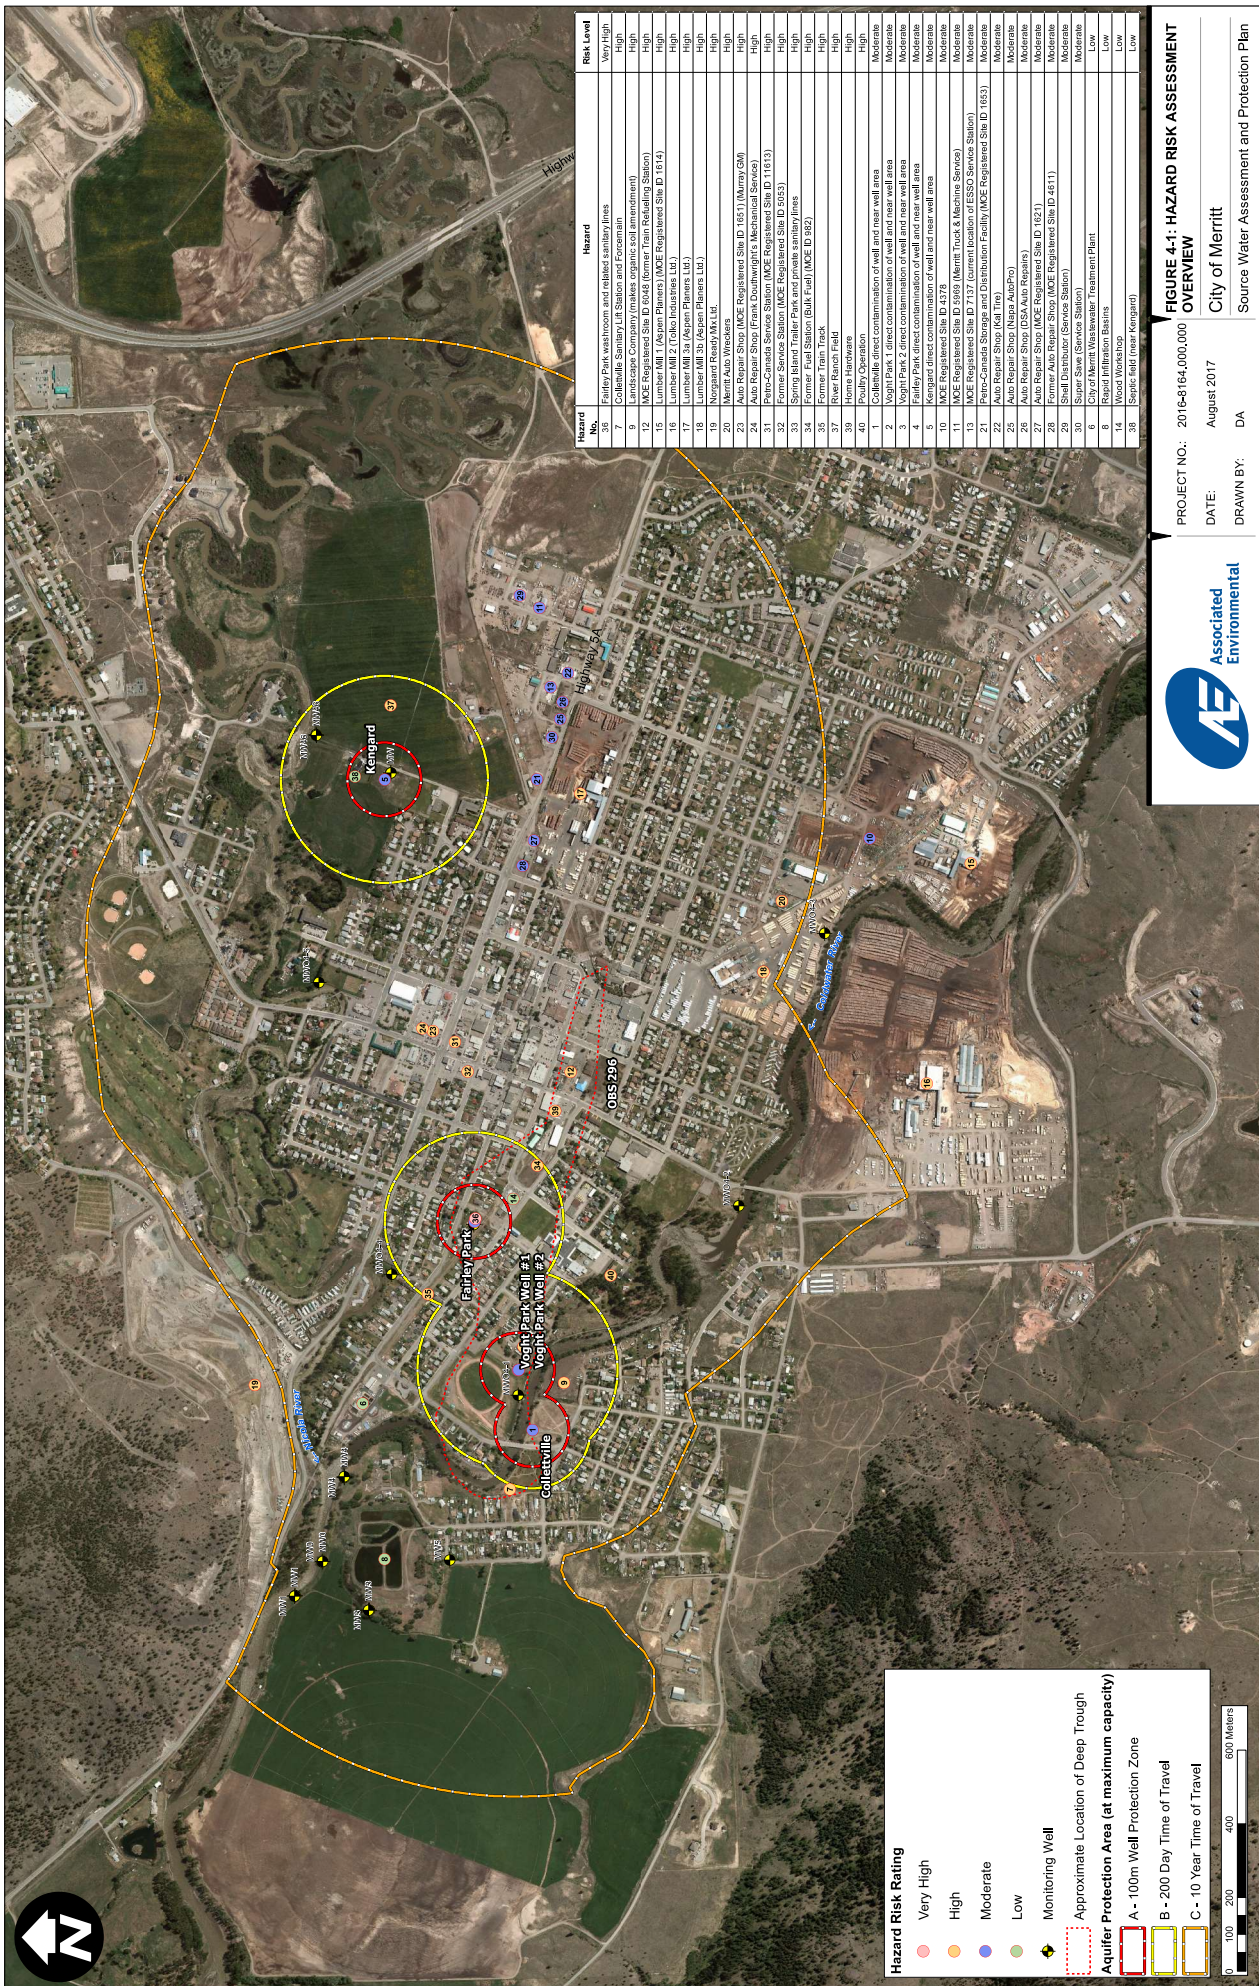
FIGURE 4-1: HAZARD RISK ASSESSMENT OVERVIEW

| Hazard No. | Hazard | Risk Level |
| 1 | Fairley Park washroom and related sanitary lines | Very High |

The hazards identified during the records review, field survey, interviews, and TAC Workshop 1 were used to produce the final list of hazards (Appendix D). The locations of the identified point source contaminants are shown in Figure 4-1.

and 4-5 lists each hazard, the TAC agreed upon likelihood of occurrence and magnitude of consequence score, and the risk rating based on that score. The locations of the hazards are shown on Figures 4-1, 4-2, 4-3, and 4-4.
