# **FINAL REPORT**

# **Interior Watershed Assessment Procedure** and Rehabilitation Options

# **Falls Creek**

# Carver Consulting

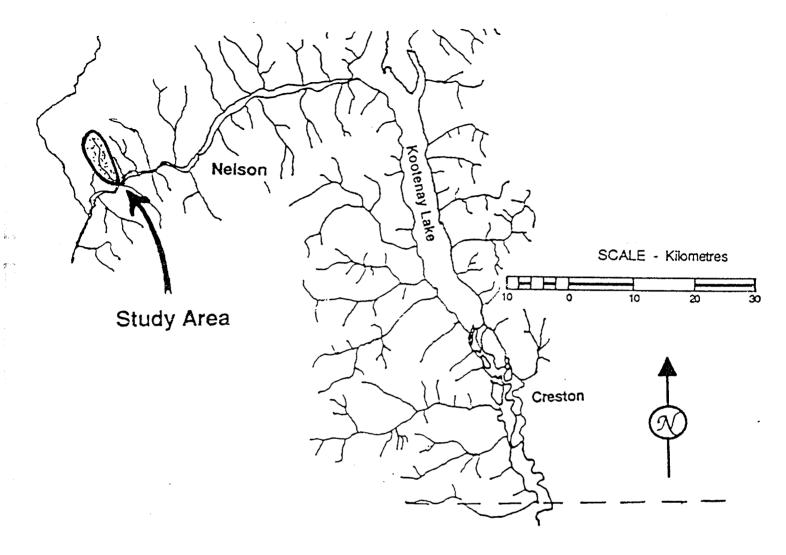
Figure 2.1. Study area location.

The Falls Creek study area is shown in Figure 2.1. The watershed is 29.8 km<sup>2</sup> in area and is located 16 km west of Nelson, B.C.
