NIMPKISH WATERSHED RESTORATION PROJECT

2005 Level 2 Prescriptions For Yookwa Creek Fan

northwest hydraulic consultants ltd.

March 2005

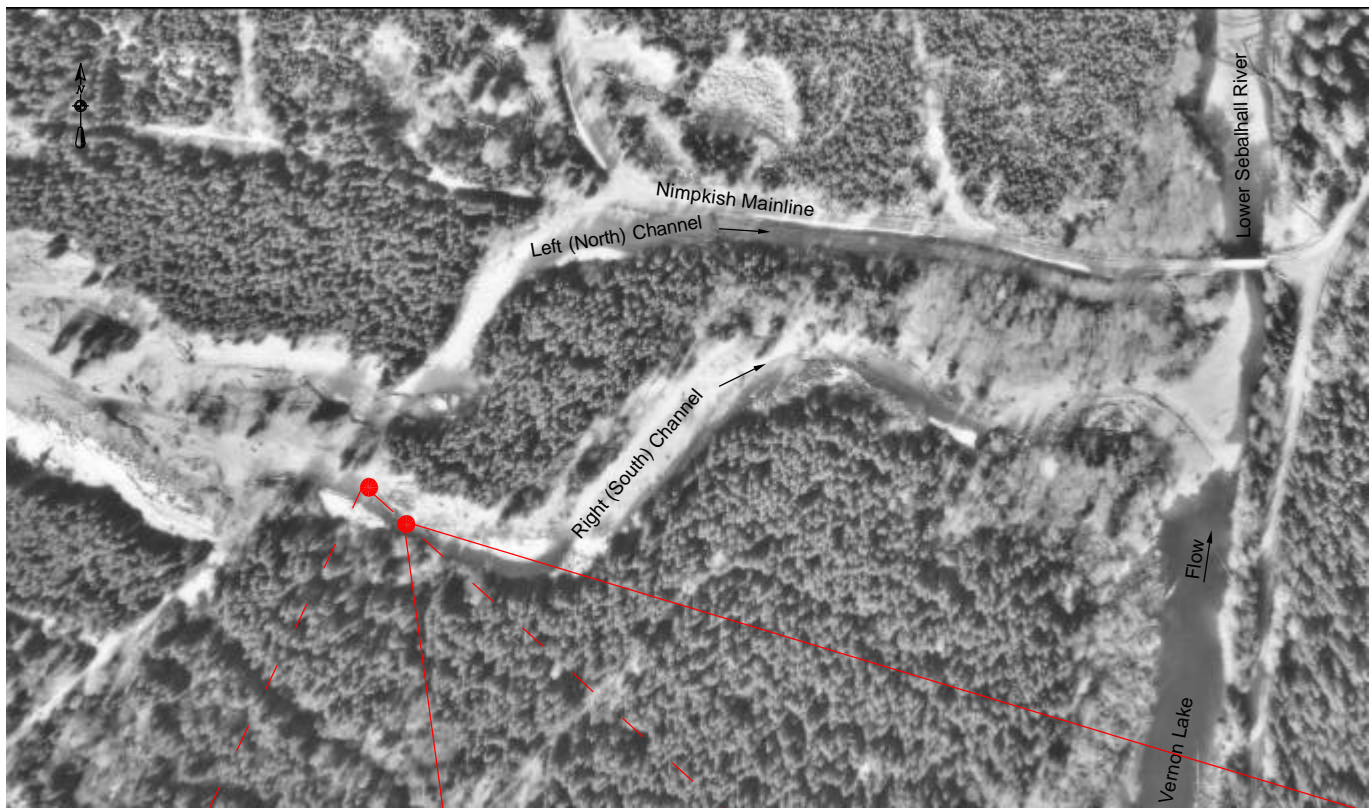
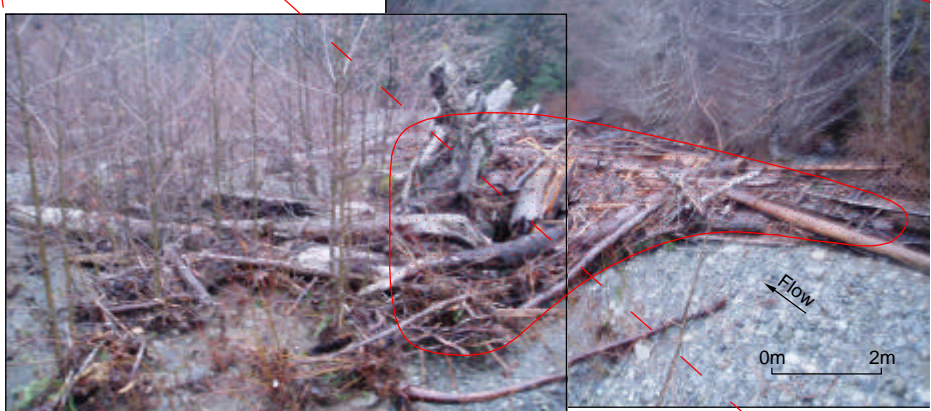
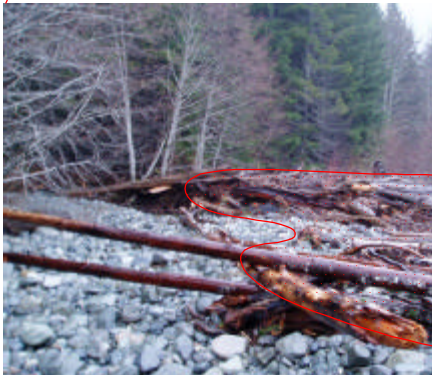
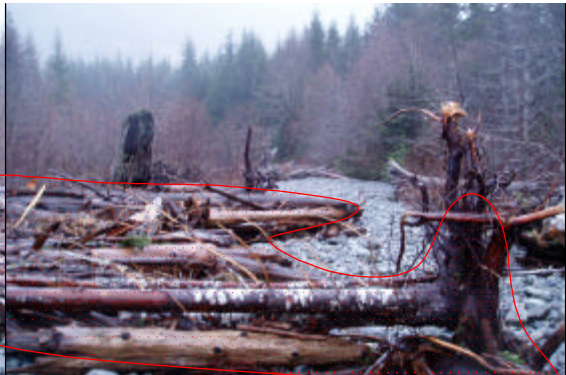
Photo 1:
Downstream
log jam at
0+500m

Photo 2:
Upstream
log jam at
0+530m

Figure 2 shows a sketched plan view of the two log jams and current photographs.

The restoration plan for this site would be quite simple. It consists of removing two log jams from the right bank channel and lining the adjacent riparian forest with the LWD. The location of the two log jams is shown in Figure 2. No cable or boulder anchors would be used to hold the logs in place. Instead, high velocity flow down the centre of the channel and flow spilling into the surrounding forest would hold the realigned logs against the channel margins.

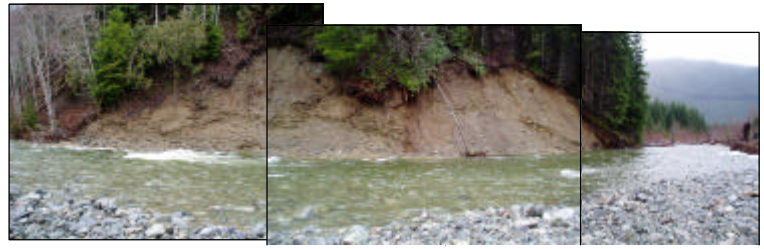
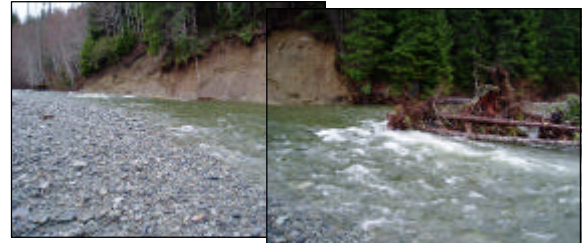
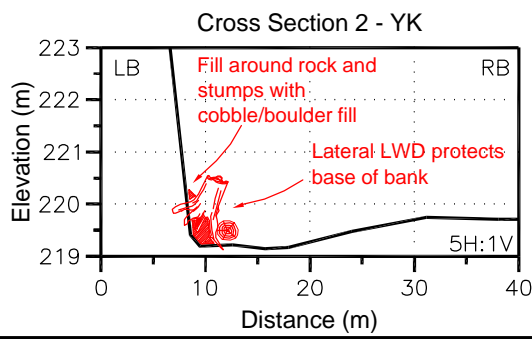
Photographs of the Eroding Bank in February 2005

Looking across at the bank from the edge of the bar

Looking upstream at the bank

Yookwa Creek Prescriptions
YK1LWD3 - Left Bank Protection at 1000 m
 Plan and Section

Figure 4 shows a sketched plan view of the eroding bank and current photographs. The bank has two main scarps each 10 to 15m high and till can be seen outcropping into the bed of the channel at a couple of locations along the bank. Currently a 55m long section of the bank is eroding.

The restoration plan consists of installing two LWD structures along the eroding section of bank – a long lateral log jam and a downstream LWD spur. Their location is shown in Figure 4. Like the downstream bank, a long lateral log jam is prescribed rather than a series of LWD spurs due to the high, vertical nature of the bank that precludes spur construction. This structure should be about 40m long and wrap around the upstream corner of the bank, onto the alder covered floodplain. The upstream end of the structure should be either attached to a very secure, large tree on the bank or be buried in a trench complete with boulder anchors that would act like deadmen. This upstream attachment will provide much of the lateral stability for the entire structure.
