### Survey of 2 Tributary Creeks in the Courtenay River Estuary

# **DRAFT Final Report**

Prepared for: Fish and Wildlife Compensation Program

Prepared by: Jennifer Sutherst (Comox Valley Project Watershed Society)

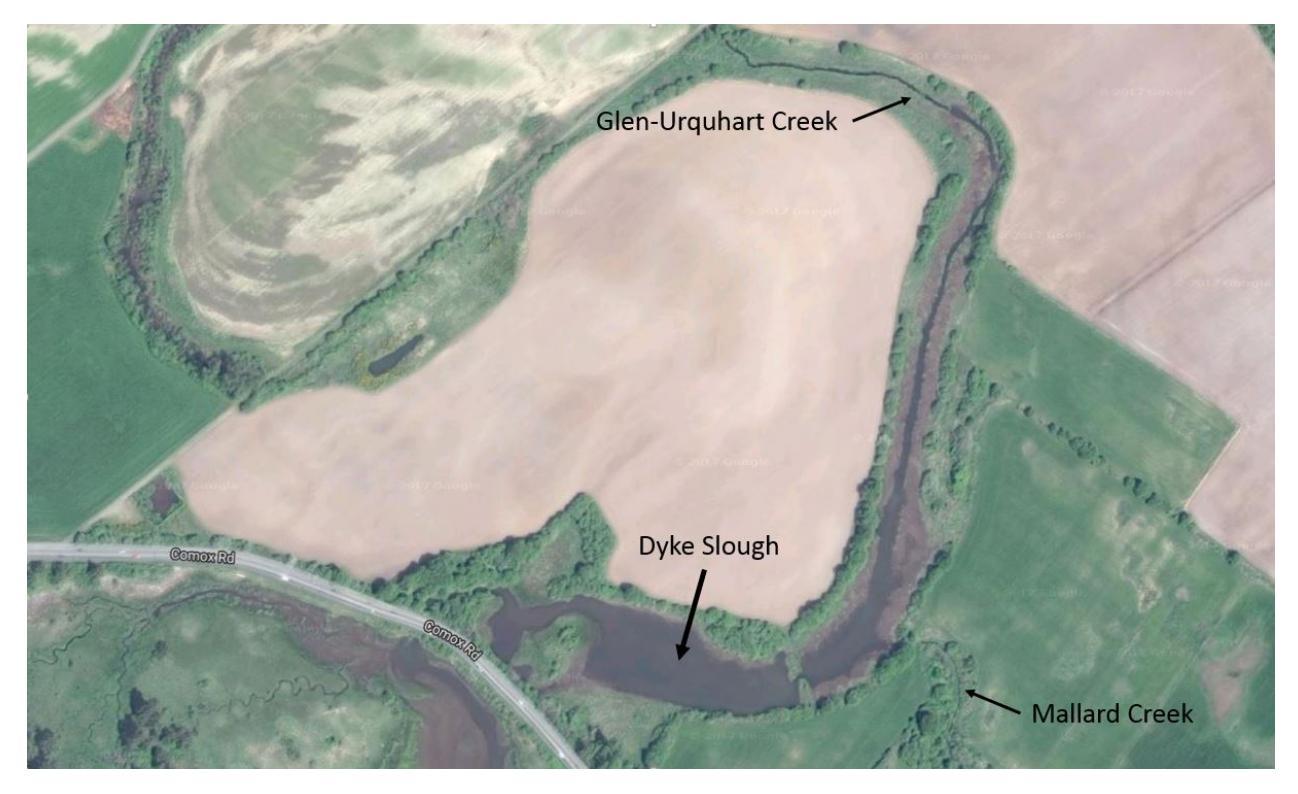
Figure 1 - Glen-Urquhart and Mallard Creeks flowing into Dyke Slough.

Historically the Comox Slough / Dyke Slough was a tidal slough in the K'ómoks Estuary. Over time the surrounding land was diked and converted to agricultural land. The remnant slough remained a brackish-freshwater wetland with water sources from Glen-Urquhart and Mallard Creeks which flow into the slough and subsequently through flap gates underneath Comox Road (see Figures 1) into the Courtenay River and then the K'ómoks Estuary. While both of the streams are salmon bearing, the connection of the slough to the Courtenay River is restricted for fish access (returning spawners as well as out-migrating and over-wintering juveniles) due to the flap gates (see Figure 2). These top-hinged gates close during incoming (flood) tides to prevent tidal waters from moving upland. During outgoing (ebb) tides the gates open to allow upland water to flow through the culverts under Comox Road and into the slough. Therefore this type of gate is generally open only 50% of the time<sup>1</sup> and limits the movement of fish between the slough and estuary. However, the flap gates provide socio-economic and ecological benefits to the slough by reducing the risk of tidal inundation (saltwater intrusion) to the farmland, facilitating drainage and creating a wetland that is used by a diversity of freshwater species.

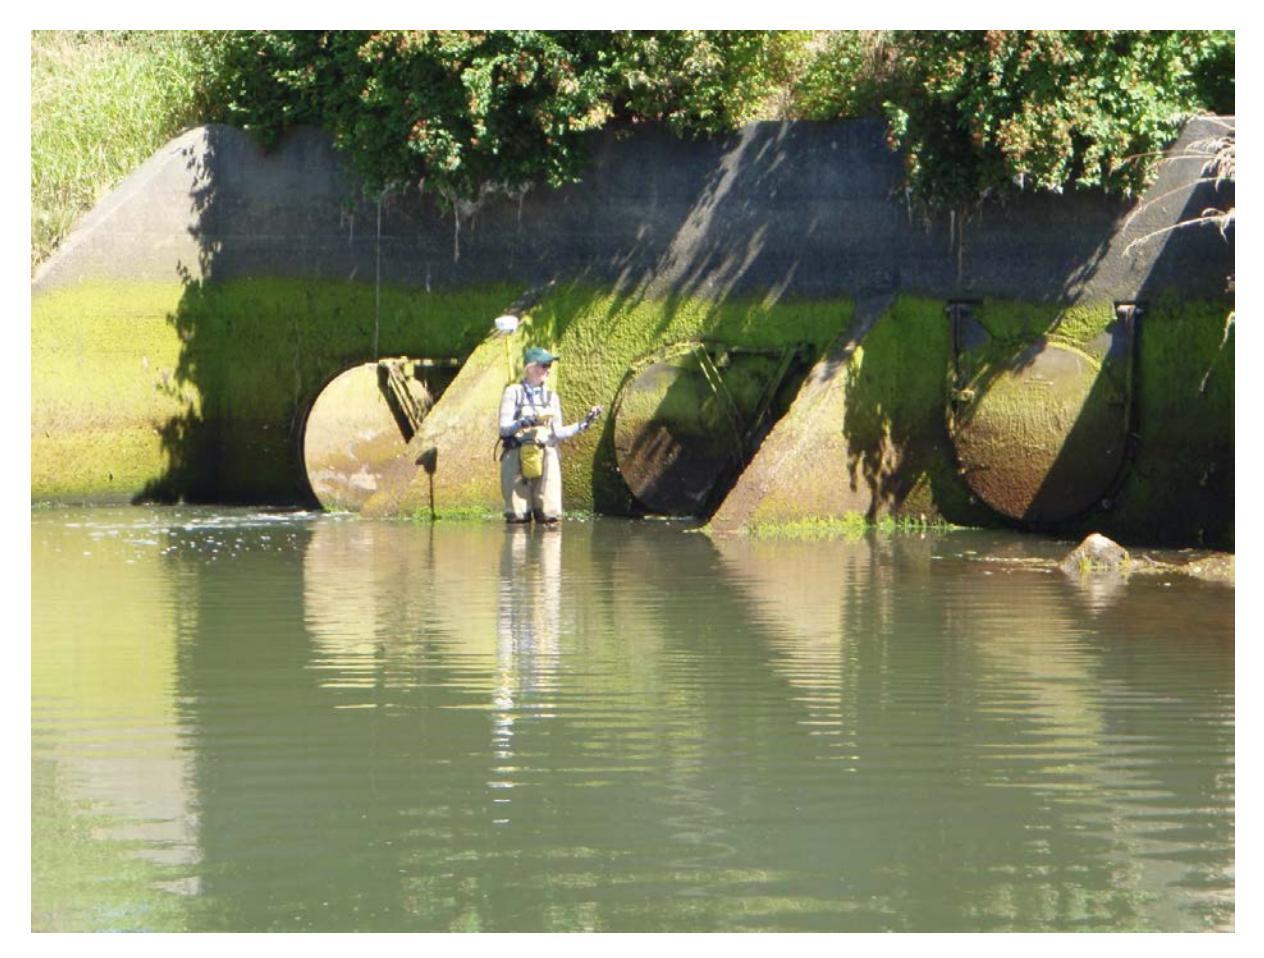
*Figure 2 - Photo of Dyke Slough flap gates underneath Comox Road.*

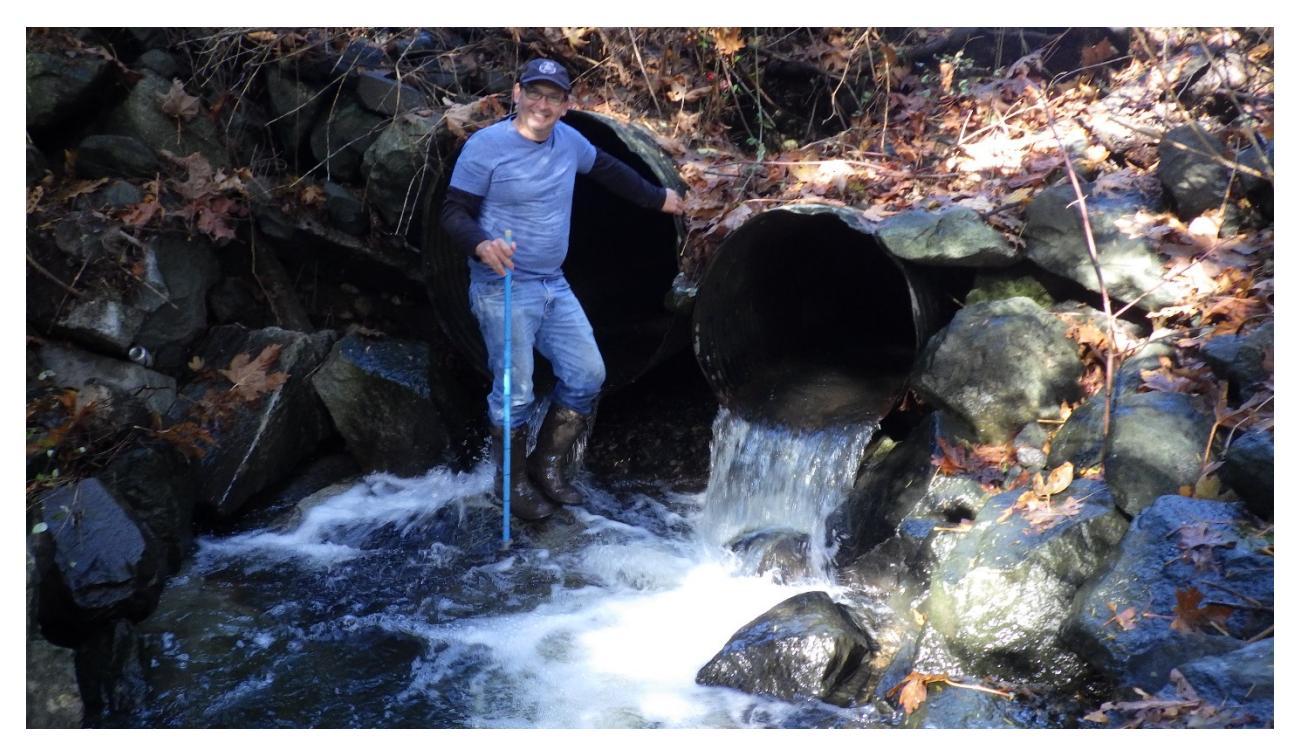
Figure 4 - K'ómoks First Nation Guardian Tony Billie next to Back Rd. culverts.

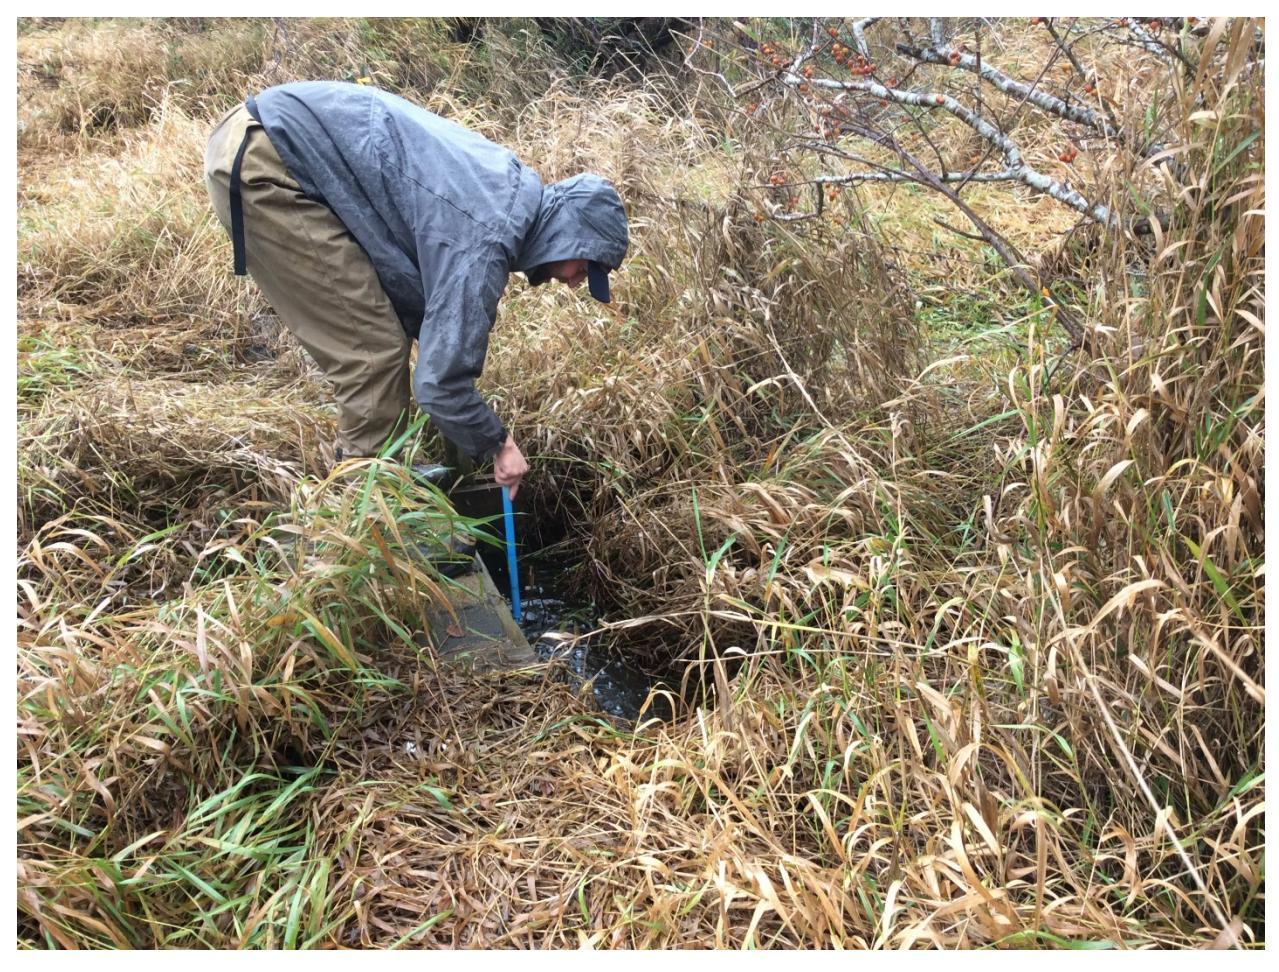
Mallard Creek has cool and reliable water flows, which provide valuable habitat attributes to salmonids. However, the creek has suffered impacts from headwater development, channelization and encroachment by RCG. Along its lower reaches, Mallard Creek is choked with RCG for almost 350 m (before it flows through a culvert for 300 meters under a farm field to connect to the streams upper reaches). In its upper reaches, significant sediment deposits are built up behind weirs. Restoring salmonid (chum, coho and cutthroat) habitat along Mallard Creeks' lower section, in addition to making it more accessible to salmon by modifying the functioning of the floodgates, can help mitigate some of the impacts of this headwater development and channelization<sup>6</sup>.

Figure 5 - Section of Mallard filled in with reed canarygrass.

Removal of RCG from the channel bottom, banks and riparian area of Mallard Creek is one of the restoration options which has been identified for this system in order to improve habitat for salmonids (see Appendix 7). The landowners that have RCG growing on their property have been supportive of managing and removing this invasive plant. Removal will have to adopt a phased, multifaceted and adaptive approach to be successful. Removal of RCG can be done with several different techniques<sup>8</sup>, however, to be effective removal must be paired with planting of riparian shrubs and trees<sup>9</sup>. Keys to long-term success in the elimination of RCG in the creek will include on-going monitoring and removal of new plants until riparian trees and shrubs have successfully established in RCG dominated riparian areas. Once re-established these trees should provide adequate shading to limit RCG regrowth and reduce the need for continued maintenance of the site (refer to Appendix 7 Mallard Creek Restoration Options for more detailed recommendations).
