ALBRED A / ROBINA
TERRAIN STABILITY INTERPRETIVE MAP

BCGS Mapsheet 83D.045, 83D.055, 83D.065

Scale 1:20,000

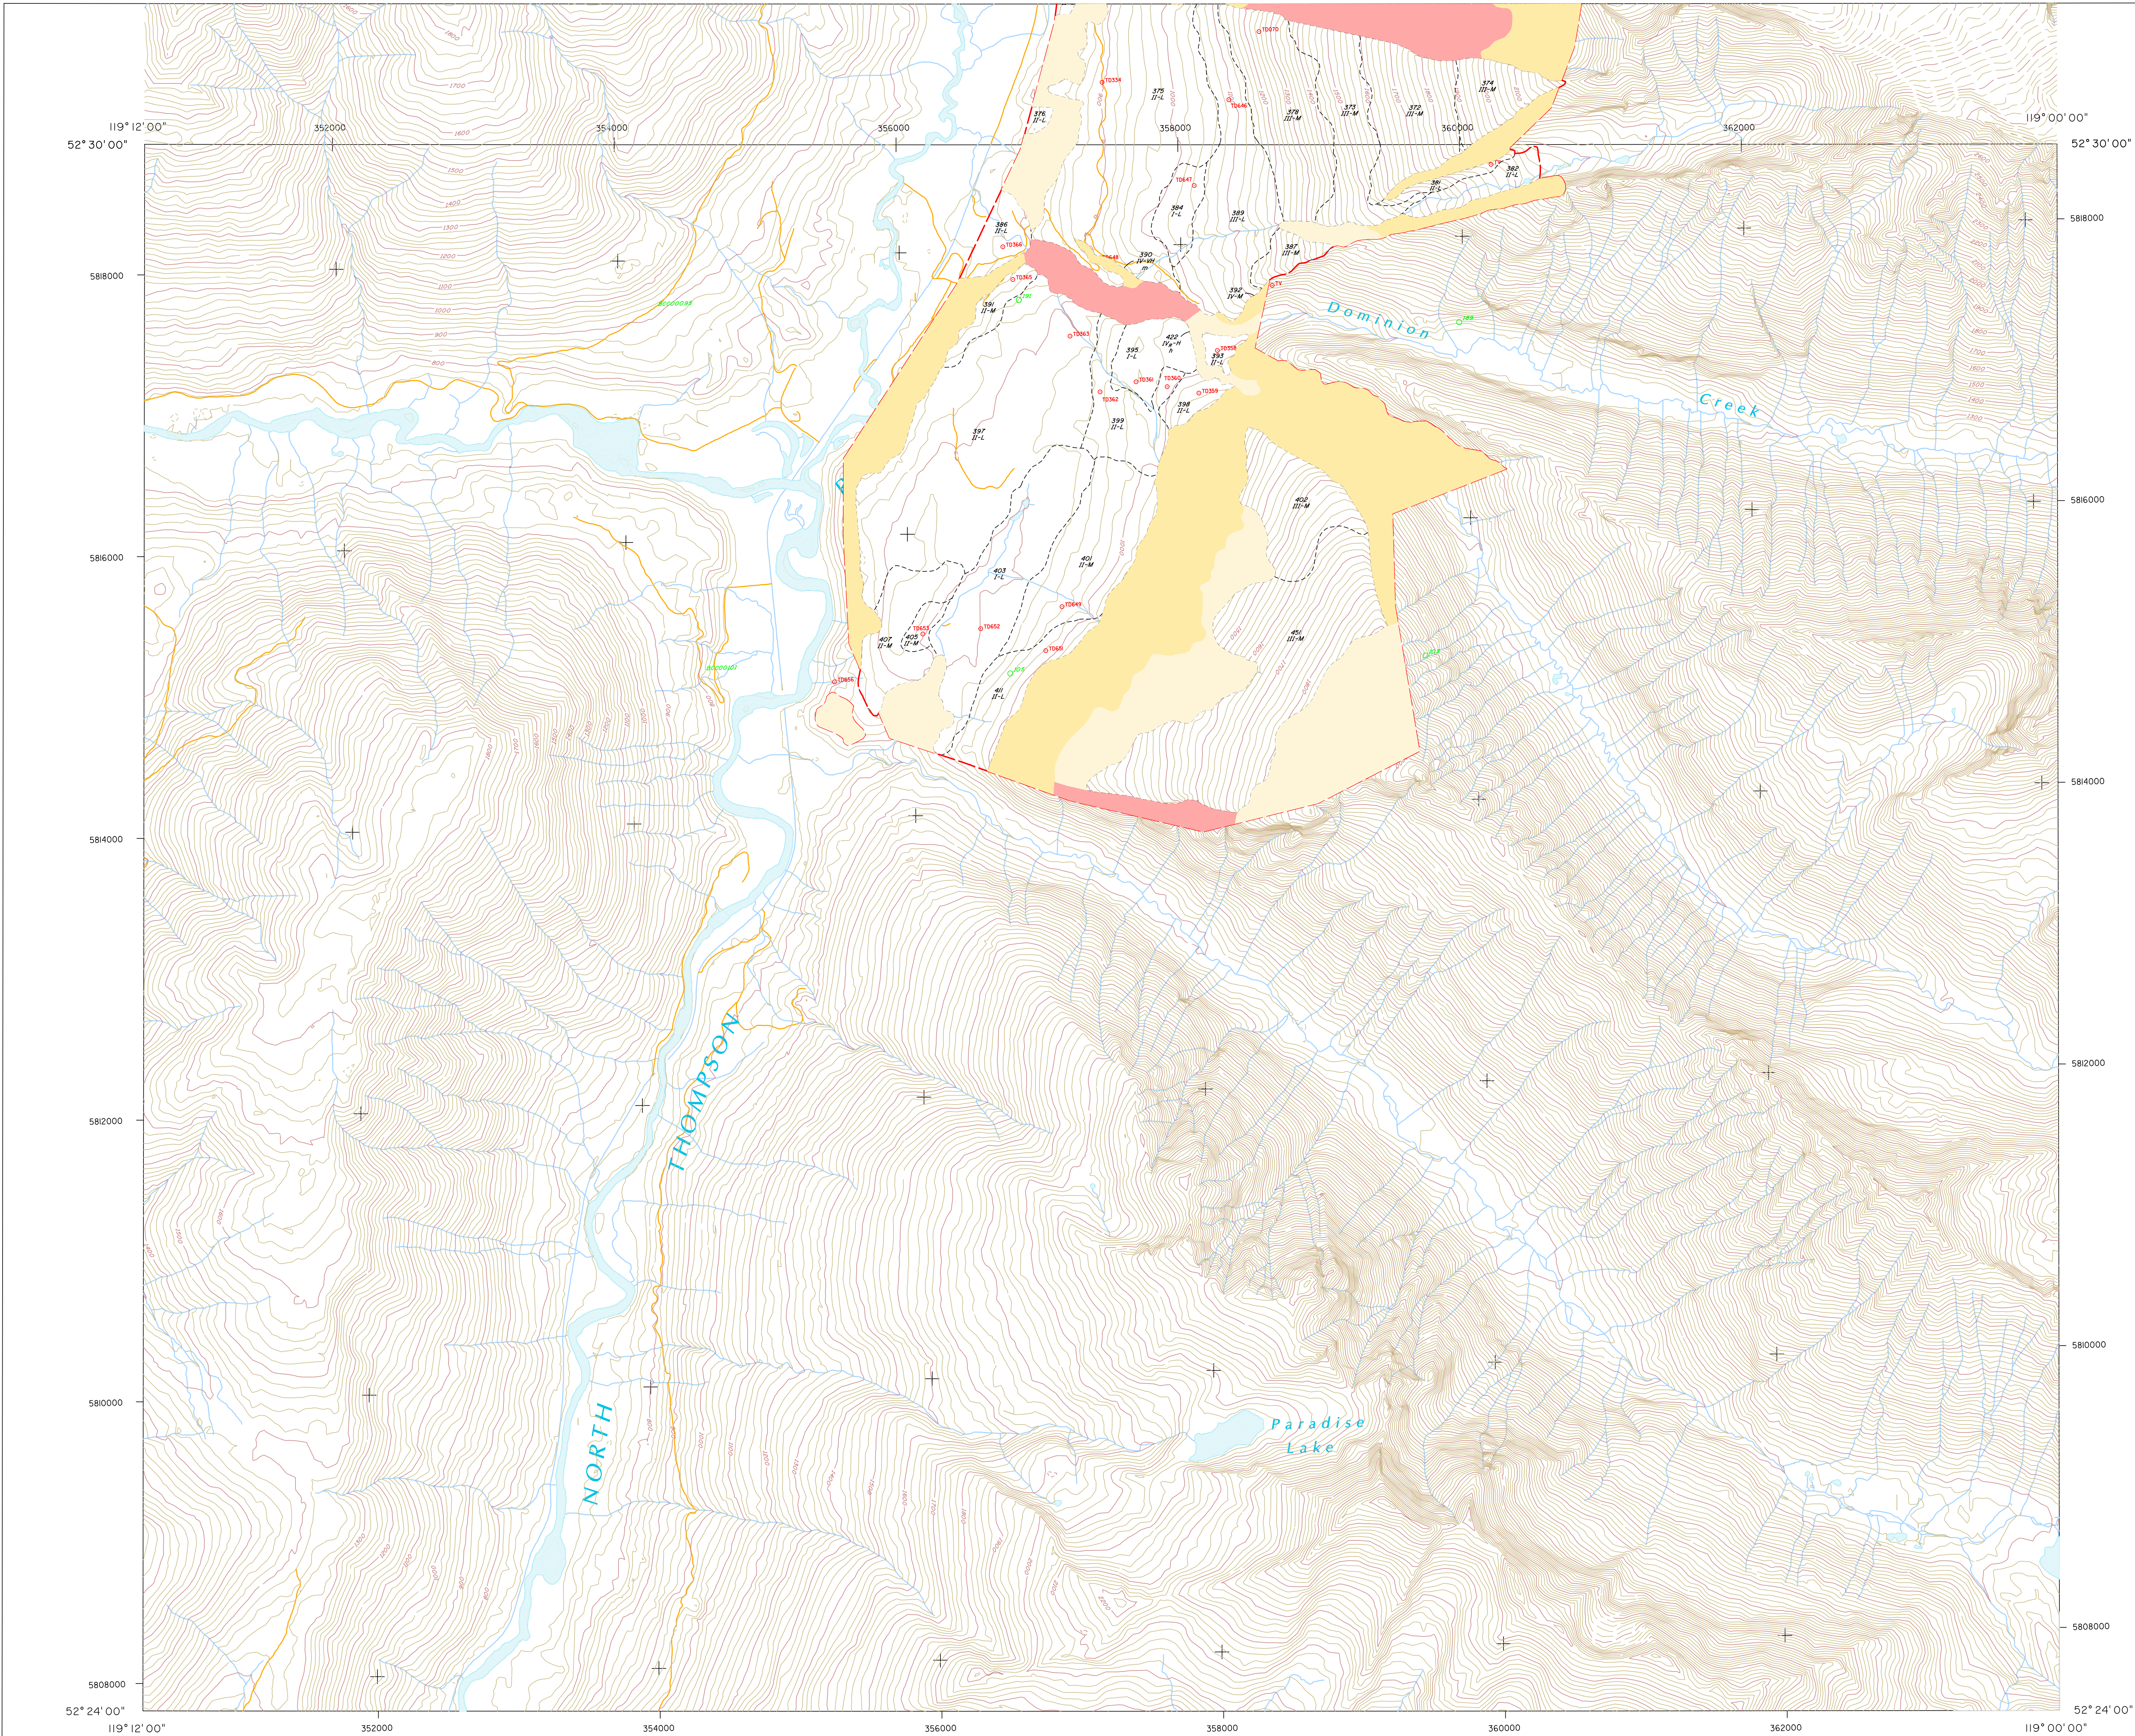
83D.045

TERRAIN STABILITY CLASSIFICATION

BOUNDARY LINES AND ON-SITE SYMBOLS

—	Definite polygon boundary	—	Scarp in surficial materials
- - -	Indefinite polygon boundary	—	Recent or recurrent landslide scar
.....	Arbitrary polygon boundary	—	Headwall scar
—	Study area boundary	—	Gully
—	Ground Observation	—	Terrain Stability Class IV _a
A	Visual Observation	—	Terrain Stability Class IV
+++++	Meltwater channel; small	—	Terrain Stability Class V
+++++	Meltwater channel; large
