**Project Completion Abstract
Barren Creek, S3
Km. 18.2 Michelle Bay FSR
Fish Passage Project**

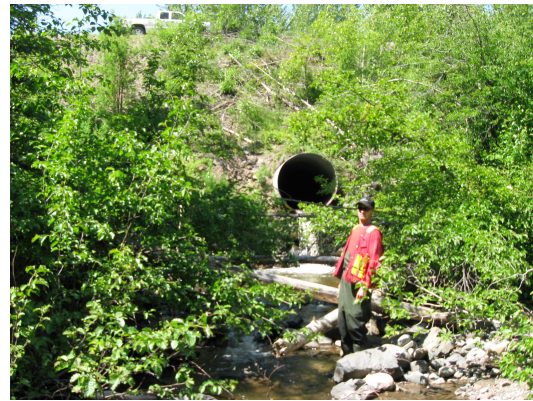
An assessment of this crossing was completed by Triton Environmental Consultants in November of 2007. The existing culvert is considered a full barrier to fish migration based on the vertical drop at the outlet of the culvert. (see photo # 1)

Photo 1. Stream Culvert Outlet.

Replace closed bottom culvert with a clear span bridge and restore the stream channel. A 39.624m clear span steel / concrete composite bridge was chosen to replace the existing culvert because:

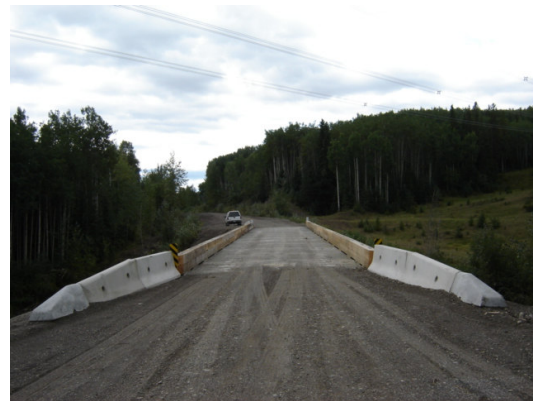
Photo 2. New Barren Creek Bridge

- Design completed: 2008/12/08
- Environmental Management Plan completed: 2008/08/13
- Contract for culvert removal, streambed rehabilitation and the supply and installation of the new structure was tendered December 17, 2008 and awarded January 26, 2009.
- Materials purchase and delivery completed: March 30, 2009
- Construction Completed September, 14, 2009. (Photo 2 and Photo 3)

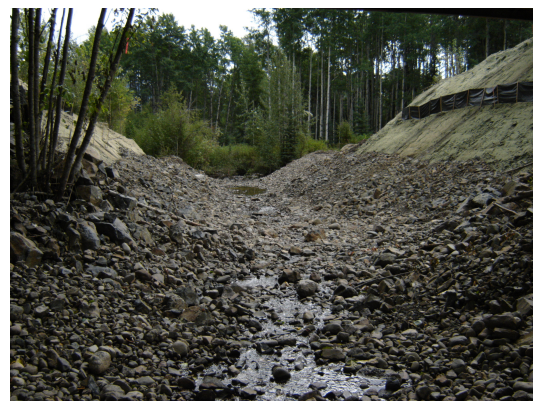
Photo 3. View of New Channel Looking Downstream.
