Fish Habitat Assessments for Fish Passage Restoration in the Kootenay Business Area

Project Number PD13TFE005

Prepared For: **Ministry of Forests, Lands and Natural Resource Operations**
British Columbia Timber Sales
907 Ridgewood Road
Nelson, British Columbia
V1L 6K1

Prepared By: **Vast Resource Solutions Inc.**
PO Box 538
Cranbrook, BC
V1C 4J1

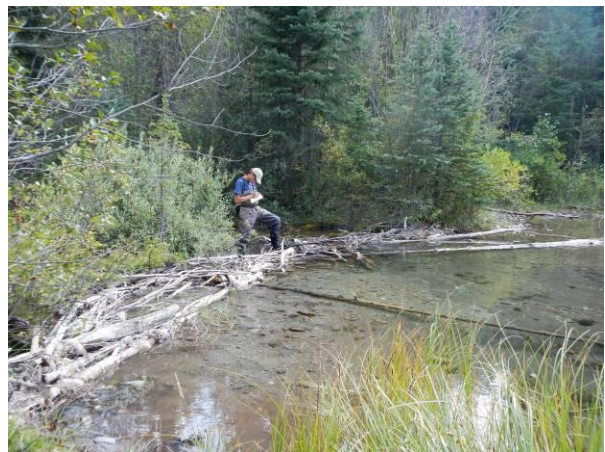
Permanent beaver dam and resulting impoundment.

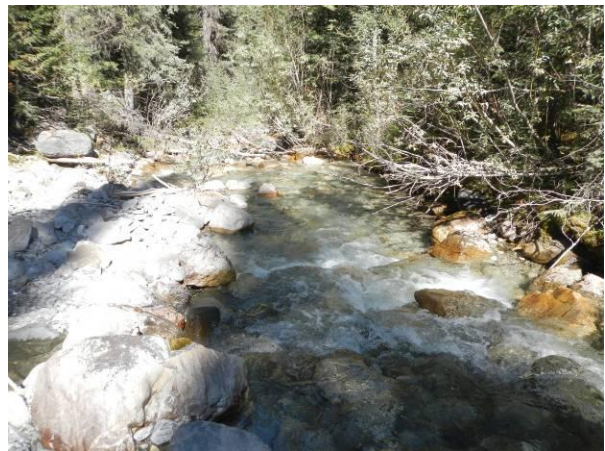
Outlet of perched culvert.

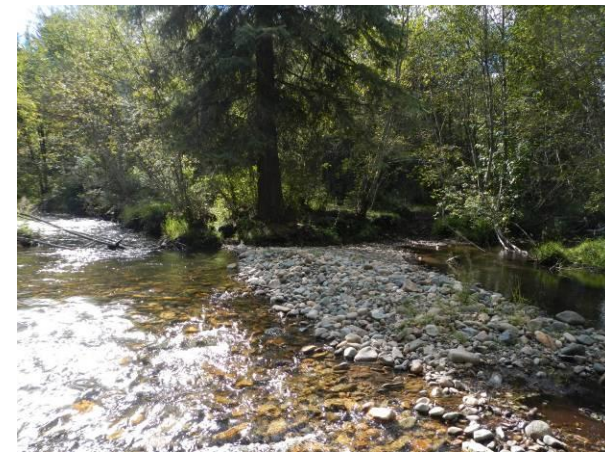
Downstream Habitat: A beaver dam was observed immediately upstream of the confluence with Linklater Creek. The rest of the downstream section offers similar habitat as upstream characterized by low gradient and fine sediments.

Confluence with Linklater Creek.

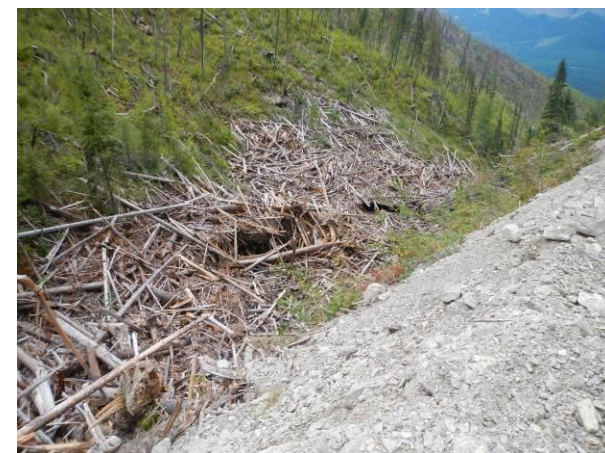
Persistent large woody debris at km 38.

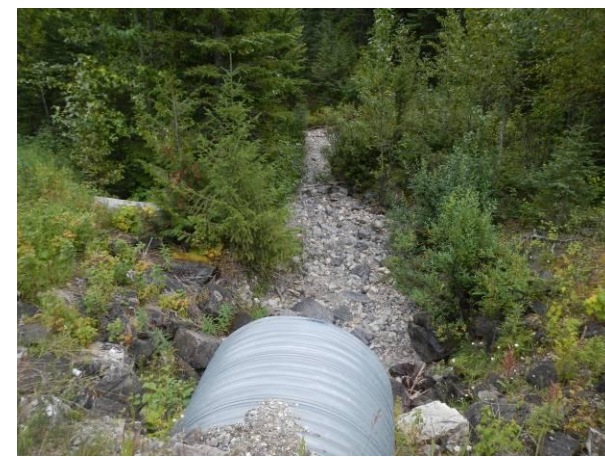
Downstream of outlet of White20.
