## **Fish Passage Culvert Inspection - City of Prince George**

Prepared for:  
**City of Prince George**  
505-4<sup>th</sup> Avenue  
Prince George, British Columbia  
V2L 3H2

EDI Project No.: 04-BC-0104

February 2005

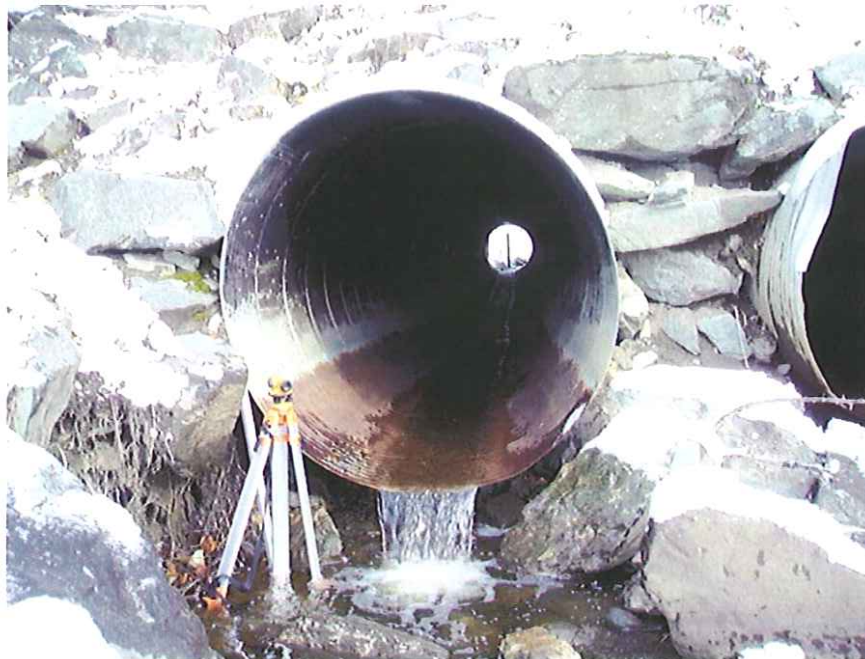
**Site 1 - McMillan Creek (Prince George Pulp Mill Road): Full Seasonal Barrier, High Priority**

View of left bank outlet.

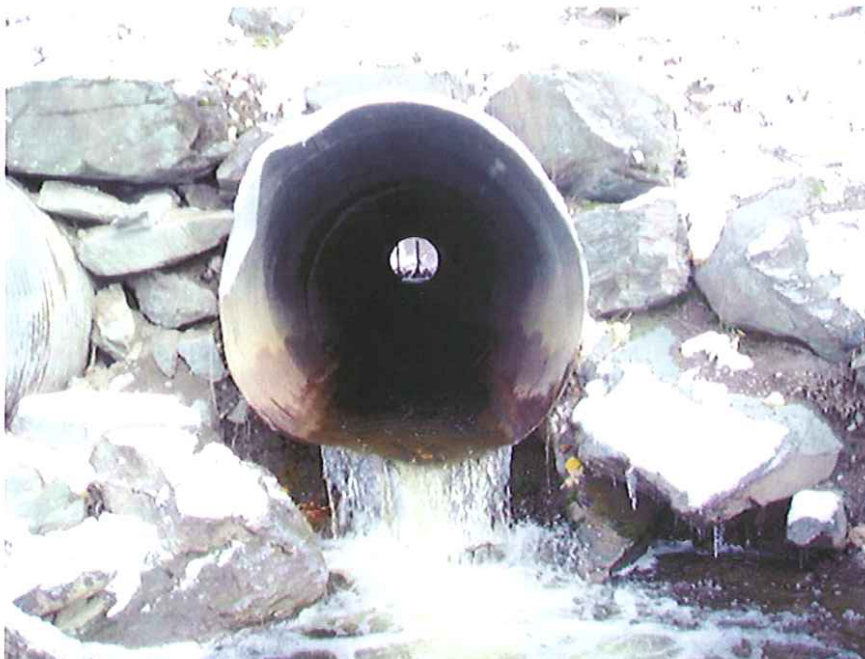
View of right bank outlet.

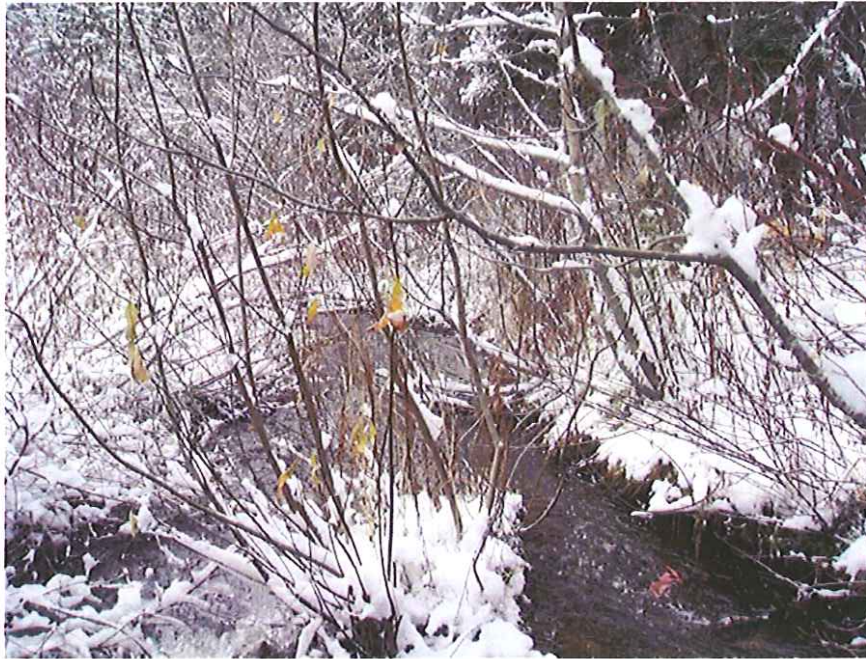
**Site 2 – McMillan Creek (Hoferkamp Road): Full Barrier, High Priority**

View downstream of outlet.

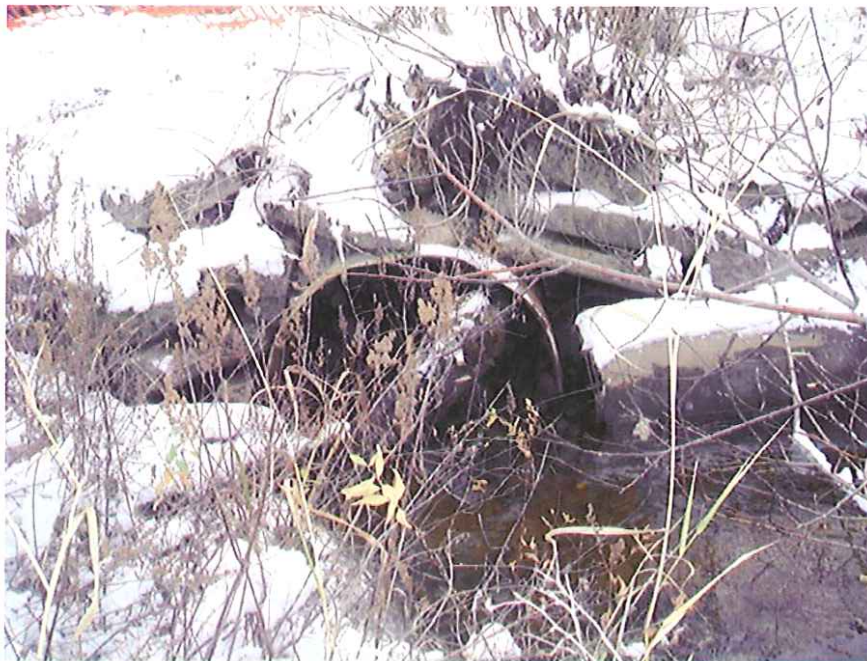
**Site 3 McMillan Creek (Aberdeen Road): No Barrier, No Maintenance Concerns**

View of left bank outlet.

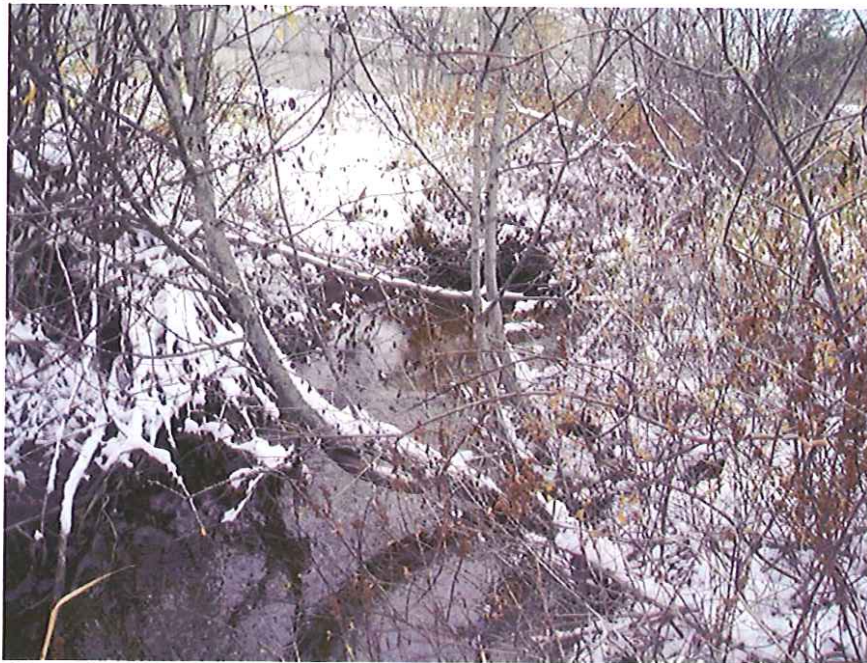
**Site 3 - McMillan Creek (Aberdeen Road): No Barrier, No Maintenance Concerns**

View downstream of outlets.

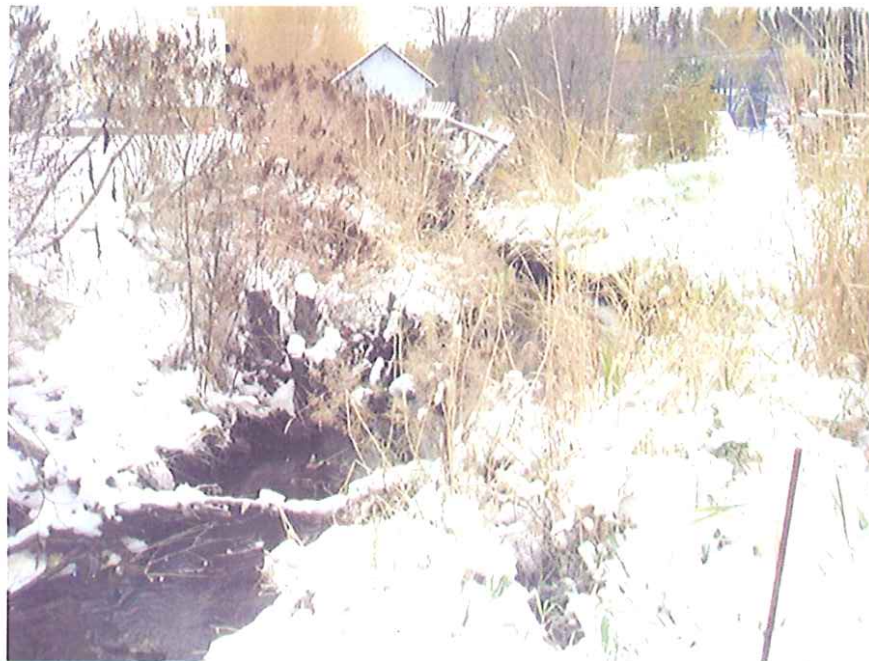
**Site 4 - McMillan Creek (McMillan Ave): Full Barrier, High Priority**

View downstream of outlets.

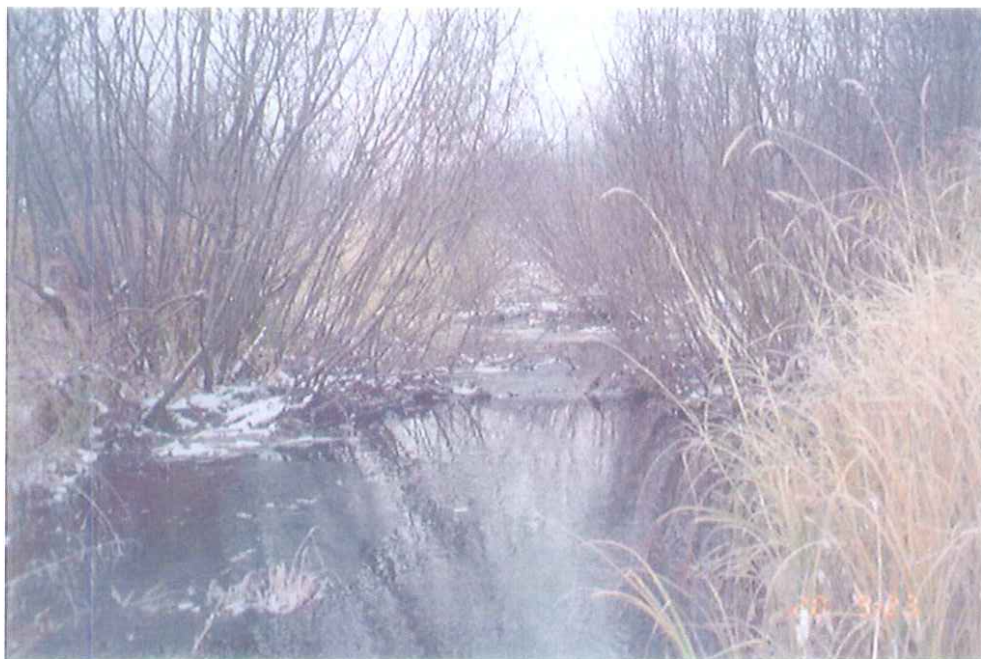
**Site 6 - McMillan Creek (Noranda Road East): No Barrier, High Maintenance Issues**

View downstream of outlet.

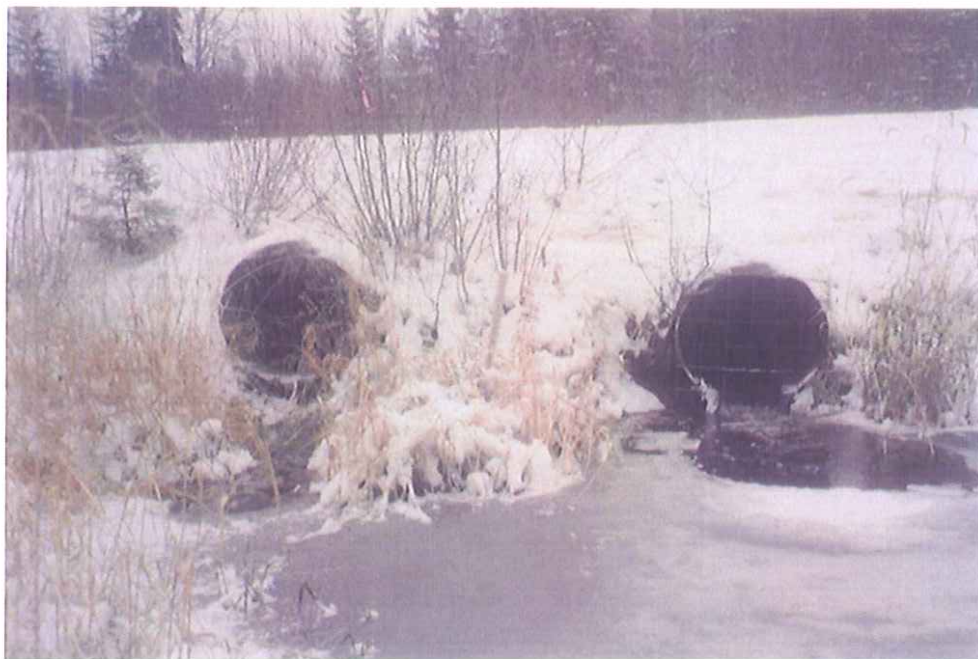
**Site 9 - McMillan Creek (Old Summit Lake Road): No Barrier, No Maintenance Issues**

View of outlets

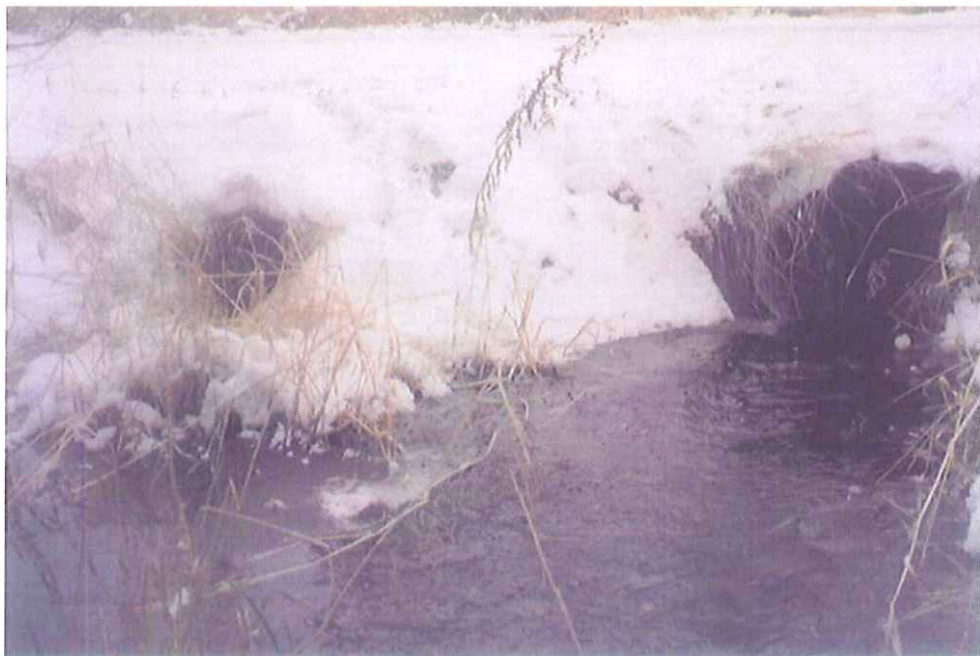
**Site 10 - McMillan Creek (Goose Country Road): No Barrier, No Maintenance Issues**

View of outlets.

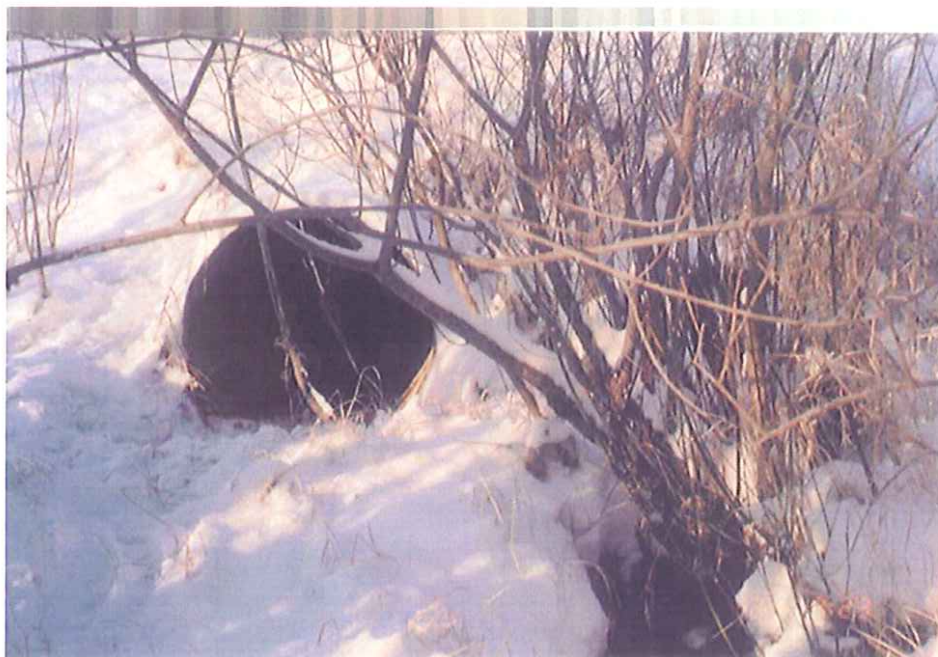
**Site 11 - McMillan Creek (Old Summit Lake Road): No Barrier, No Maintenance Issues**

View of right bank outlet.

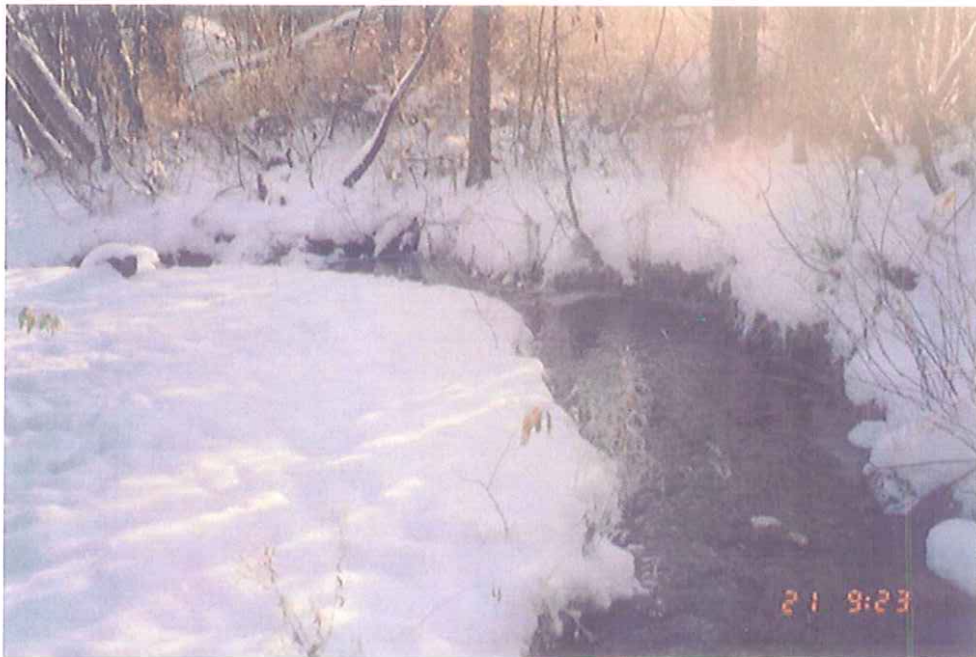
**Site 11 - McMillan Creek (Old Summit Lake Road): No Barrier, No Maintenance Issues**

View downstream of outlet.

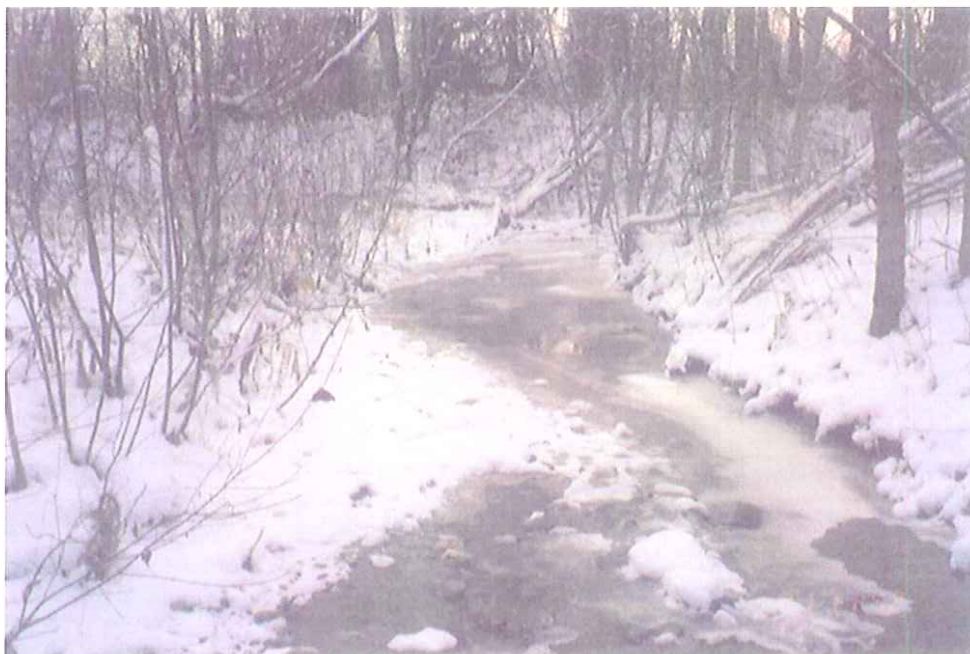
View downstream of outlets.

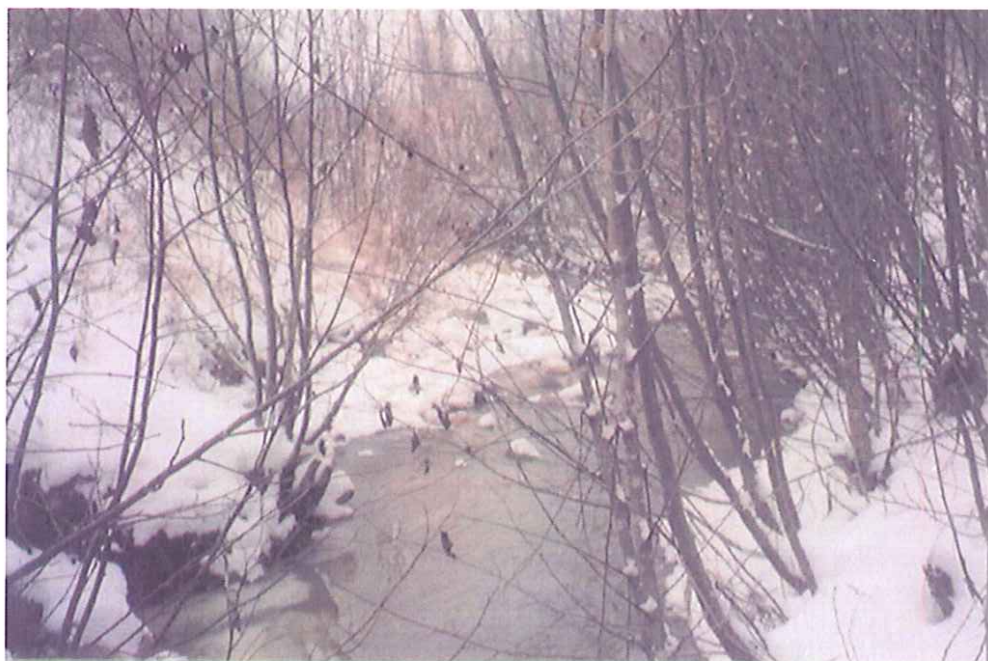
**Site 13 – Unnamed Stream (Indian Reserve Road): Full Seasonal Barrier, High Priority**

View downstream of outlets.

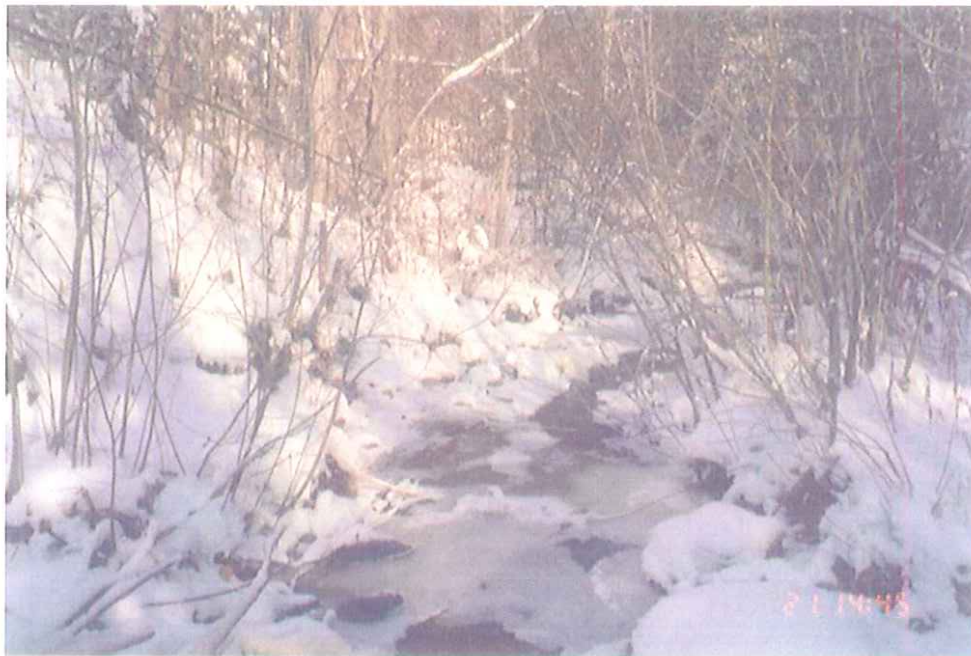
**Site 14 – Parkridge Creek (Domano Road): Full Barrier, High Priority**

View downstream of outlets.

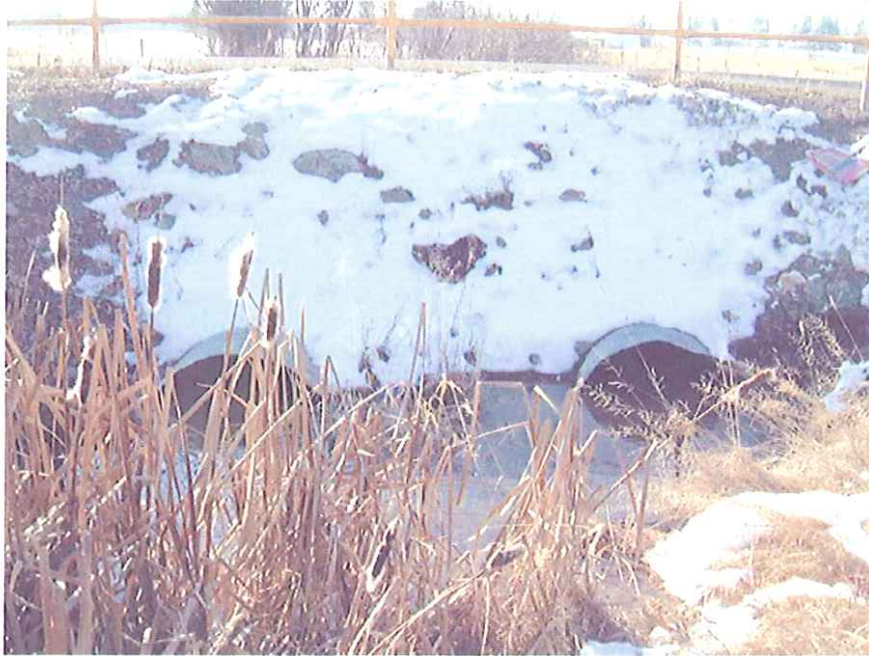
**Site 16 – Bittner Creek (Giscome Road): No Barrier, No Maintenance Issues**

View of outlets.

The culverts at this site are over half full of water. Thus, it is probable that they could fail at high flows.

The current culvert at this site does not meet the recommended Q100 diameter estimate. The recommended Q100 estimated culver area is 14.66 m<sup>2</sup>. The current culverts have a combined area of 3.80 m<sup>2</sup>. A structure this site should be engineered, and will require a further site visit by a qualified engineer before replacement.

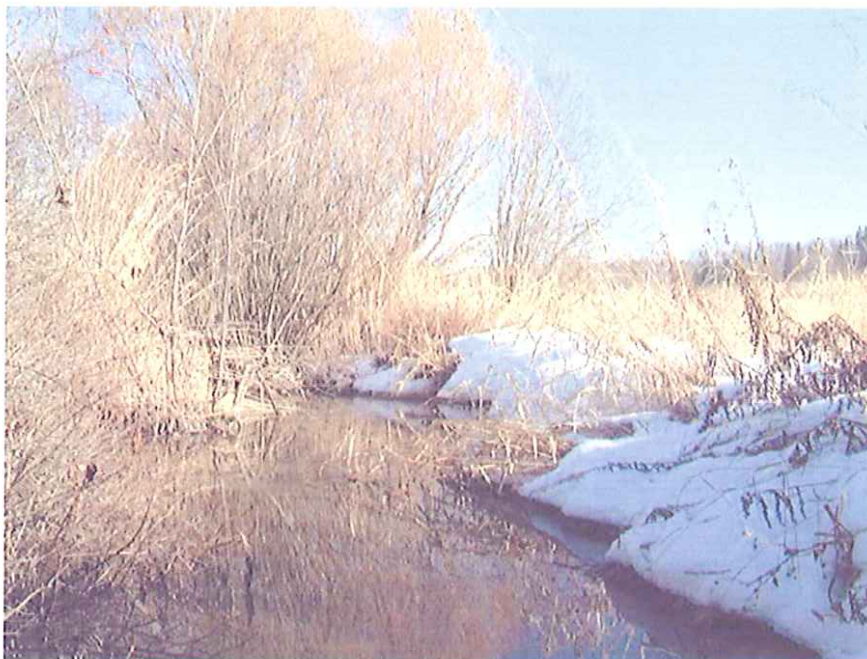
View downstream of outlets.

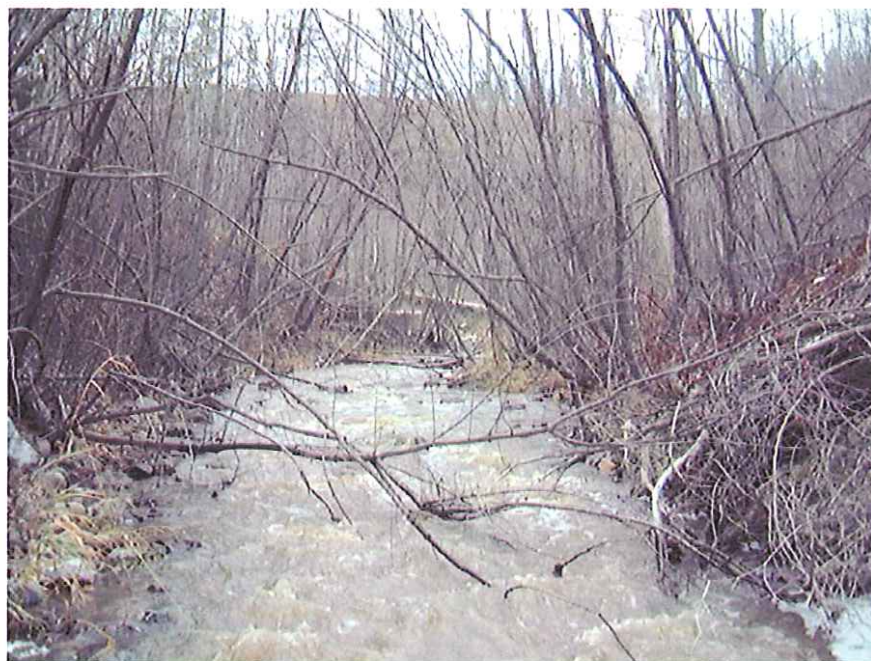
**Site 18 - Haggith Creek (Willow-Cale Road): Full Barrier, High Priority**

View downstream of outlet.
