Gitanyow Fisheries Authority

The 2008 Kitwanga-Cranberry River Watershed Restoration Project

Submitted to: B.C. Ministry of Forests and Range
Smithers, BC

Prepared by: Mike McCarthy HBSc
Gitanyow Fisheries Authority

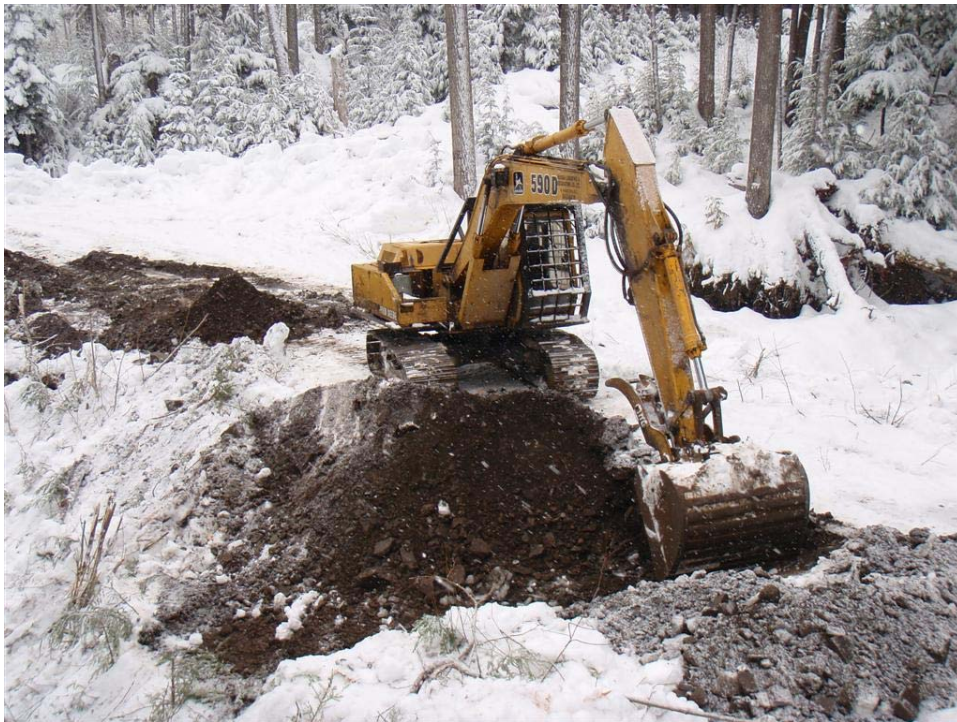
Photo 5: Start of Site 91 deactivation (February 8, 2009).

The prescription for this site was to remove the culverts and deactivate the crossing. Structural replacement was considered too costly for the NWFREP restoration funding available for 2008. Following project approval by the Gitanyow Hereditary Chiefs and the BC MoFR, the GFA and McElhanney Consulting Services prepared a detailed deactivation plan, which is presented in Appendix I. Works began on February 8th, 2009 and was completed in approximately 6 working days. Machinery on site included 2 excavators, a crawler tractor, and a dump truck. Machines excavated down to natural streambed and removed culverts in sections beginning at the downstream end (Photos 5 and 6). The stream banks and channel bed were then armored with riprap. An ATV trail was constructed on the upstream side of the crossing and the remaining approaches were graded to a 2H : 1V slope (Photo 7). All exposed soils were seeded with grass and fertilized, and the approaches leading to the stream were covered with straw mulch to aid seed germination (Photos 8 and 9).

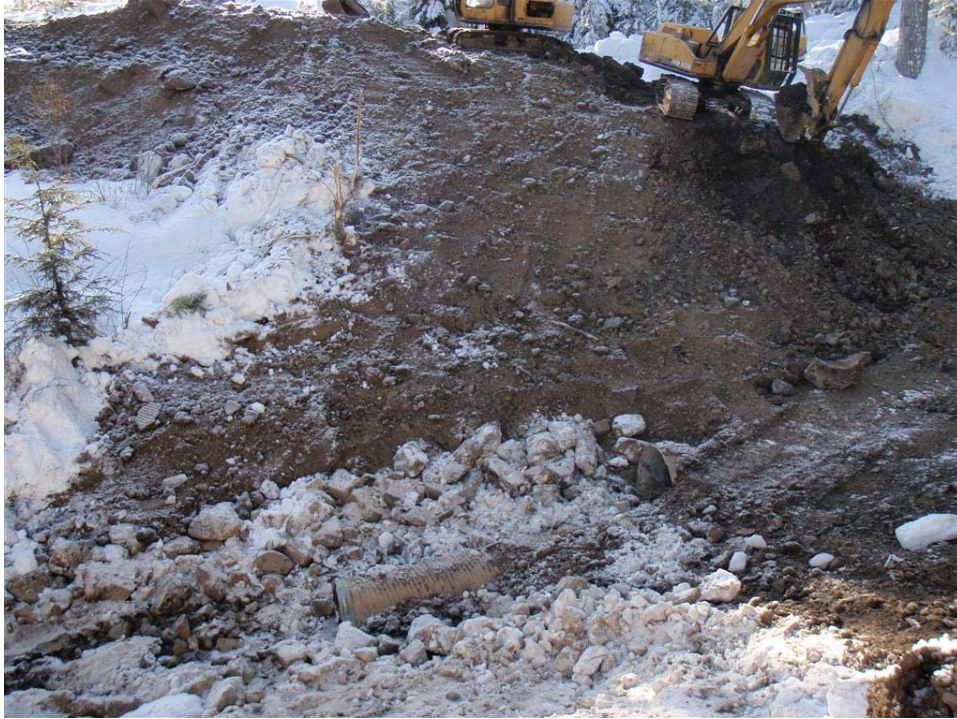
Photo 6: Removal of culverts and armoring of stream banks at Site 91 (February 11, 2008).

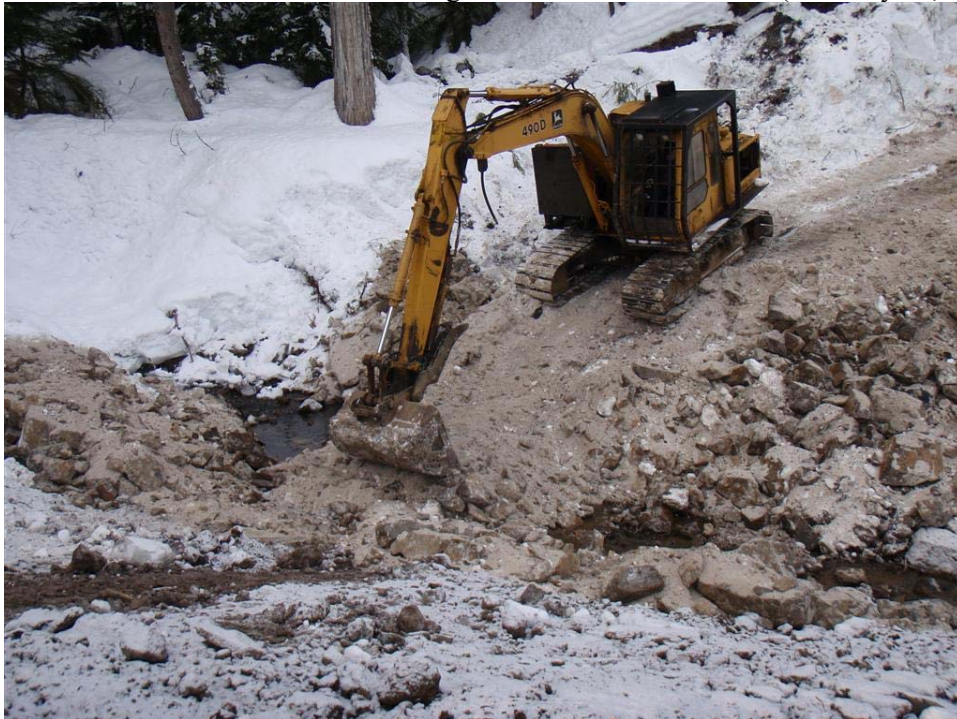
Photo 7: Construction of an ATV crossing over the upstream section of Site 91 (February 19, 2009).

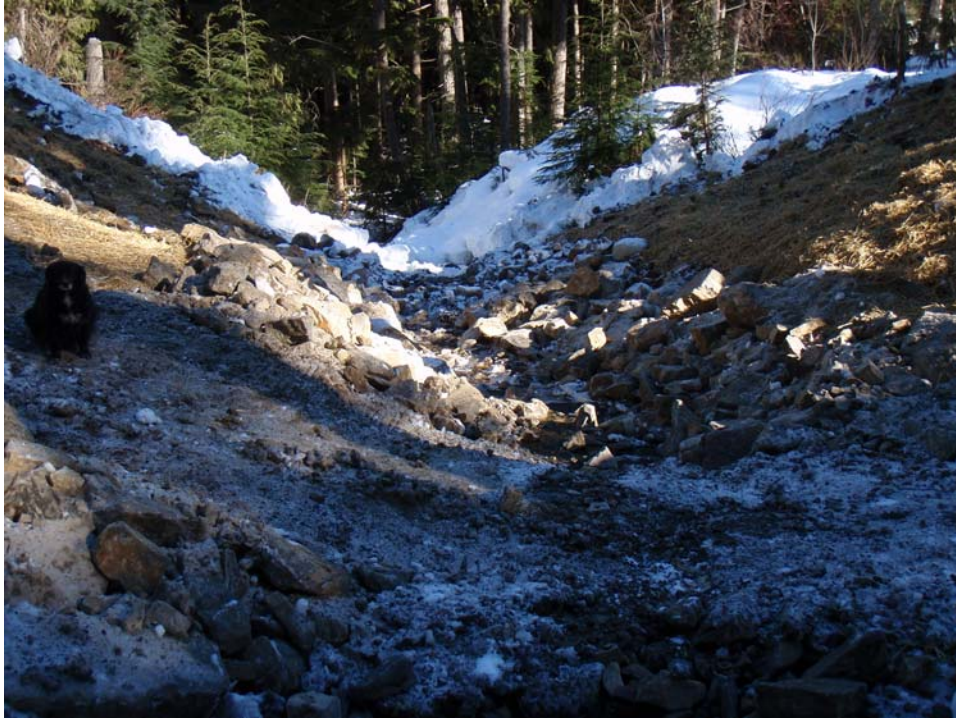
Photo 8: Armored stream channel following the deactivation of Site 91 (February 25, 2009).

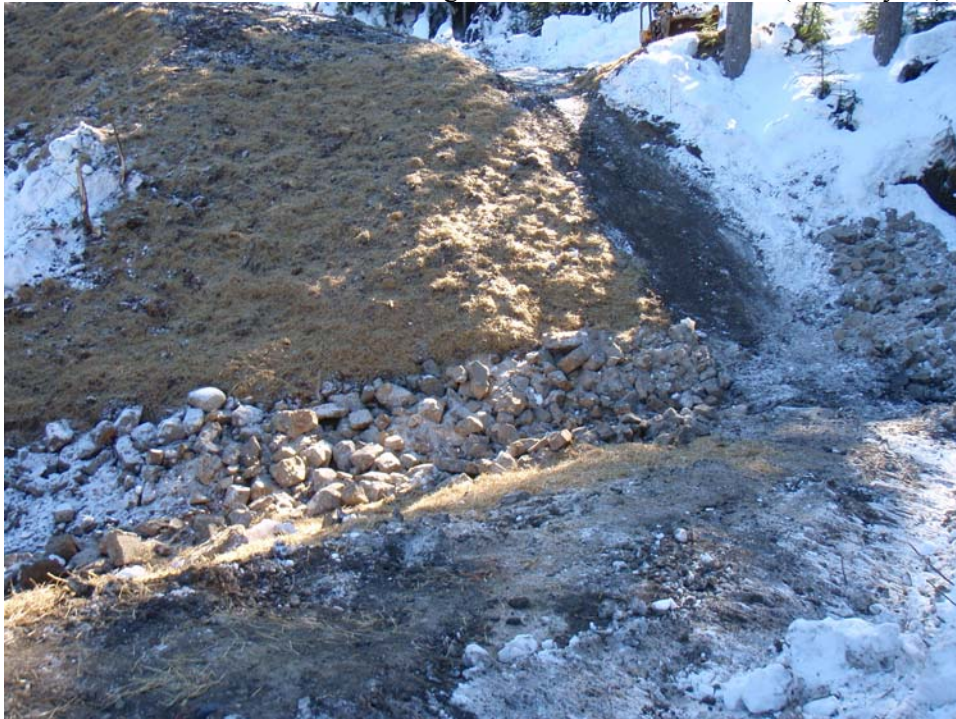
Photo 9: Grass seed and straw mulch applied to the stream banks following the deactivation of Site 91 (February 25, 2009).

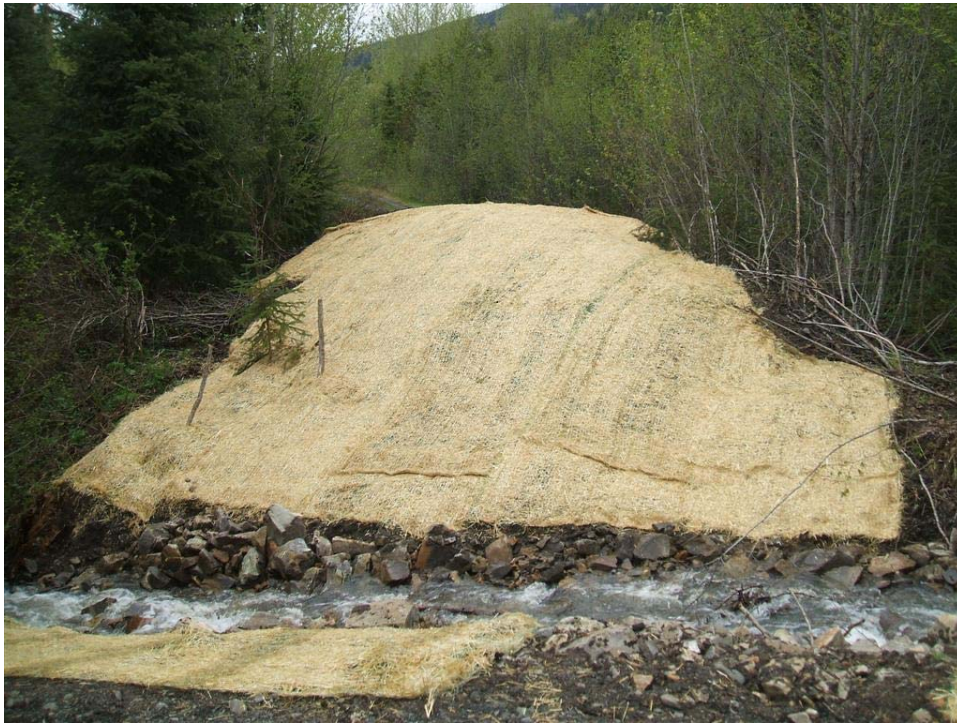
Photo 12: Right bank seeded and covered with ECBs at Site 61 (May 22, 2008).

In 2006, Site 61 was identified as a fish barrier (McCarthy 2007, Photo 10) and was subsequently deactivated in 2007 (McCarthy 2008, Photo 11). Initial treatment of the disturbed site was undertaken on May 22nd, 2008 when grass seed, fertilizer, and erosion control blankets were applied to approximately 340 m² of exposed soil (Photos 12 to 15). This site is located 50 meters from Hwy 37 N and was revisited on six occasions throughout the growing season, mostly while on-route to other destinations (June 4th, 9th, 17th, 27th; August 19th; and October 1, 2008; additional photos on CD in Appendix I). By June 9th, a large portion of the grass seed had germinated and was beginning to penetrate through the ECBs. By June 27th most of the seed had germinated and by October 1st (final visit), the entire area was well vegetated. No further works are recommended for this site.

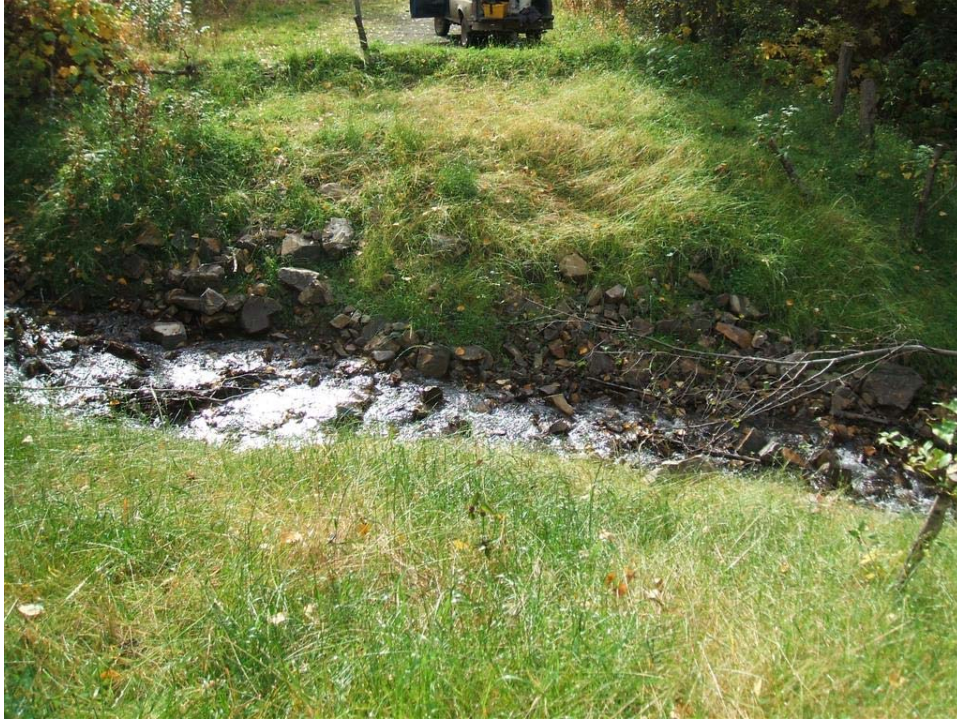
Photo 15: Well-vegetated left bank at Site 61 (October 1, 2008).

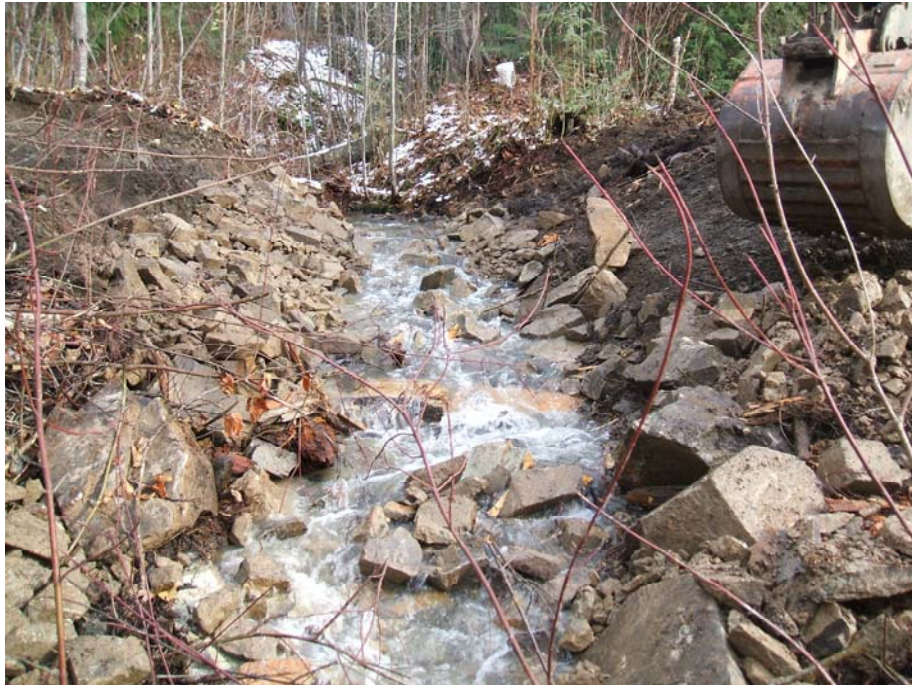
Photo 17: Final stages of deactivation at Site 14 (October 2007)

In 2006, Site 14 was identified as a fish barrier (McCarthy 2007, Photo 16) and was subsequently deactivated in 2007 (McCarthy 2008, Photo 17). Initial treatment of the disturbed site was undertaken on May 23rd, 2008 when grass seed, fertilizer, and erosion control blankets were applied to approximately 200 m² of exposed soil (Photos 18 to 22). When revisited on July 17th, 2008 most of the grass seed had germinated and penetrated through the ECBs. By October 1st, 2008 (final visit) the entire site was considered completely vegetated. No further works are recommended for this site.

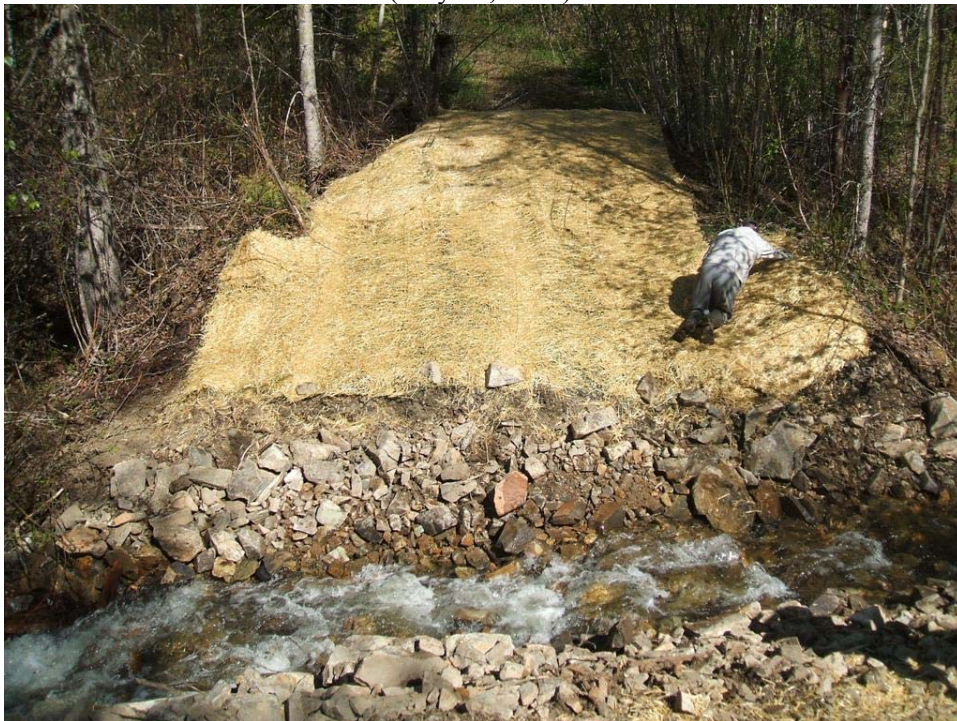
Photo 19: Right bank seeded and covered with ECBs at Site 14 (May 22, 2008).

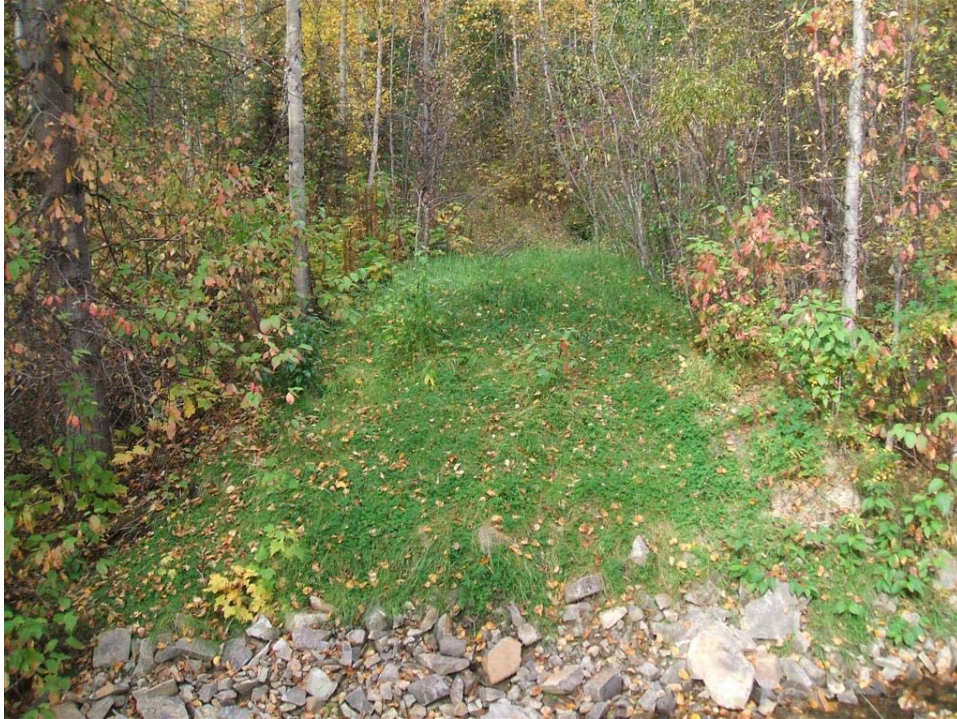
Photo 20: Well-vegetated right bank at Site 14 (October 1, 2008).

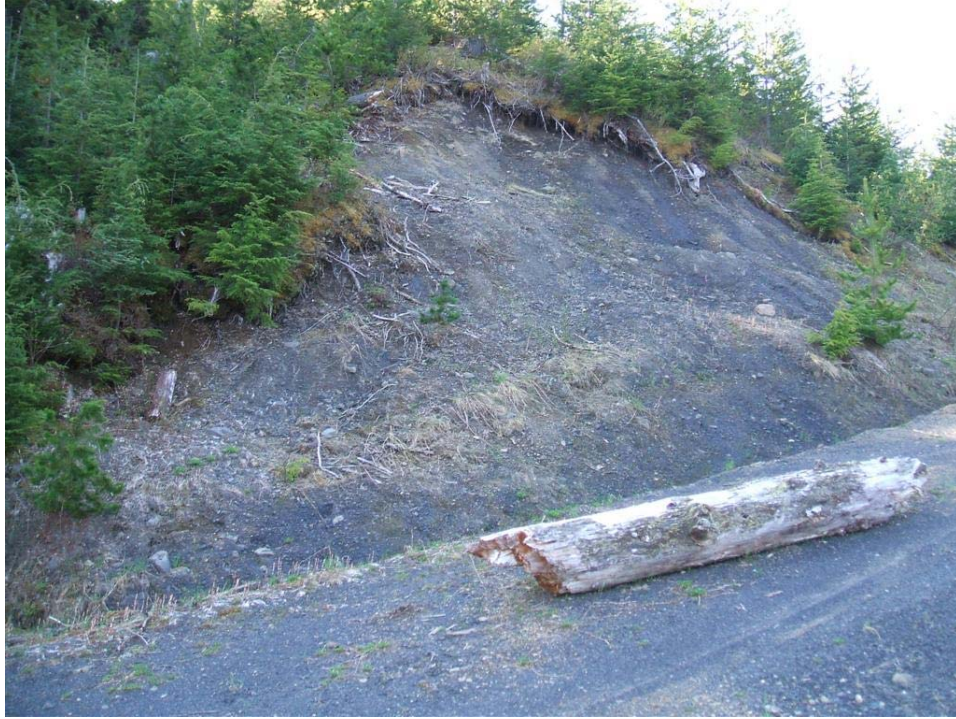
In 2007, Site 35 received a high WQEE score of 6.0 m3 (McCarthy 2008)). Mass wasting has occurred on a steep left road cutbank (85 percent slope approximately) adjacent to the stream channel (Photo 23). Initial treatment was undertaken on May 26th, 2008 when grass seed, fertilizer, and erosion control blankets were applied to approximately 450 m² (Photo 24). When revisited on July 17th, 2008 much of the seed had germinated but had yet to penetrate through the ECBs. By October 14th, 2008 (final visit) approximately 90 percent of the area treated with grass seed and ECBs was well vegetated (Photo 25). An adjacent area treated with grass seed only was less successful with approximately 50 percent coverage. No further works are recommended for this site.

Photo 23: Exposed left road cutbank at Site 35 prior to treatment (May 26, 2008).

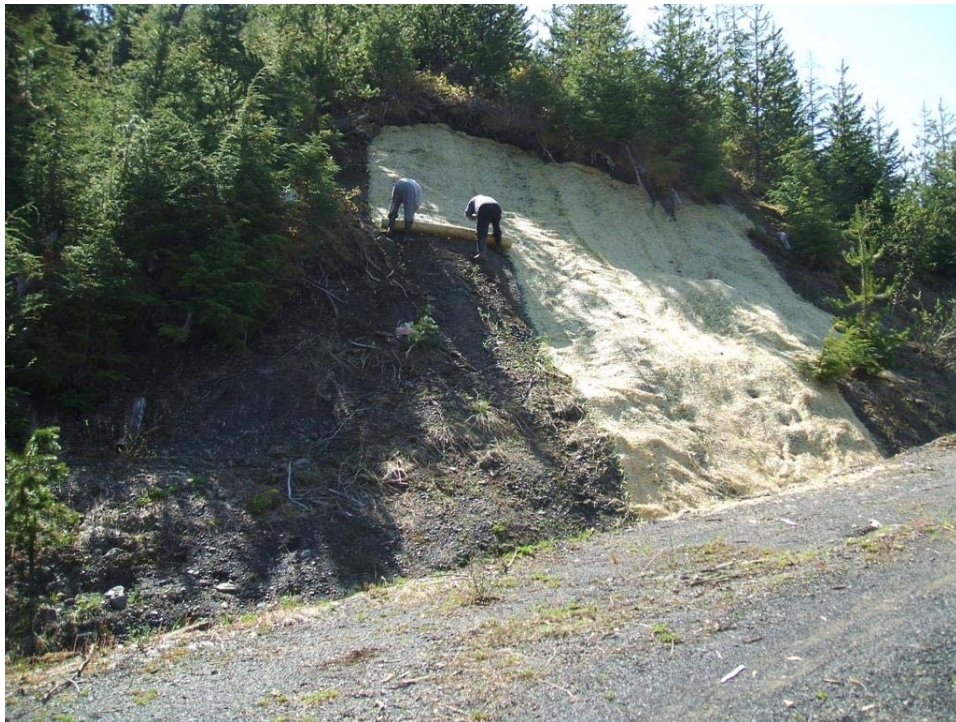
Photo 24: GFA crew applying ECBs at Site 35 (May 26, 2008).

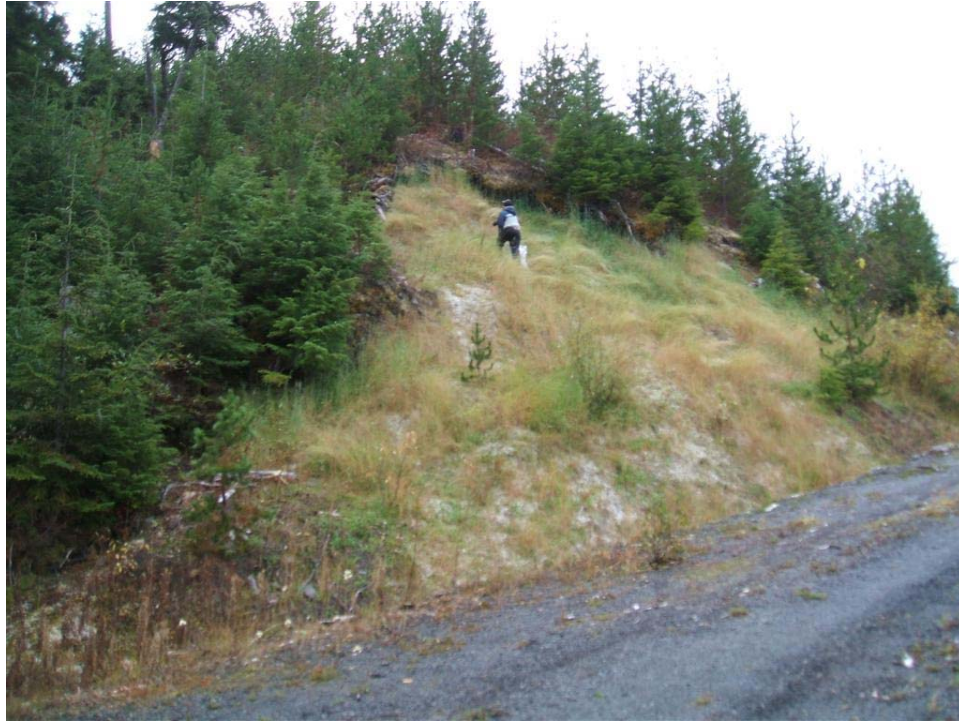
Photo 25: Well-vegetated treatment area at Site 35 (October 14, 2008).

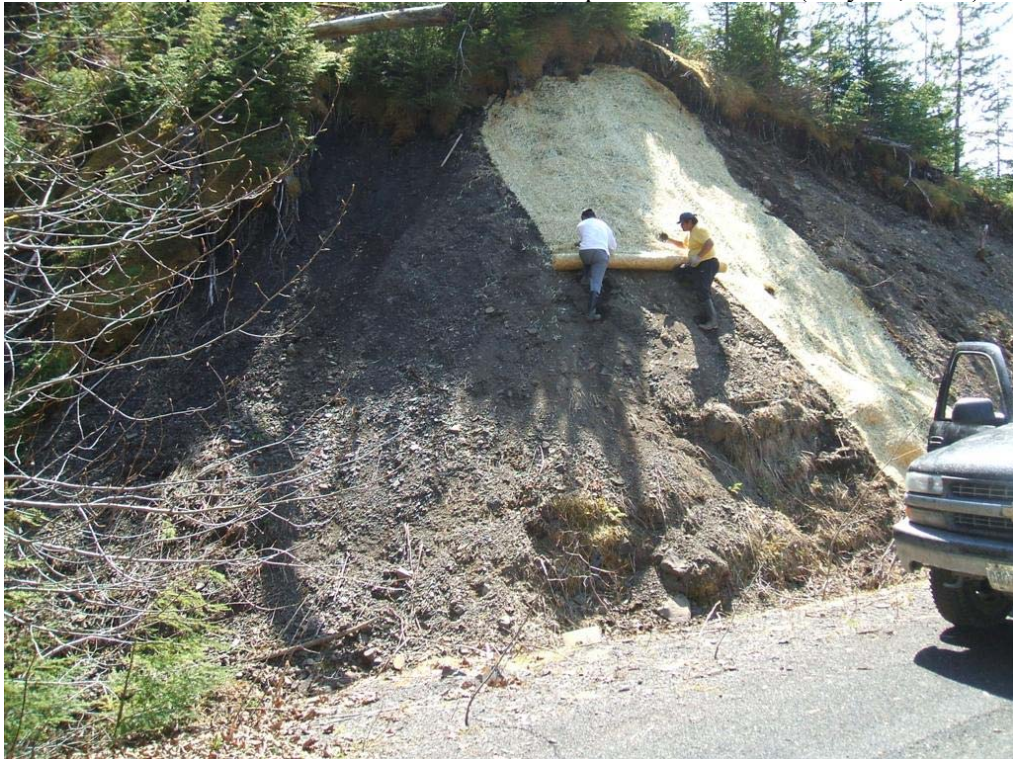
Photo 27: GFA crew applying ECBs at Site 42 (May 26, 2008).

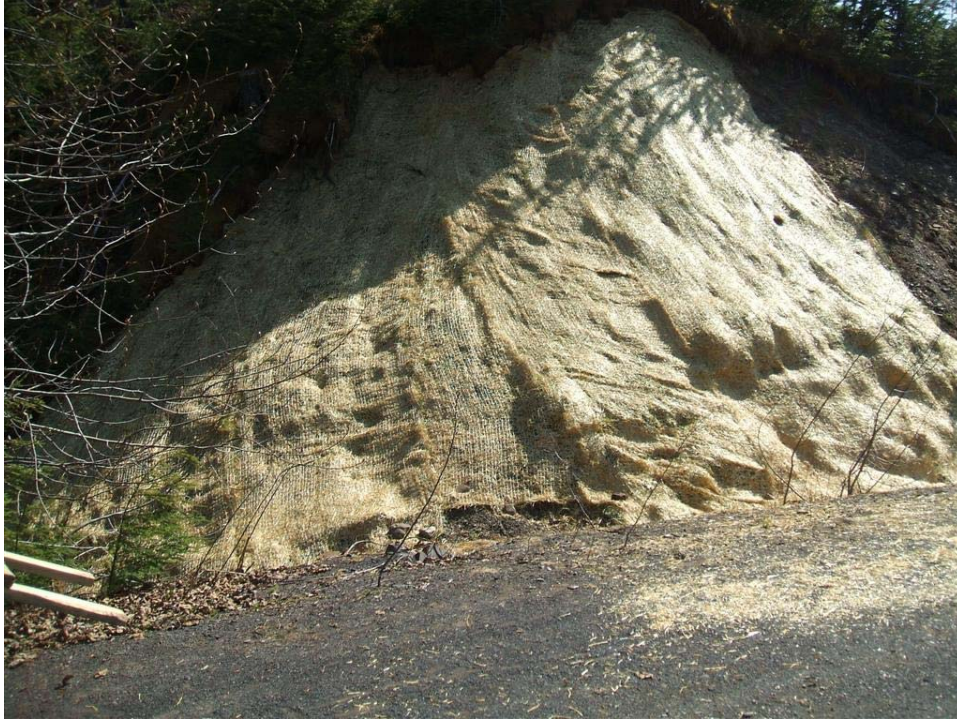
Photo 28: Left bank seeded and covered with ECBs at Site 42 (May 26, 2008).

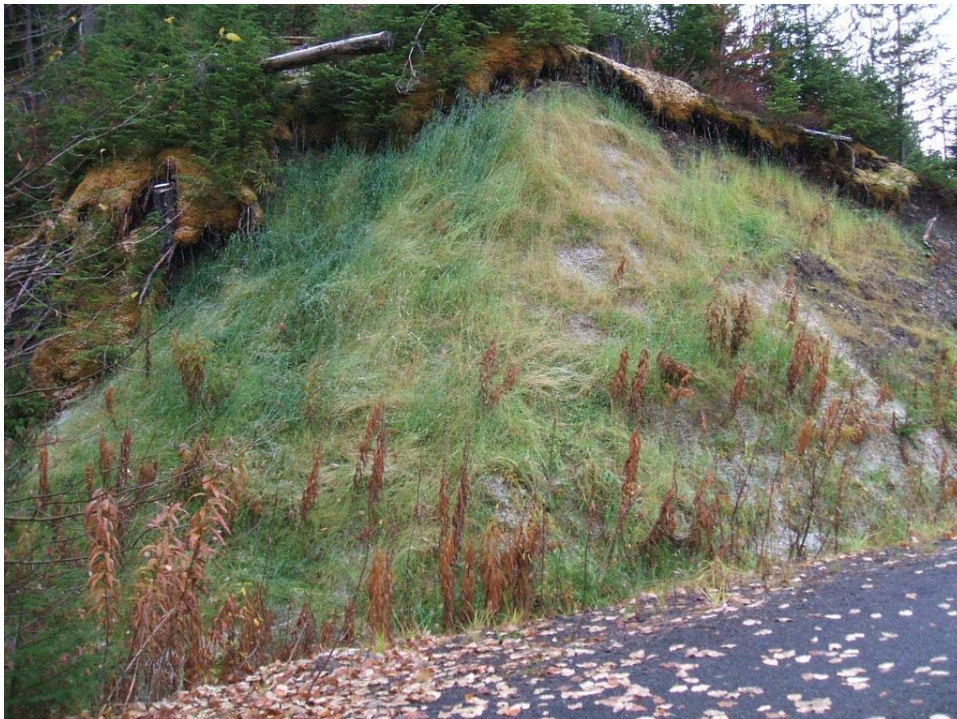
Photo 29: Well vegetated treatment area at Site 42 (October 14, 2008)

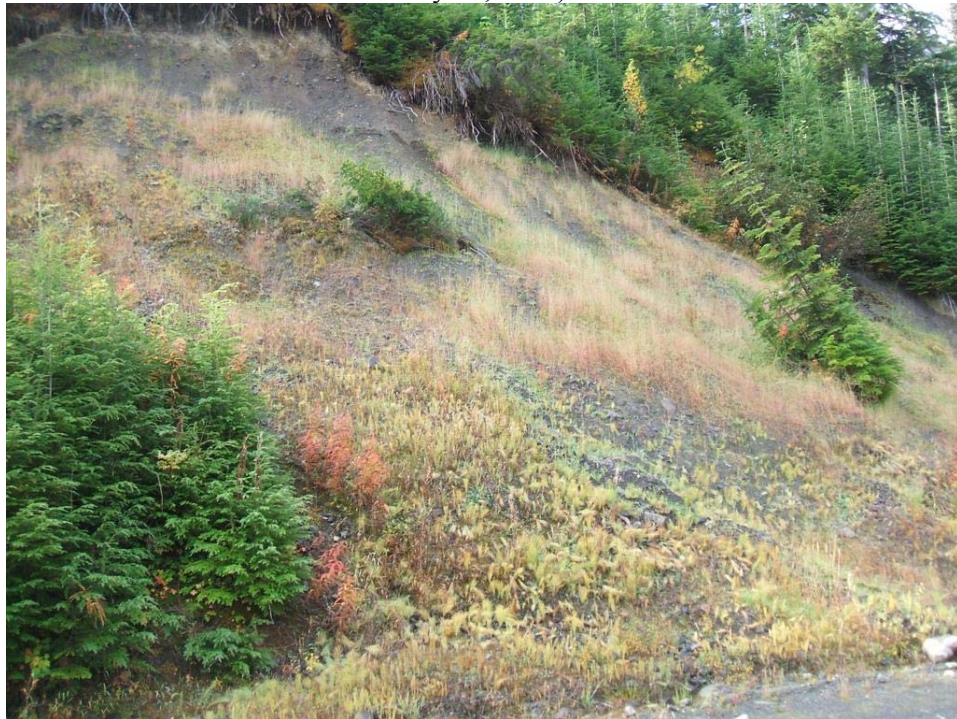
Photo 33: Partially vegetated right road cutbank following treatment (looking towards stream, October 1, 2008).

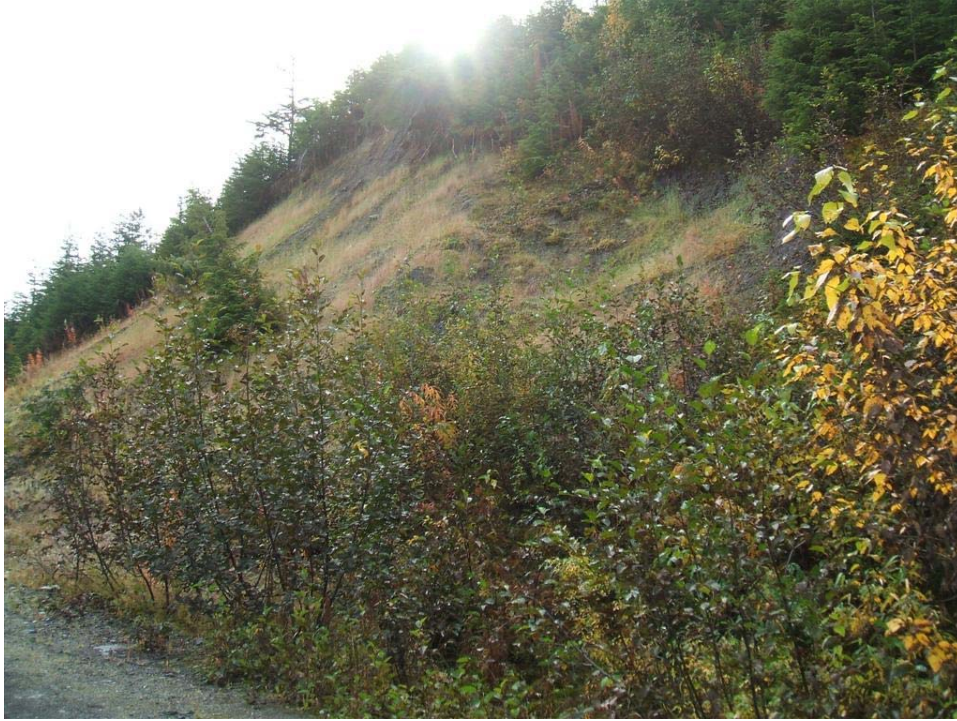
Photo 34: Partially vegetated right road cutbank following treatment (looking away from stream, October 1, 2008).

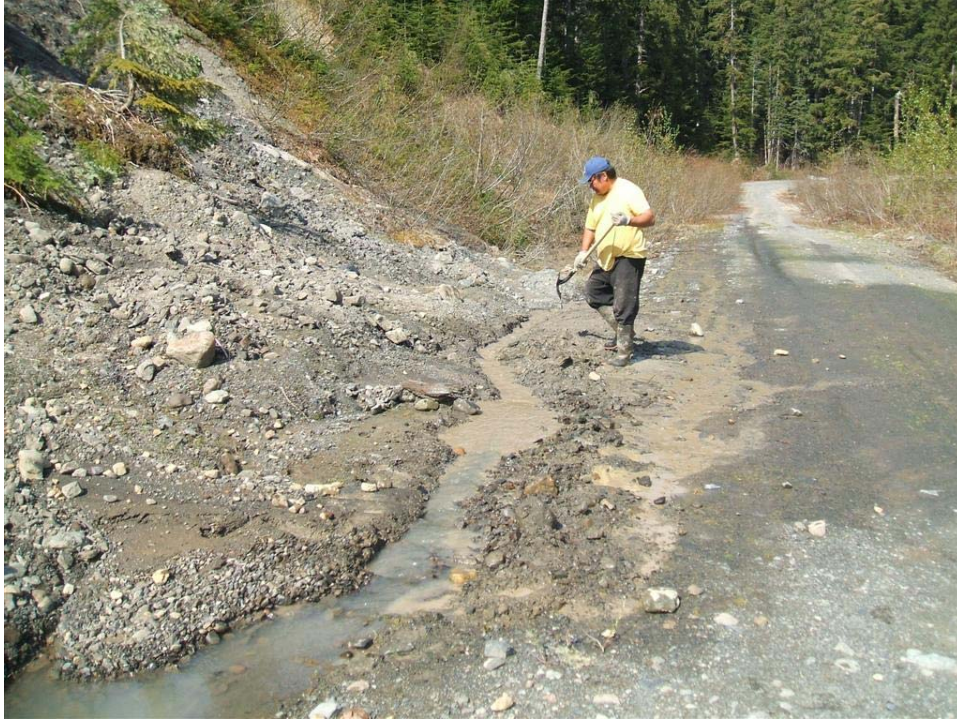
At the time of initial treatment sediment-laden groundwater was seeping out of the cutbanks and flowing down rills onto the road surface below. The ditch was completely filled with cutbank sediment (Photo 35). The GFA crew hand-shoveled a temporary ditch to direct water away from the road surface into a series of sediment retention ponds downslope (Photo 36). Although the temporary ditch remained intact until the final visit on October 1, 2008, it is anticipated that it will be filled with sediment during 2009 freshet and water will again flow over the road. GFA recommends that this ditch be reinstated properly and monitored regularly for infilling.

Photo 36: GFA digging a temporary ditch at Site 186 prior to direct water into a series of small retention ponds (May 27, 2008).

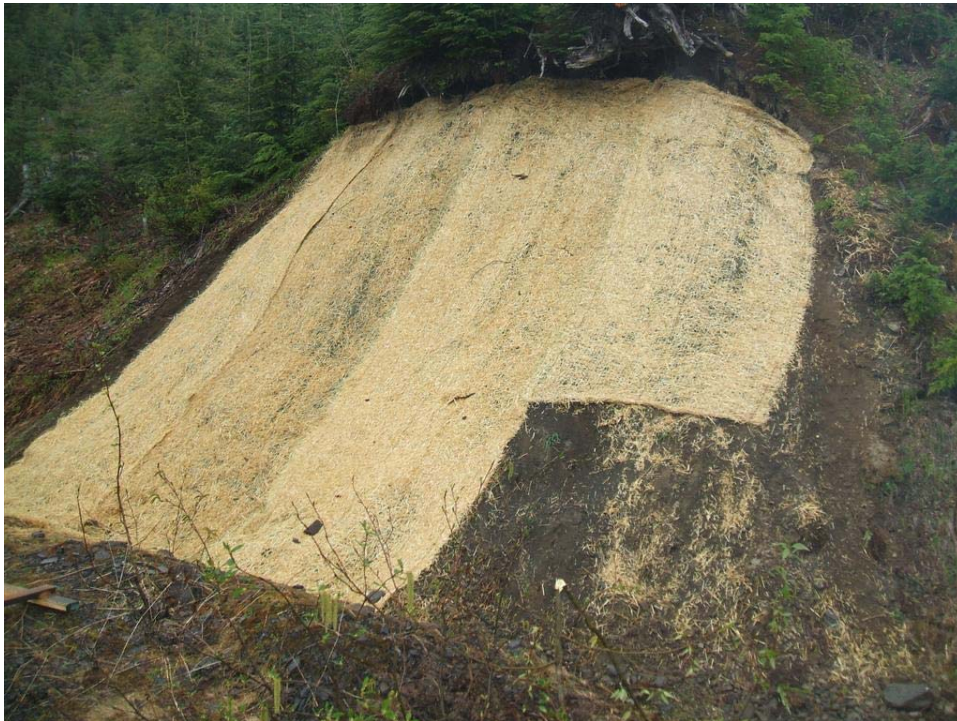
Photo 38: ECBs applied at Site 313 (May 26, 2008).

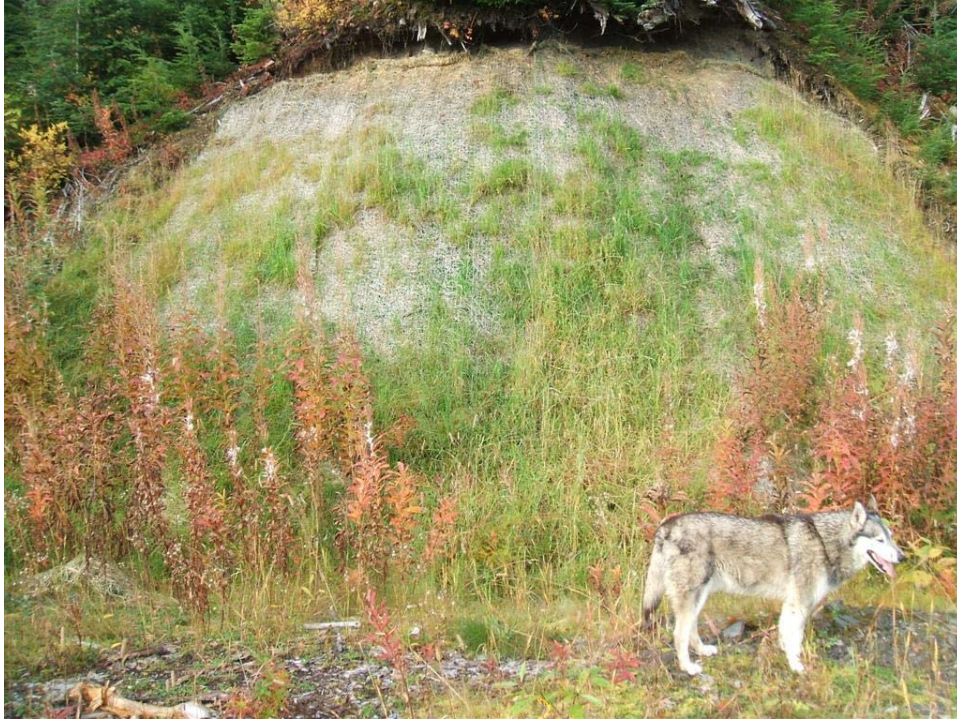
Photo 39: Right bank moderately vegetated at Site 42 (October 1, 2008).

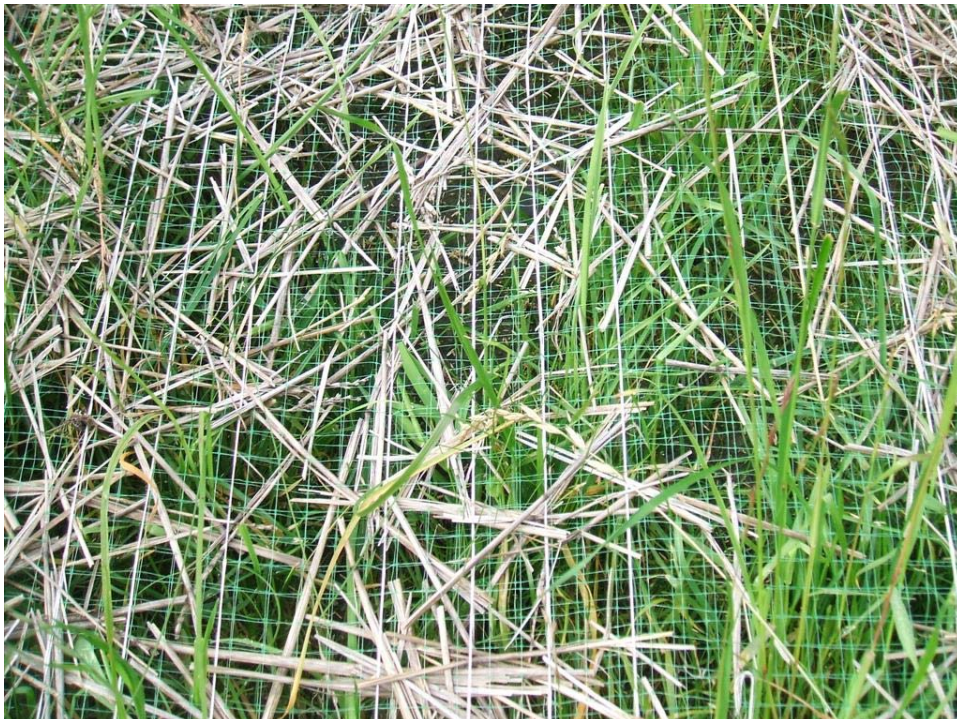
Photo 40: Grass beginning to grow though ECBs at Site 42 (October 1, 2008)

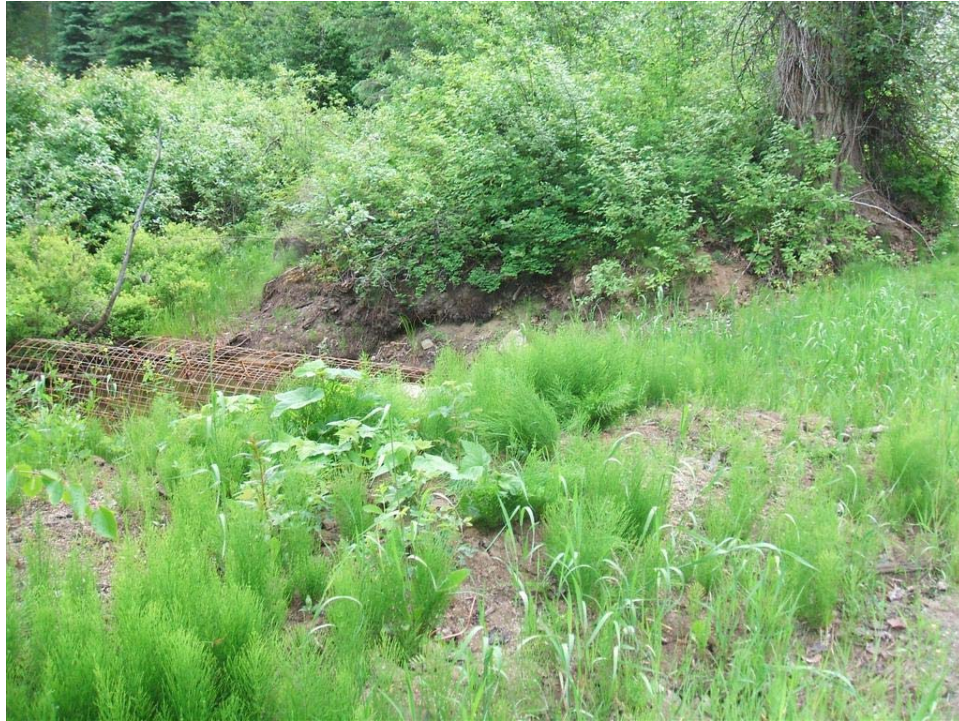
Photo 42: Natural vegetation colonizing Site 270 (June 17, 2008).

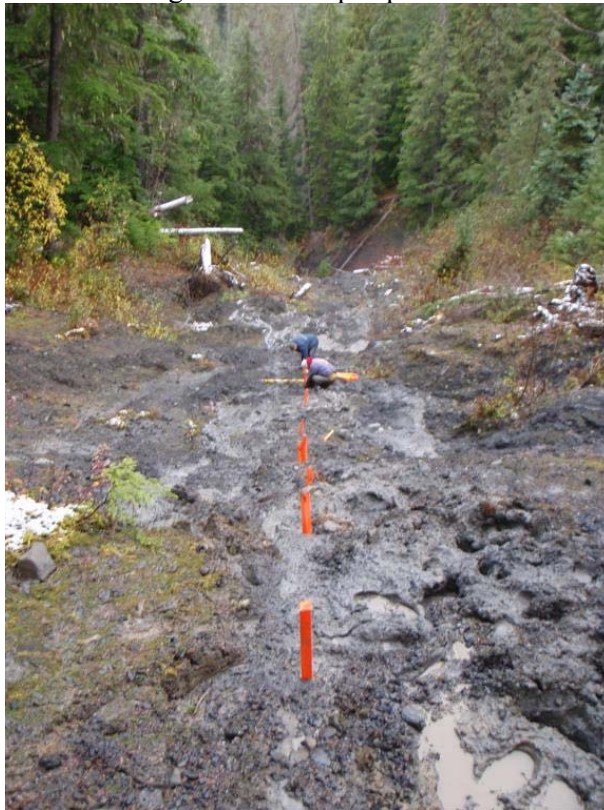
Photo 47: Line 1 stake placement at Site 48 (October 17, 2008).

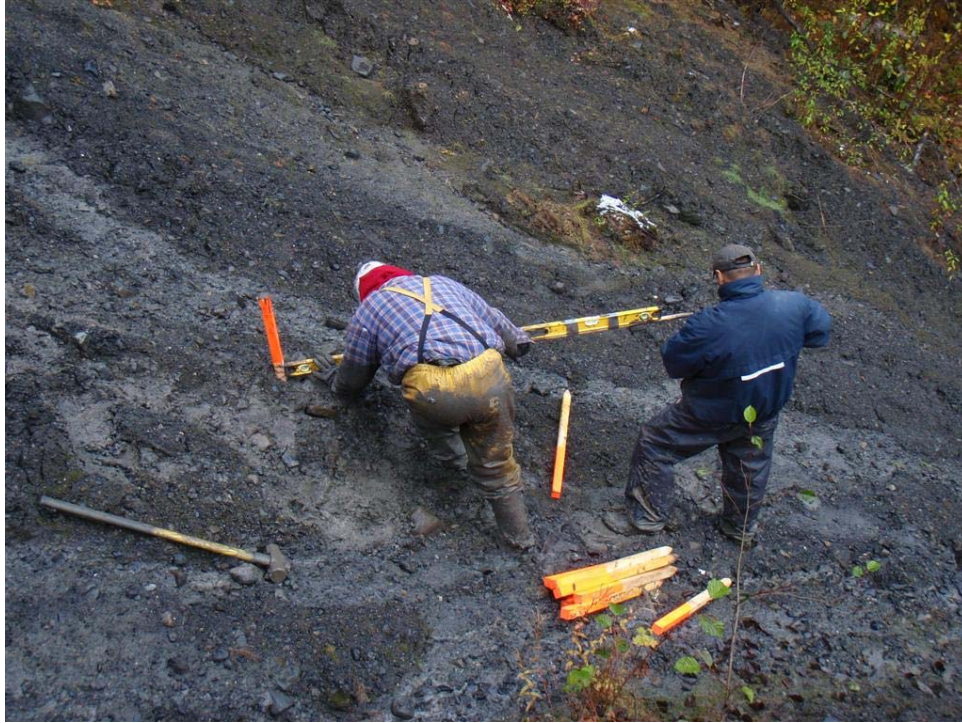
Photo 48: Line 1 stake placement using 2-meter level at Site 48 (October 17, 2008).

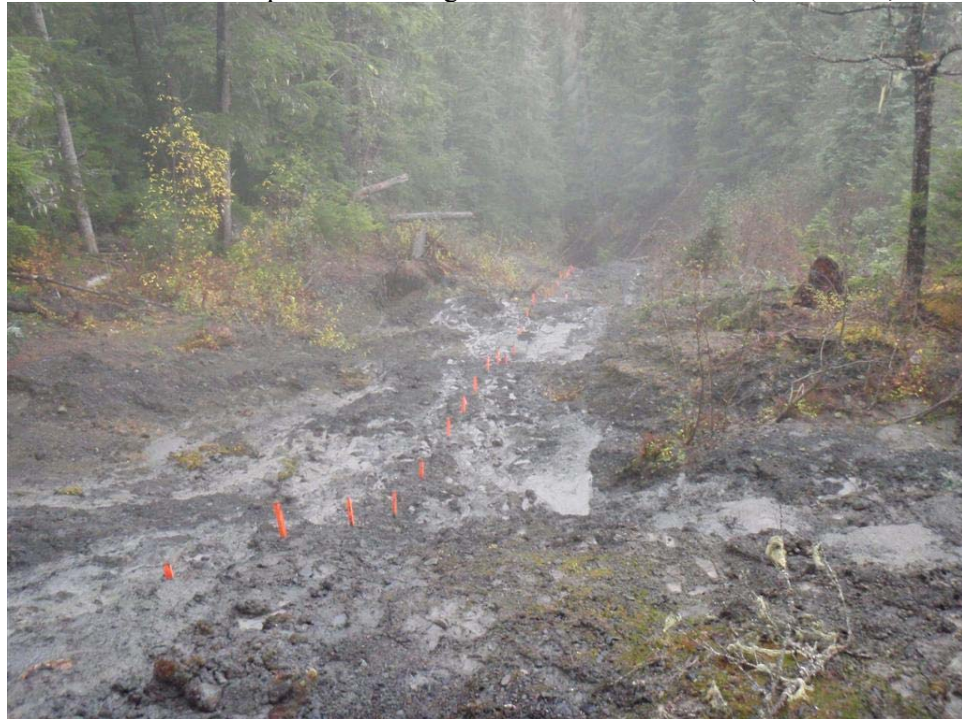
Photo 49: Completed staking of Line 1 at Site 48 (October 21, 2008).

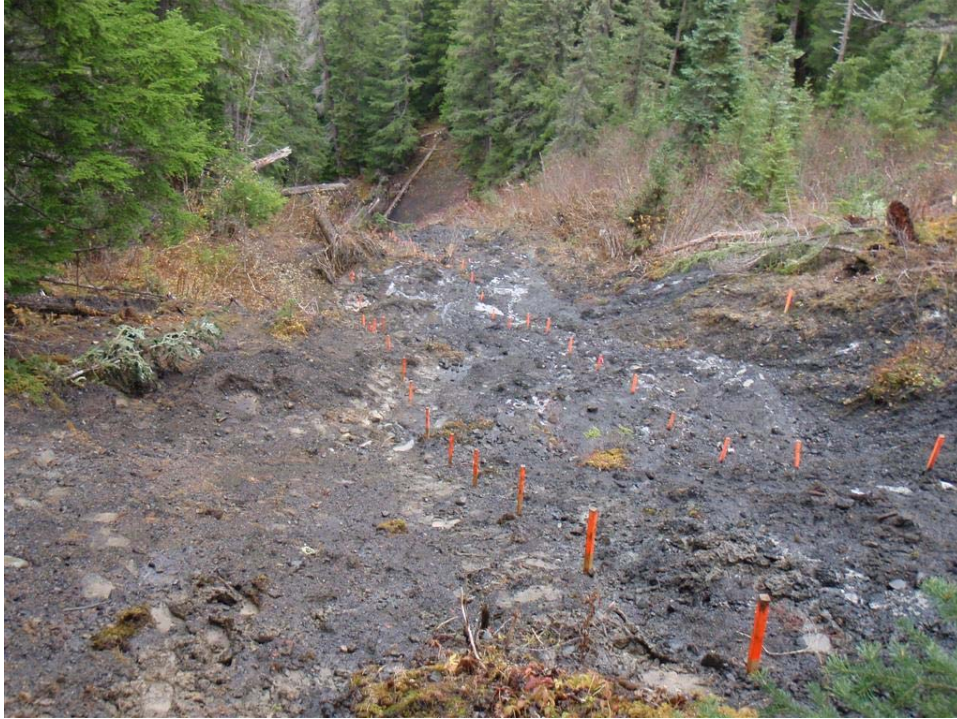
Photo 50: Completed staking of Line 2 looking downhill at Site 48 (October 28, 2008).

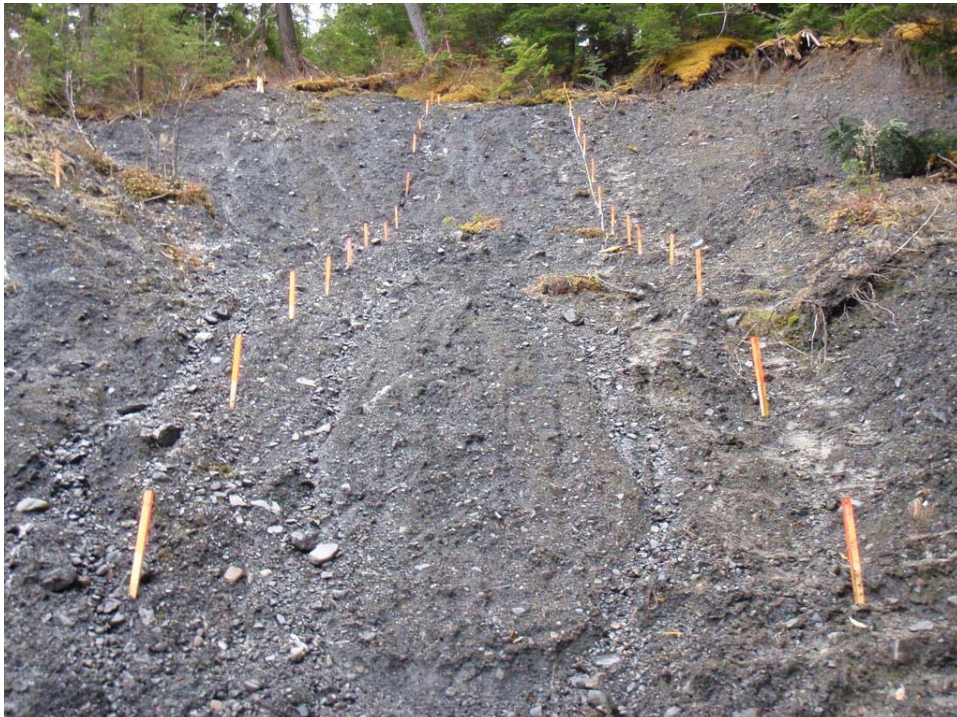
Photo 51: Completed staking of Lines 1 and 2 looking uphill at Site 48 (October 28, 2008).

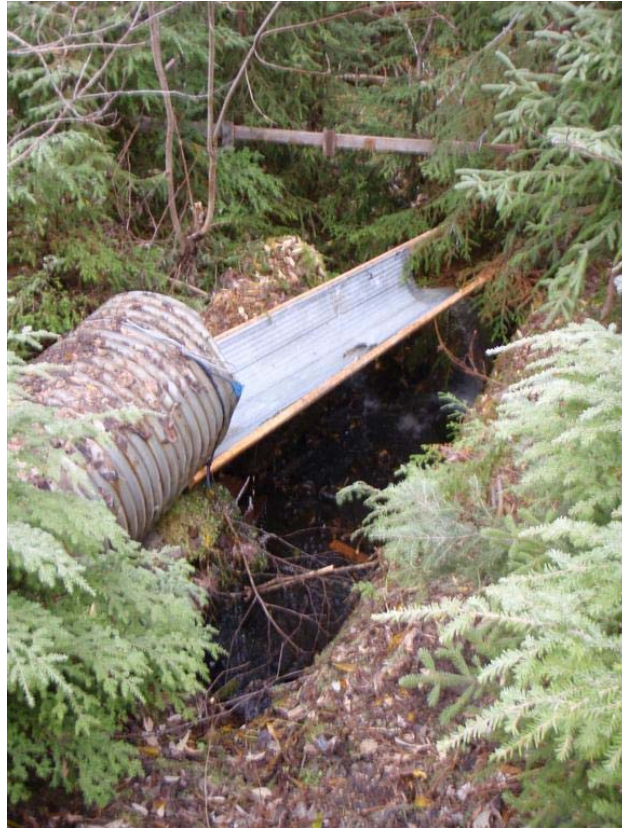
Photo 53: Diversion trough constructed to bypass water away from Site 60.

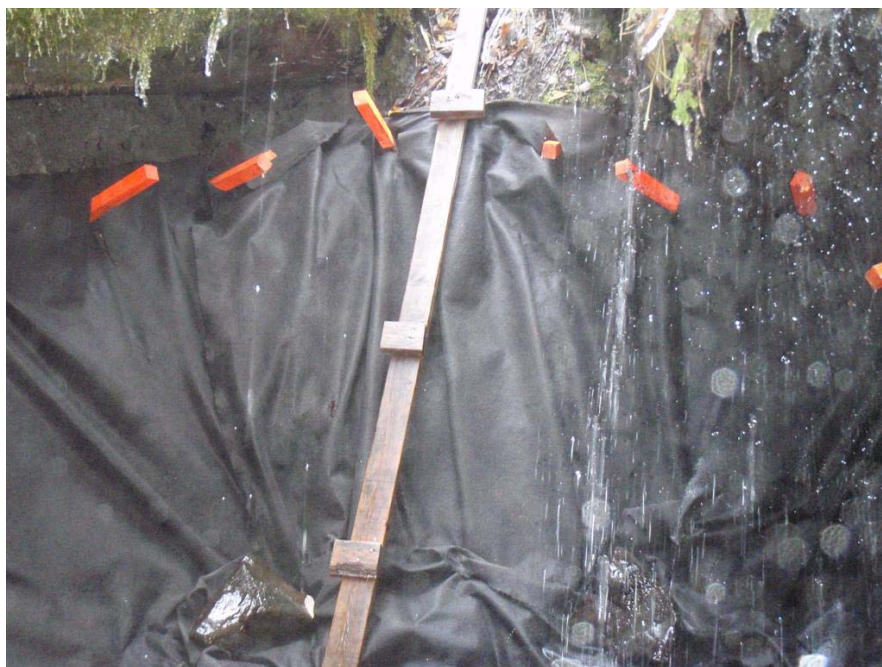
Photo 54: Eroding stream bank covered with Geotextile at Site 60.

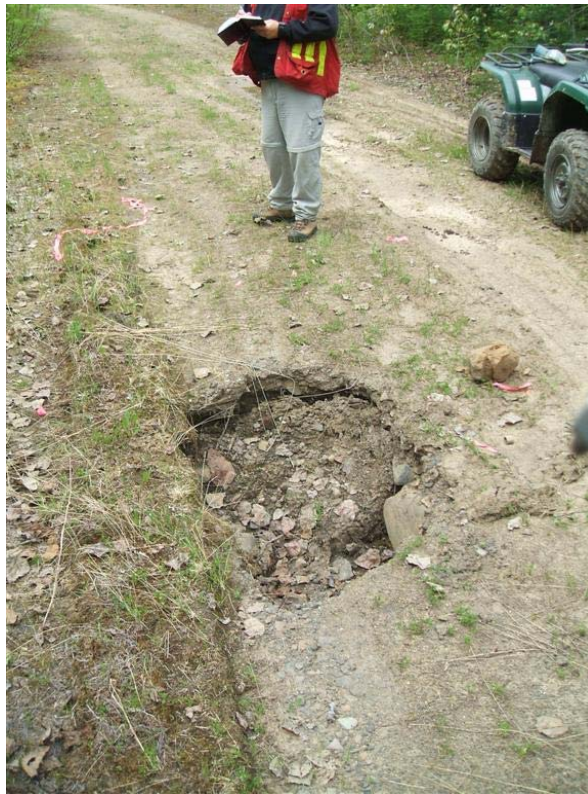
Photo 58: Collapsing wood box culvert at Site 277.

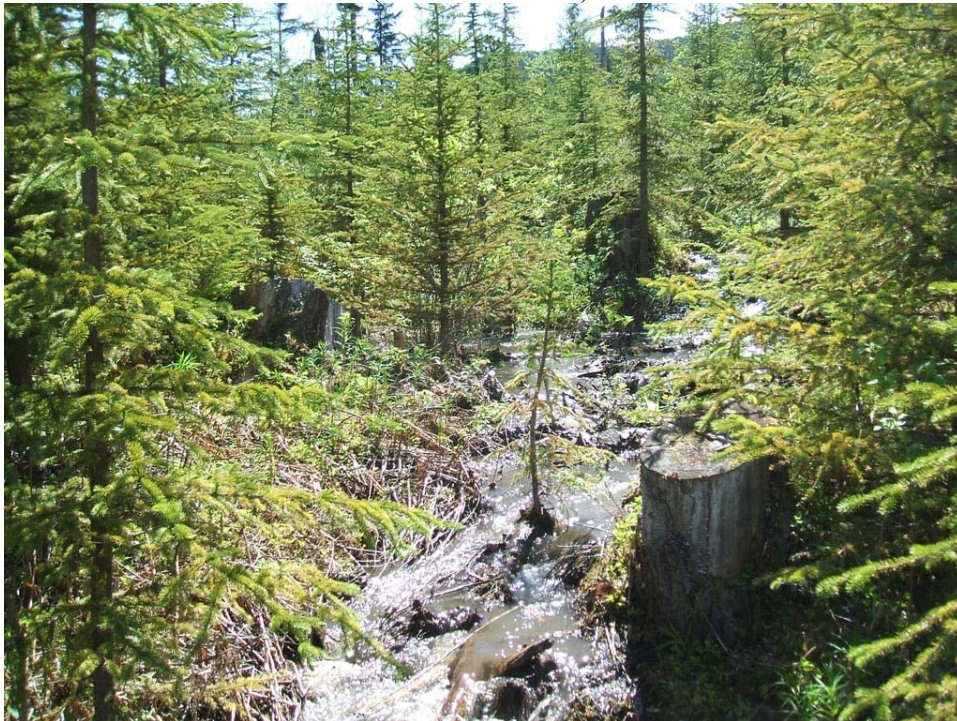
Photo 62: Chernobel Creek flowing through cutblock in Reach 5.
