Gitanyow Fisheries Authority

The 2008 Kitwanga-Cranberry River Watershed Restoration Project

Submitted to: B.C. Ministry of Forests and Range
Smithers, BC

Prepared by: Mike McCarthy HBSc
Gitanyow Fisheries Authority

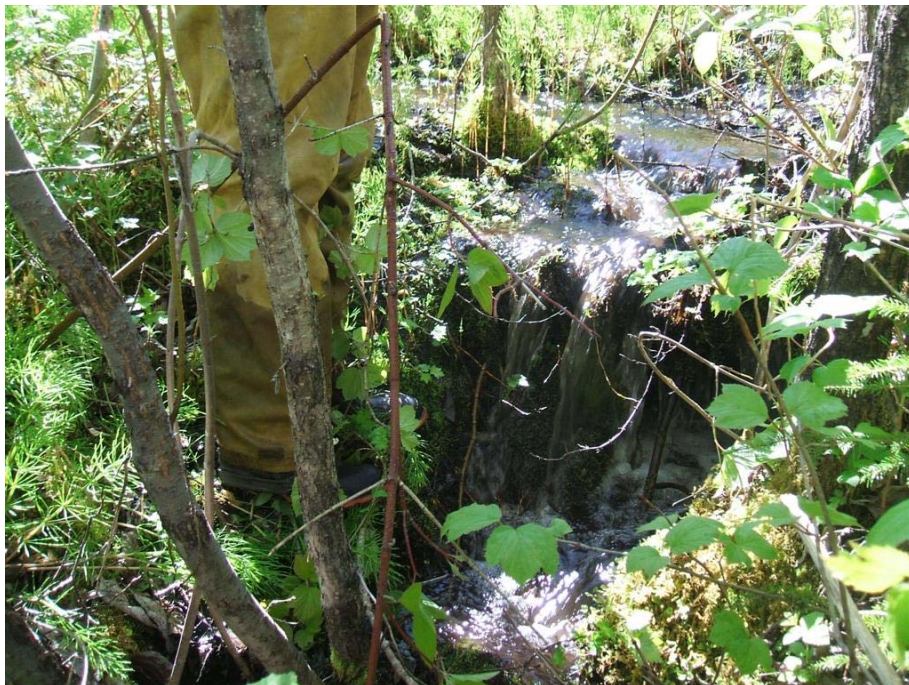
Photo 64: Small waterfalls (0.5 meters) over organic debris in Reach 1.

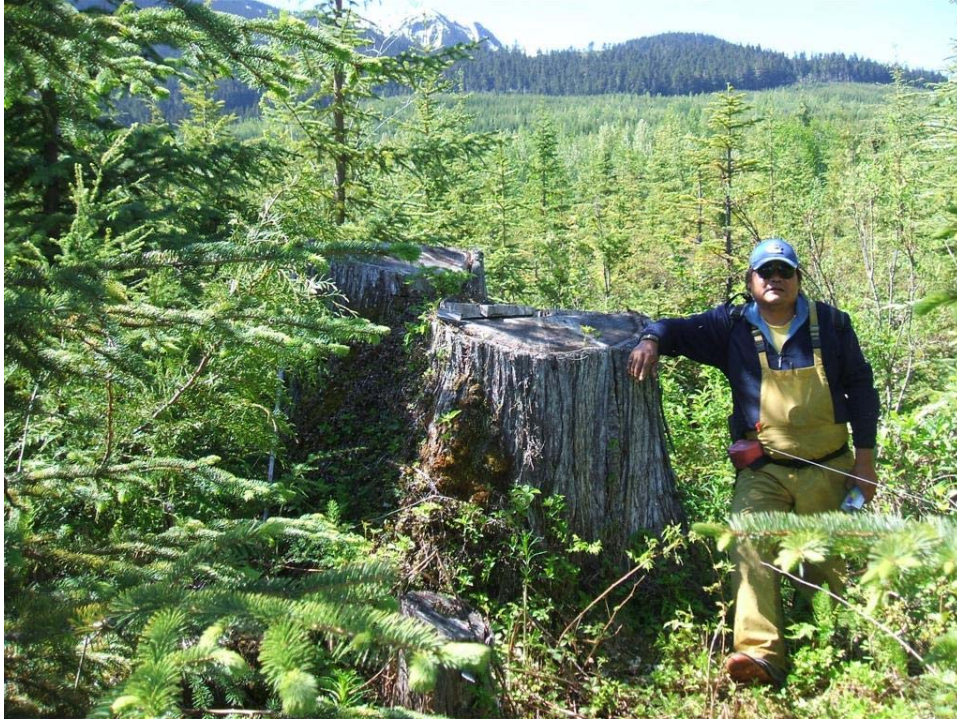
Photo 65: Cut stumps adjacent to stream channel upstream of Site 61.

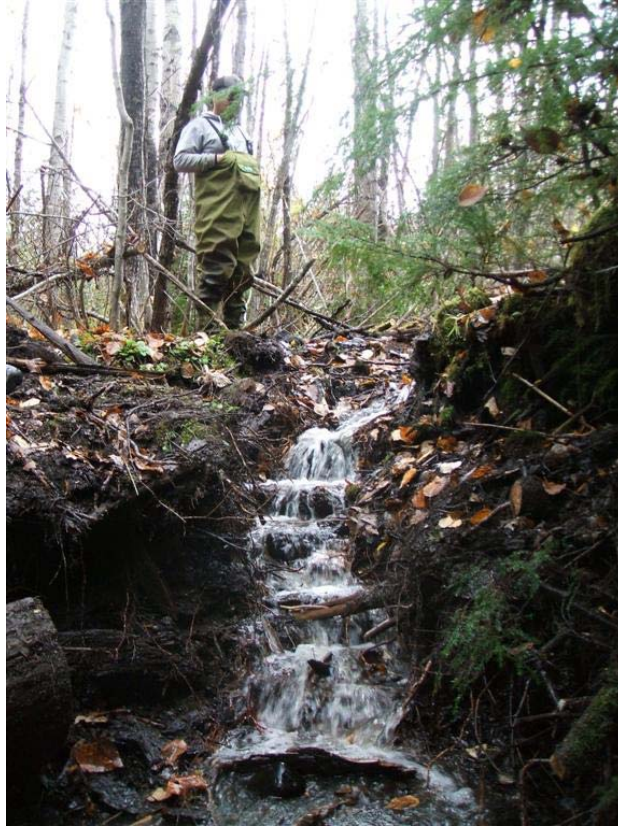
Photo 67: Channel following removal of debris jam at Site 61.

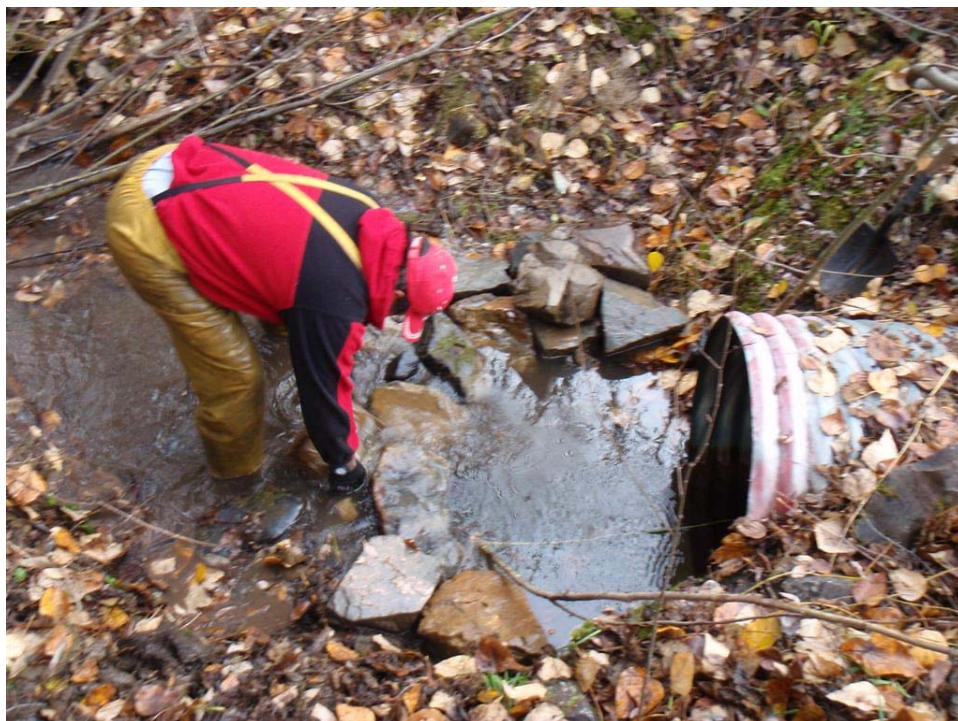
Photo 68: Hand placement of rock levee at Site 61.

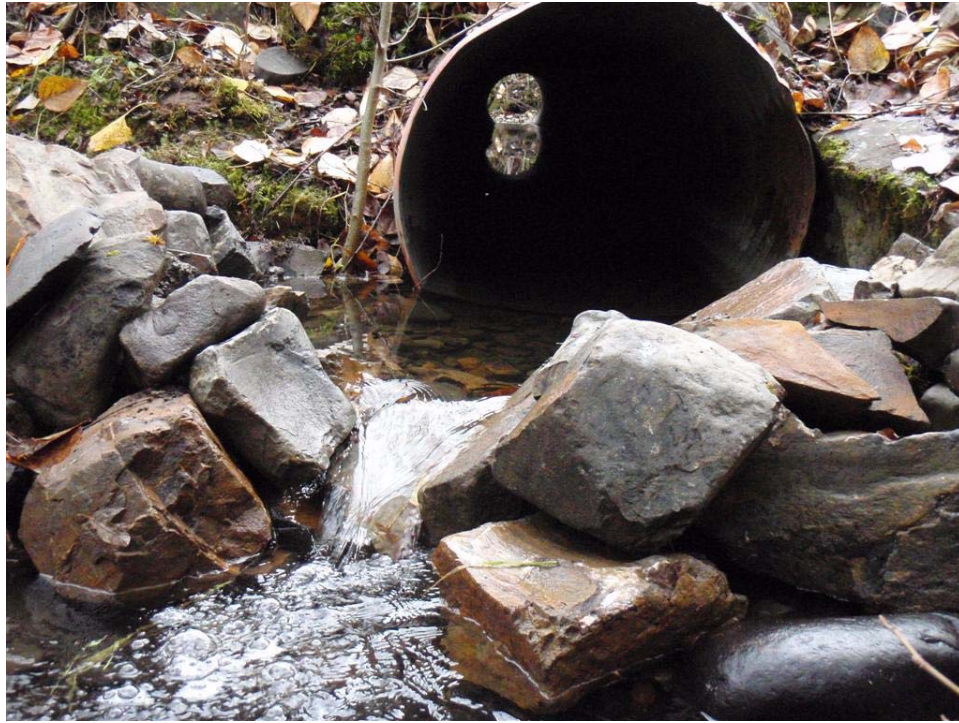
Photo 69: Rock levee and backwatered culvert following treatment of Site 61.

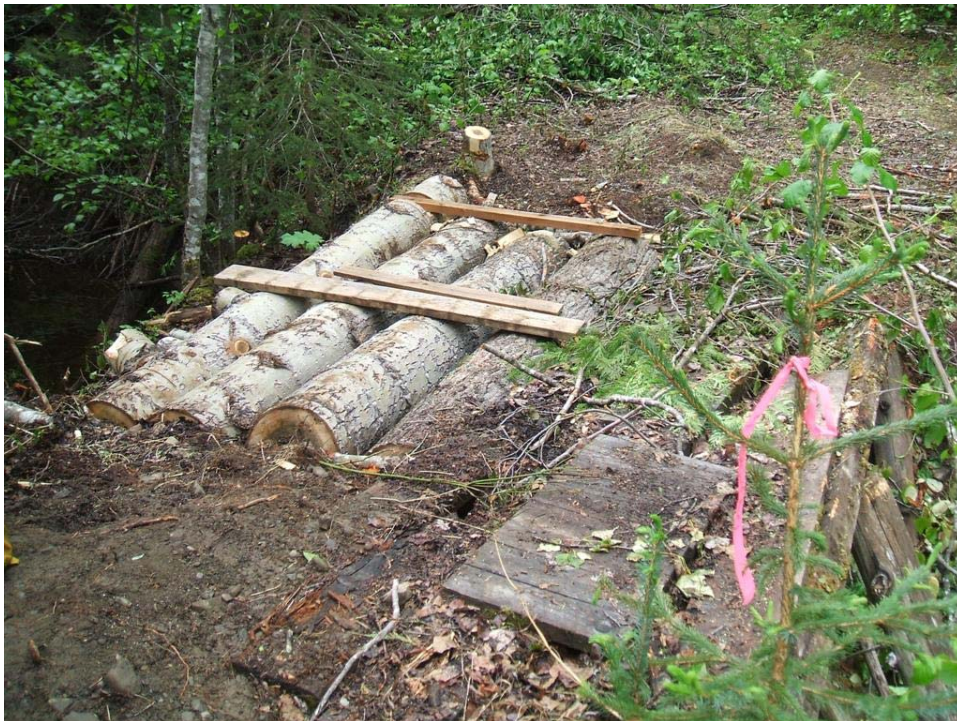
Site 347 is an old collapsed bridge crossing that has recently been rebuilt as an ATV crossing (Photos 70 and 71). Bridge timbers and road fill have plugged the channel creating a fish passage barrier (Koch and McCarthy 2008). Upstream of the crossing the stream consisted mainly of shallow riffles with numerous falls exceeding 0.5 meters. The stream flows subsurface through the crossing and reemerges below the crossing (Photo 72). Downstream of the crossing the stream consists of shallow riffle pool mix with occasional sections of subsurface flow. The stream enters a large beaver pond complex 600 meters downstream with numerous large beaver dams (Photo 73). The outlet into WRP Tributary 14 could not be found as shown on 1:20,000 TRIM. It was later determined that this stream drains into WRP Tributary 12 was found have no defined channel and no significant fish habitat by Biolith (1998). More details can be found from digitized FHAP forms in Appendix III.

Photo 71: Recently constructed ATV crossing at Site 347.

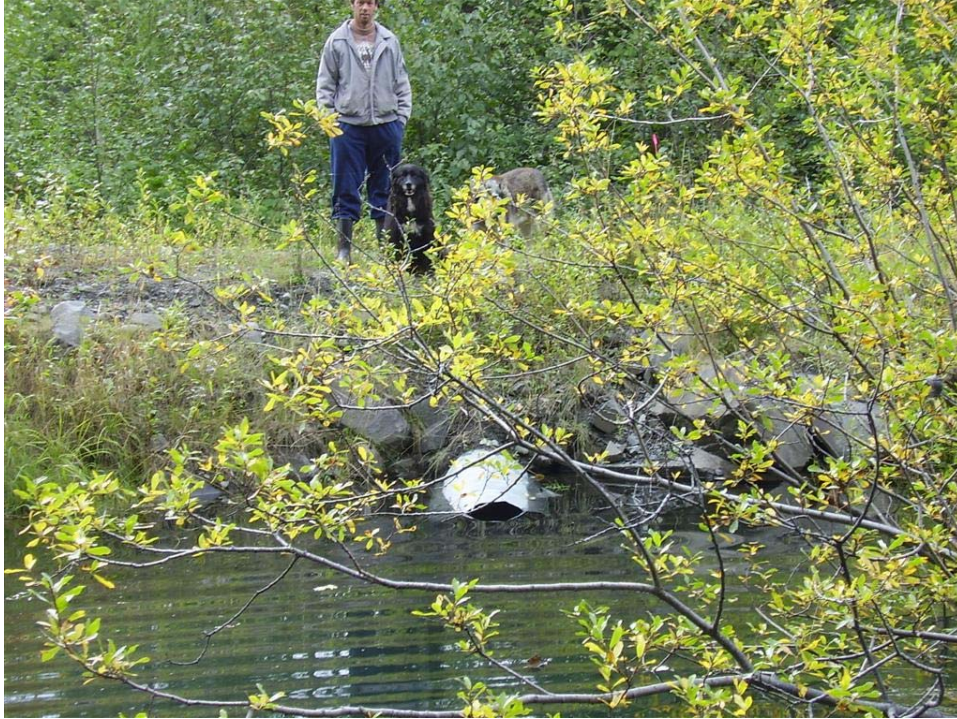
This crossing was considered a full barrier due to the excessive water velocity and insufficient water depth inside the culvert, an extreme outflow drop at the outlet (Photo 74), and a beaver dam constructed inside the culvert (Photo 75). The culvert slope was considered steep (6 percent) creating high water velocity (1.57 meters/sec) and low water depth (5 centimeters) inside the culvert. The water velocity exceeded the swimming capability of all juvenile salmonids. A suspended outlet was considered a barrier to all salmonids as it created 2-meter high plunge falls onto rock / wood debris below (no pool).

Photo 75: Site 47 looking downstream at submerged inlet - beaver dam inside culvert.

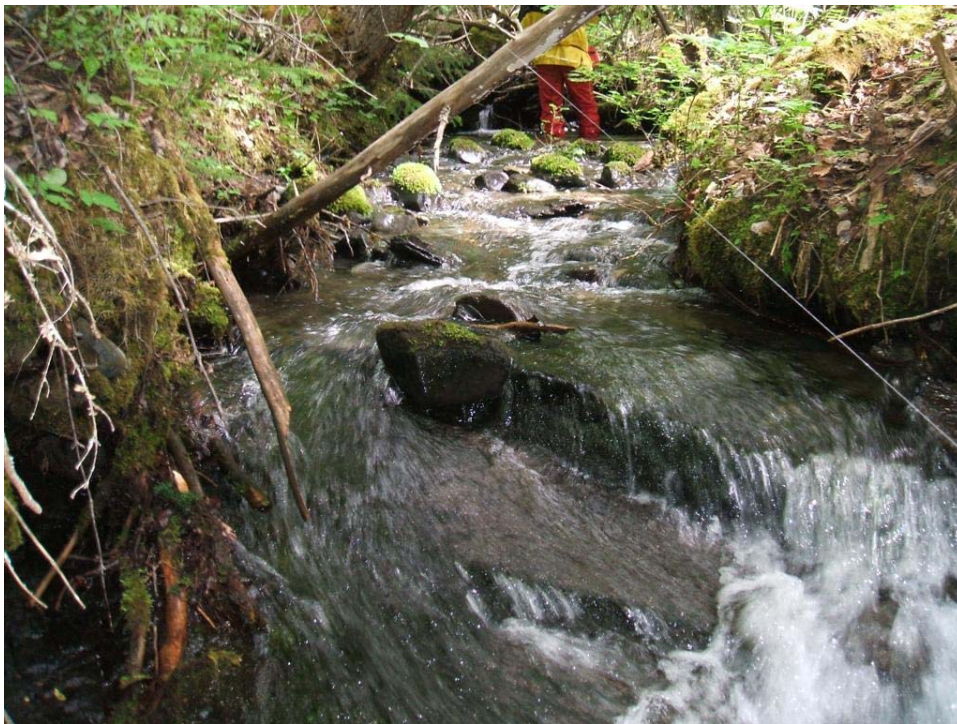
In 2008 a FHAP was undertaken upstream of the Mitten Main FSR (9U.530634.6164583) to a distance of 1060 meters. Four reaches were identified, which consisted of riffles pools and small cascades. Shallow veneer-glide over smooth bedrock was encountered at 30-45 meters (1-3 cm depth, 0.9-1.6 m/s, 18% grade) and 100-104 m (1-3 cm depth, 0.6-1.1 m/s, 15% grade). These sections are likely barriers to fish passage (Photo 76). No bedrock-based barriers were encountered upstream of these sections. More details can be found from digitized FHAP forms in Appendix III.

Fish sampling was attempted along Reach 2. Ten Gee traps set for 6 hours and spot sampling using an electrofisher in deep pools yielded no fish and no fish sighted throughout the survey. It is possible that the stream is no-fish bearing above the bedrock sections encountered at 30 and 100 meters upstream of the Mitten Main FSR (Photo 70). As such, replacing this culvert with an open bottom structure would provide minimal benefit.

Photo 76: Shallow veneer flow over bedrock 30 meters upstream of the Mitten Main FSR at Site 47.

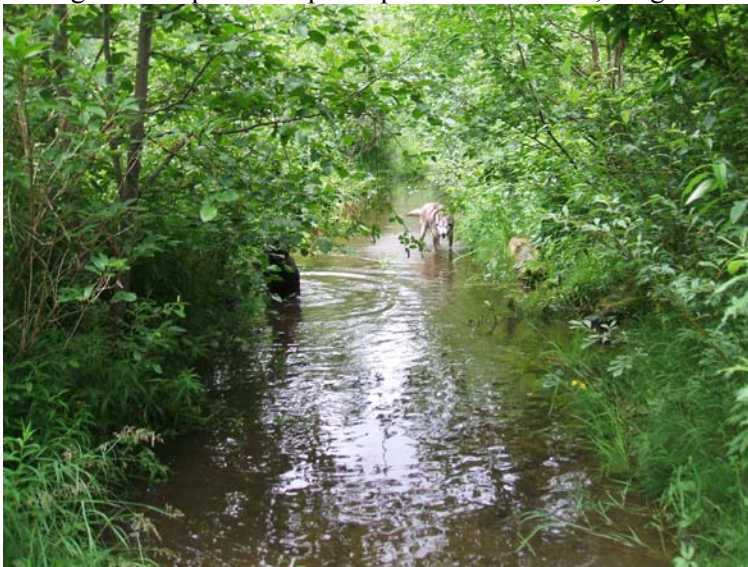
Site 38 separates two large active beaver pond wetlands (Photo 77). A blocked culvert and a dam built against the upstream road edge caused water to flow over the road in several locations (Photo 78). Without a beaver management plan, deactivating this crossing would produce minimal benefits. No further works are recommended for this site.

Photo 78: Water flowing over road from culvert blocked by beavers at Site 38, Wagon Creek Road.

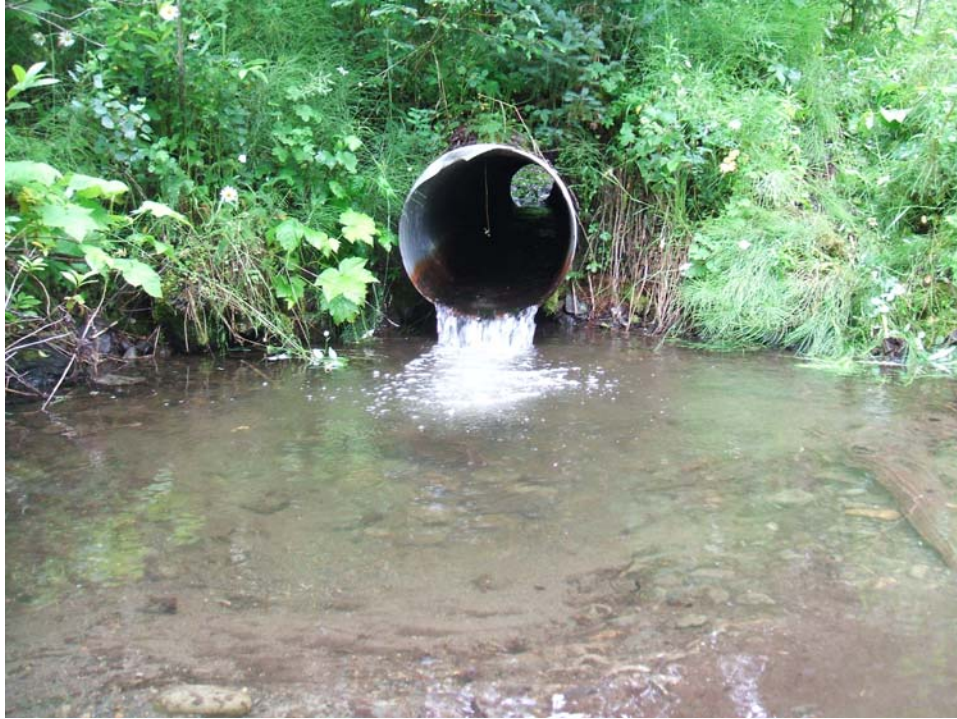
Site 59 was located immediately upstream of a series of beaver ponds that extended 250 meters to the Cranberry River (Photo 81). Approximately nine large beaver dams were encountered during a downstream walk with several structures that created waterfalls exceeding 1 meter in height (Photo 82). Without a beaver management plan, deactivating this crossing would produce minimal benefits. No further works are recommended for this site.

Photo 81: Suspended culvert outlet at Site 59, Wagon Creek Road.

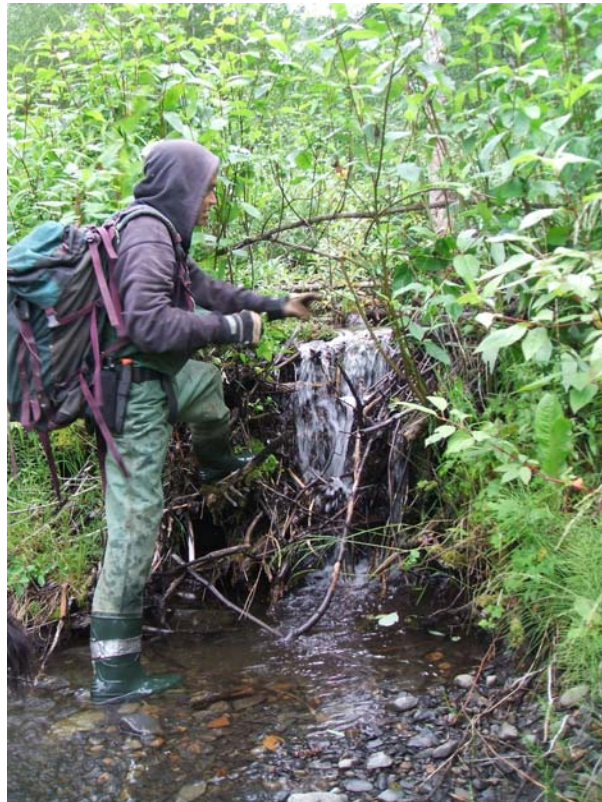
Photo 82: Beaver dam creating 1-meter high waterfalls downstream of Site 59, Wagon Creek Road.

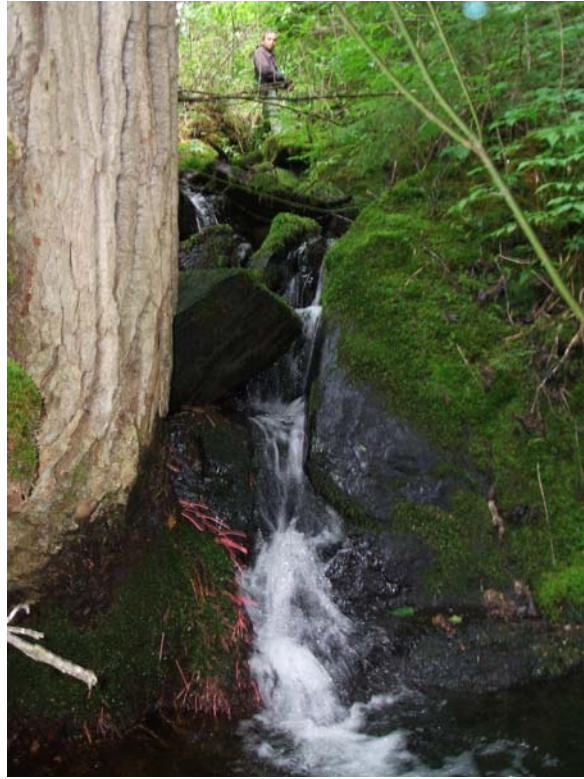
Site 60 was located along a small stream consisting mainly of shallow riffles. Approximately 120 meters upstream the GFA crew encountered bedrock-based falls/cascades that appeared impassable to fish (1.3 meter falls, 45 percent slope over 40 meters; Photo 83). Downstream of the crossing the stream drained into an extensive beaver pond complex located in an abandoned side channel of the Cranberry River (Photo 84). Due the fish barrier identified upstream, deactivating this crossing would produce minimal benefits. No further works are recommended for this site.

Photo 83: Falls/cascades over bedrock 120 meters upstream of Site 60, Wagon Creek.

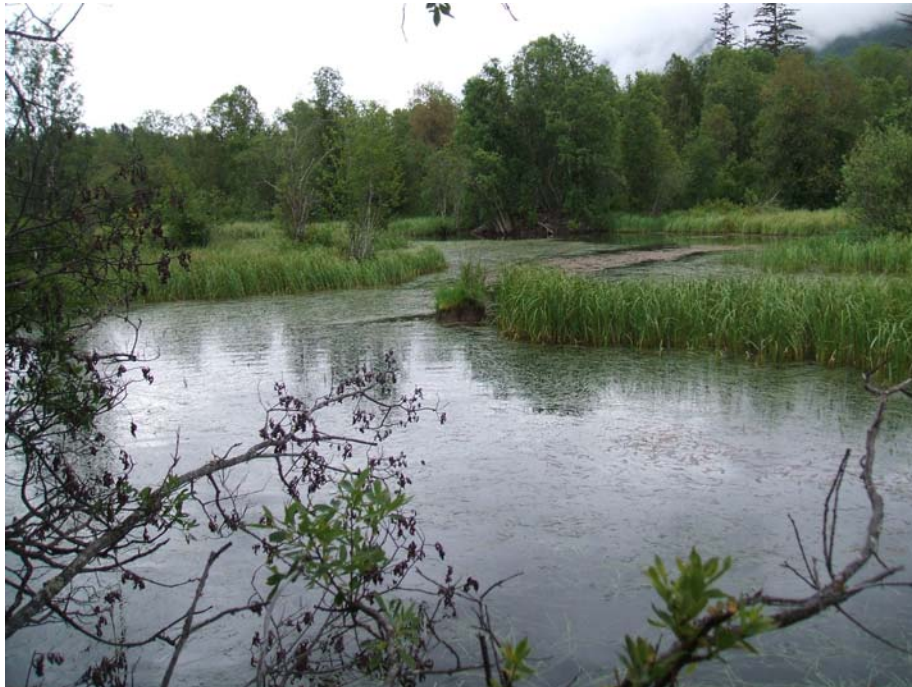
Photo 84: Beaver pond complex downstream of Site 60, Wagon Creek Road.
