SPLITROCK
ENVIRONMENTAL
SEKW'EL'WÁS

FINAL REPORT 2016 -17

Powerhouse Foreshore Restoration Project

Maintenance Program Year 3

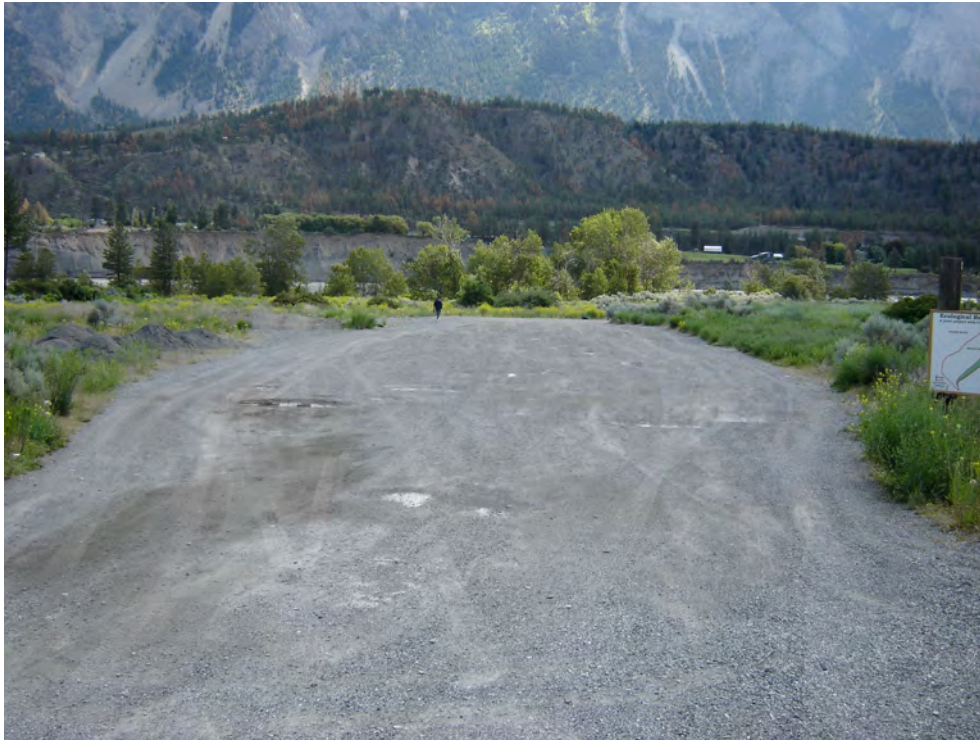
Figure 3 Site of the three initial test plots R7 Before restoration 13 June 2008

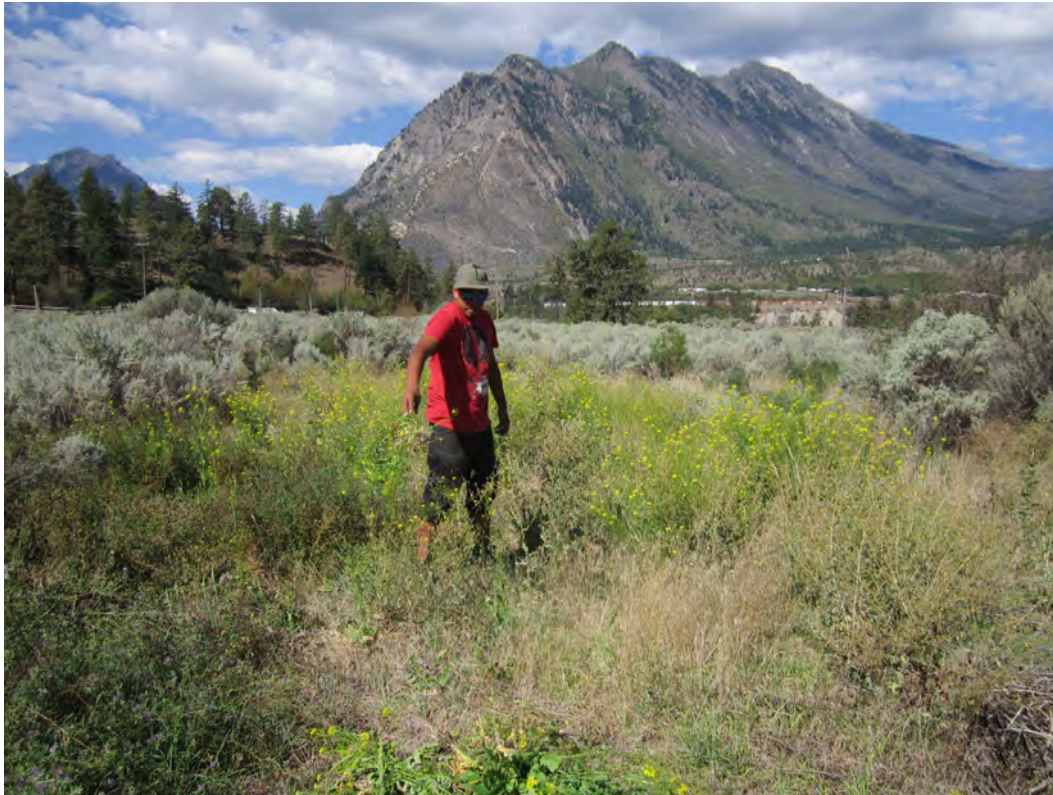
Figure 15 Polygon 4 (Map 4) Showing crew person pulling mustard 24 August 2016

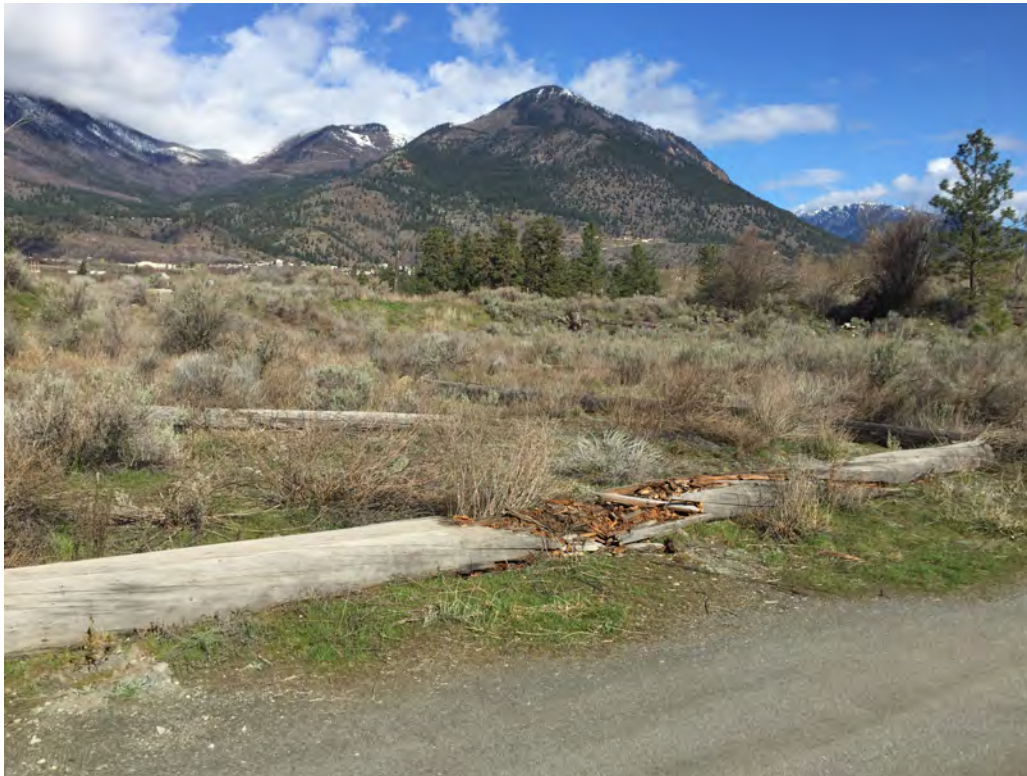
Figure 21 Polygon 2009-25 Shrubs and trees overplanted 30 March 2017

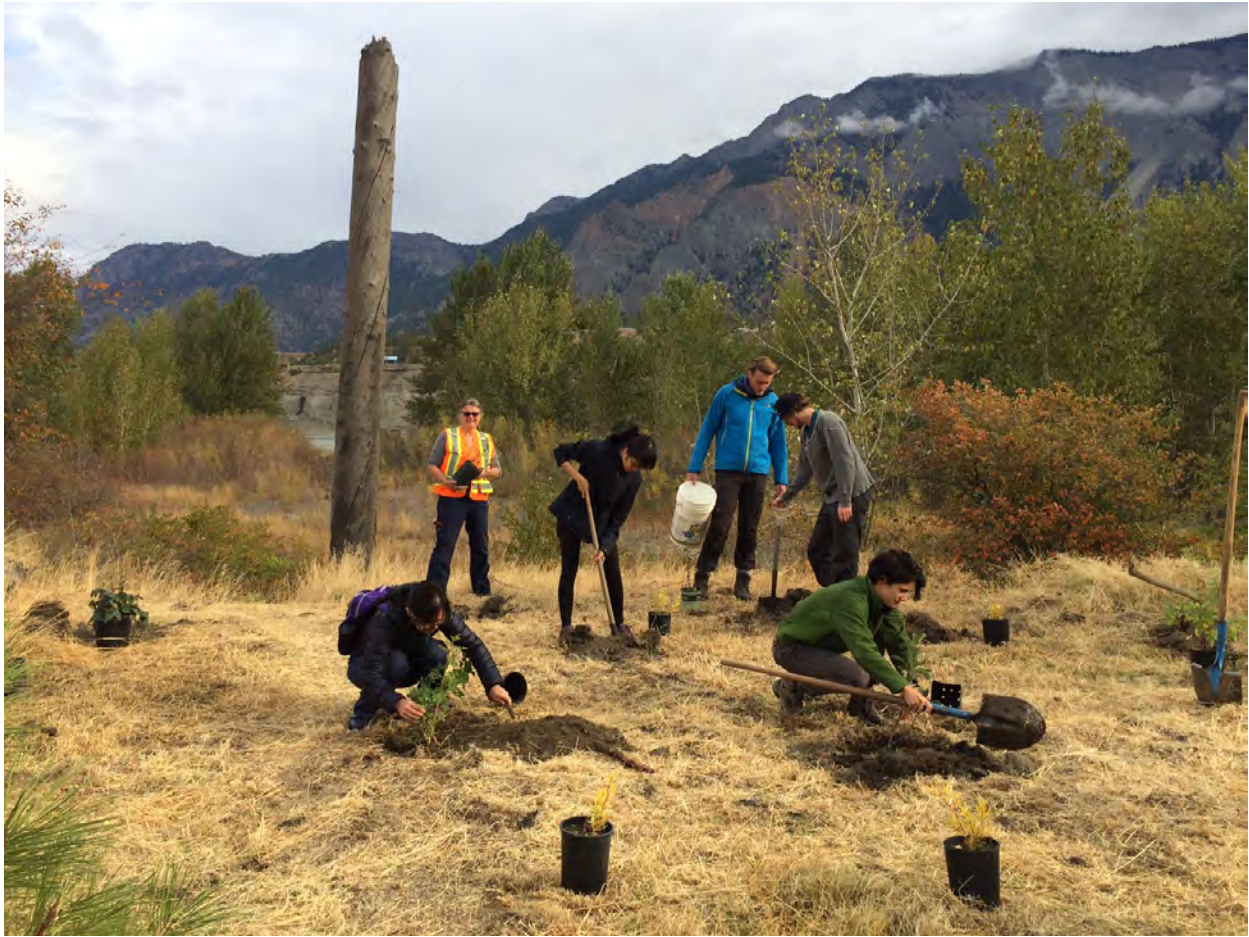
Figure 22 Polygon 12 Volunteers planting shrubs

- **Polygon 4 and 12:** This area is a transition between riparian and upland habitats planted out in the past with Ponderosa pine and shrubs. During the restoration process, soils in this area were not decompactd or contoured due to the fact that large slabs of asphalt were found in the soils. On discussions with MOE it was recommended that the asphalt be left in place as they were more detrimental to the environmental being unearthed. A total of 20 trees, 62 shrubs and 6 giant wildrye were planted over a 560 sqm area. The goal was to extended the riparian and Ponderosa pine forest out into an area that is predominately invasive weed species.
