**Project Title: Salmo River Instream Enhancement Program (Phase 2)**

**FWCP Project No: FWCP: COL-F22-F-3438**

# Effectiveness Monitoring and Maintenance Report (EMMR) for Salmo River Watershed Instream Restoration Project (SRWIRP) Phase 2

Project #16,731: Site A – Casey, Site B –Nelson Nordic Ski Club (NNSC): Columbia Basin Trust, Fish and Wildlife Compensation Program Project COL-F22-F-3348

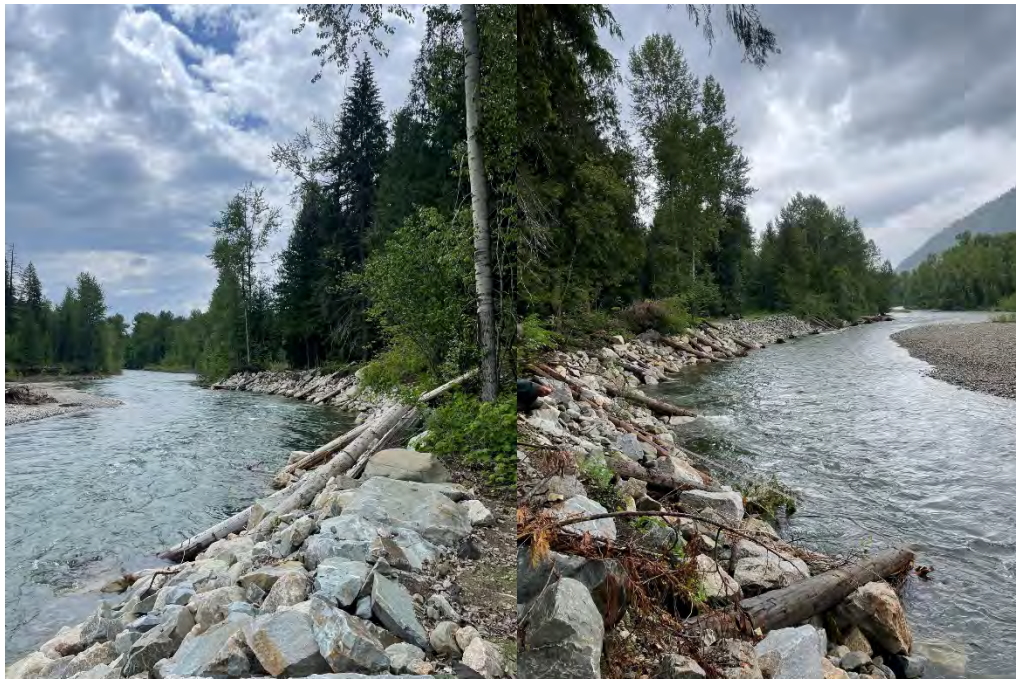
*"Figure 1. (Right) Site A Casey looking downstream (left) looking upstream (right) May 24th, 2023.*

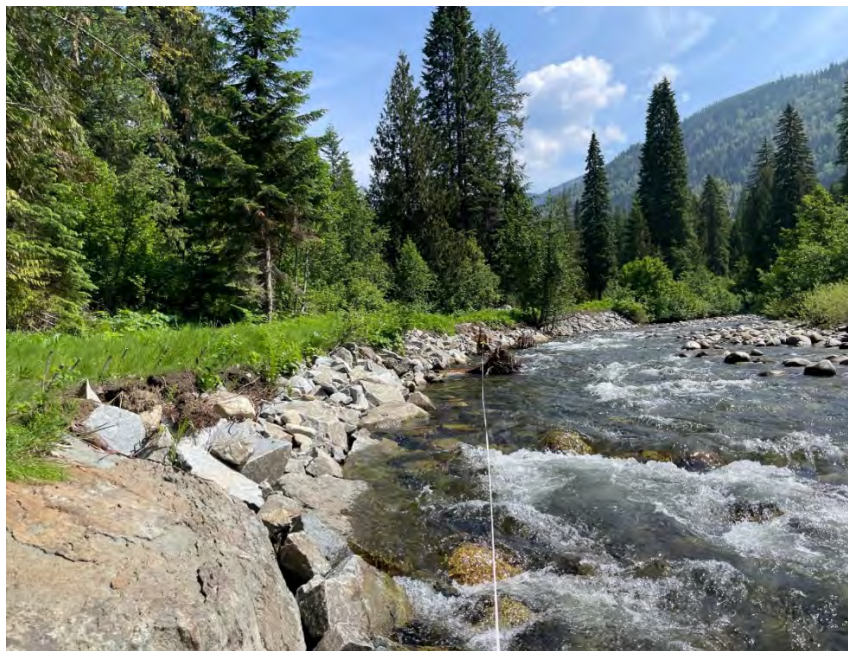
*Figure 2. Measuring distance from benchmark to instream rootwad structure at the NNSC site. June 13<sup>th</sup>, 2023.*

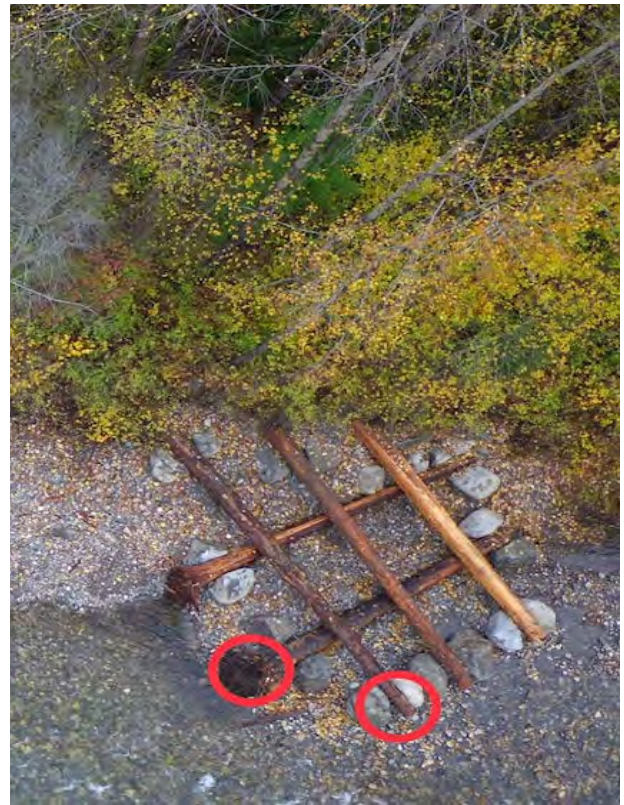
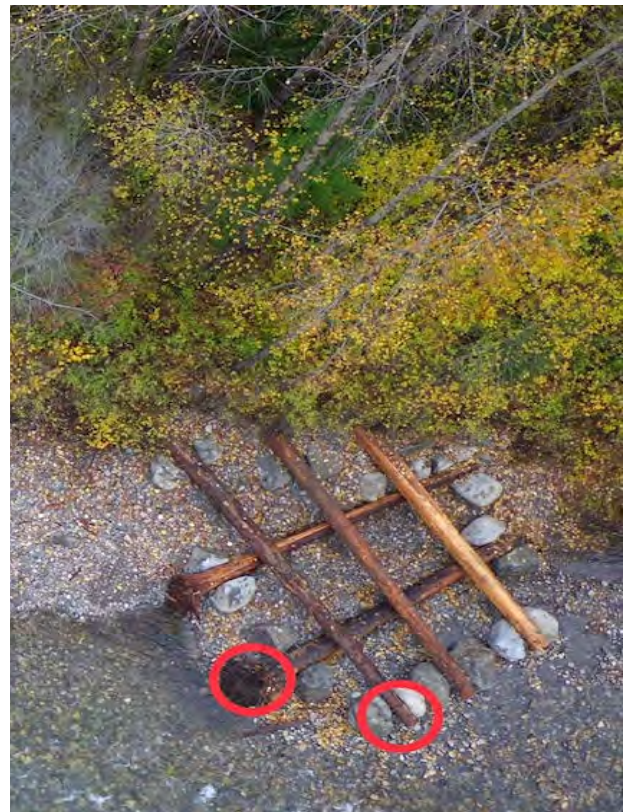
Figure 5. Debris Catcher. Down stream root wad.

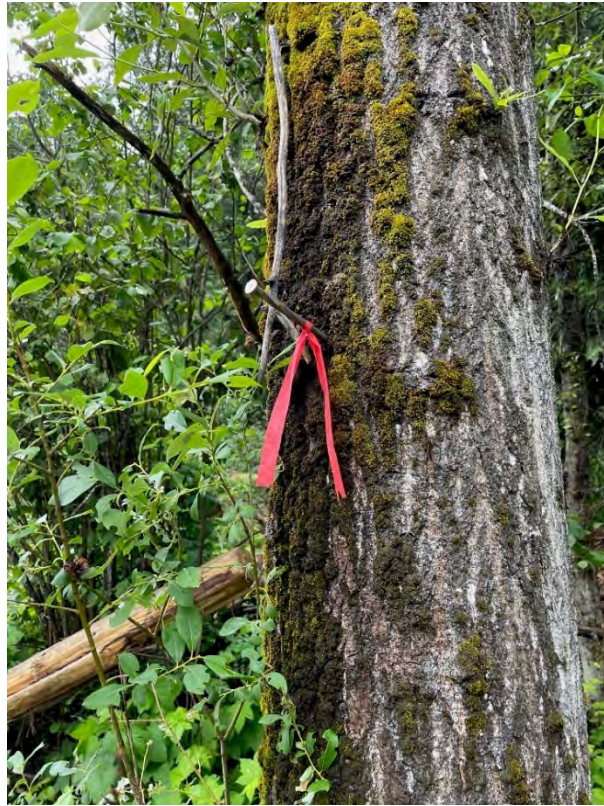
*Figure 6. Benchmark for debris catcher and lateral log on an angle. Located in riparian just upstream of the structures.*

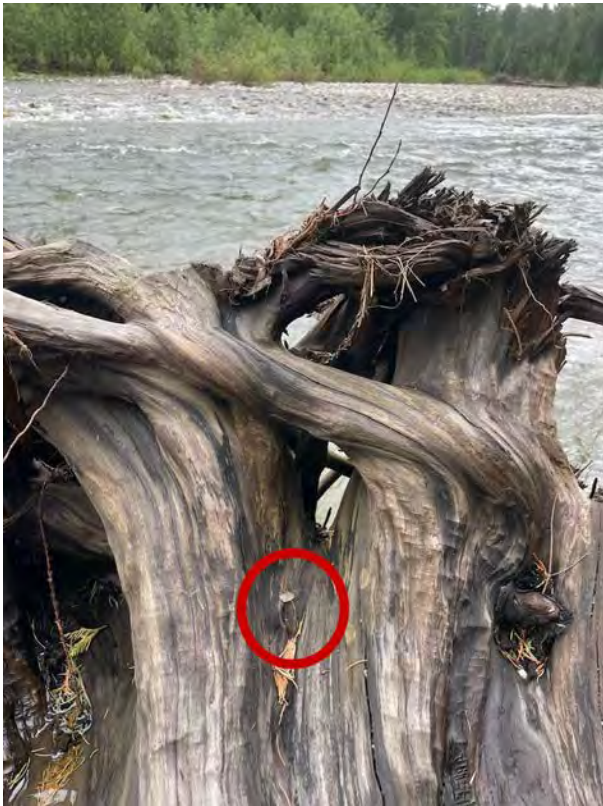
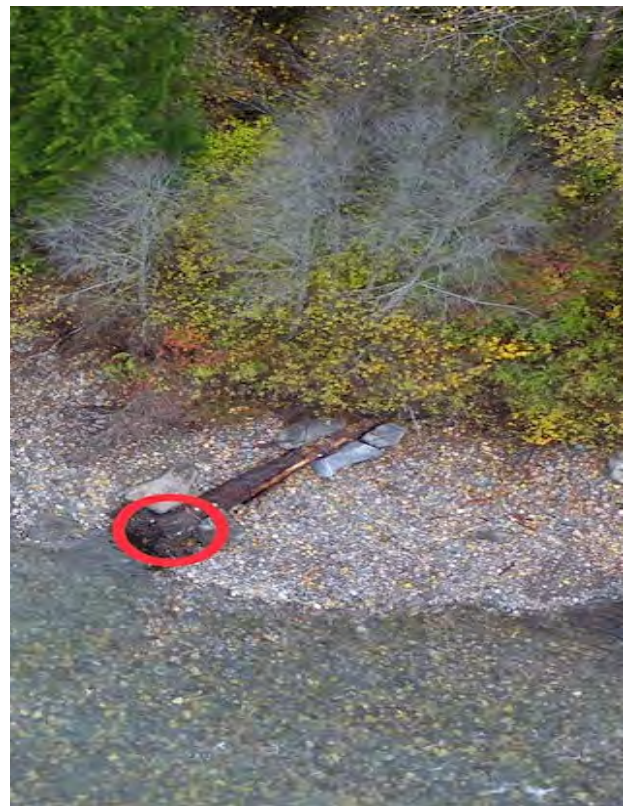
*Figure 7. First lateral log. (Lateral Log on an angle)*

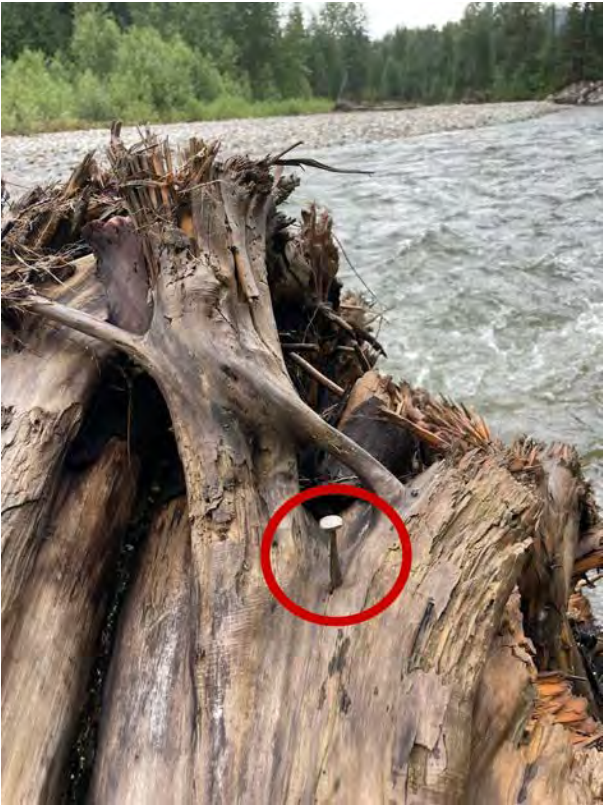
Figure 8. First Triangle. Upstream key log.

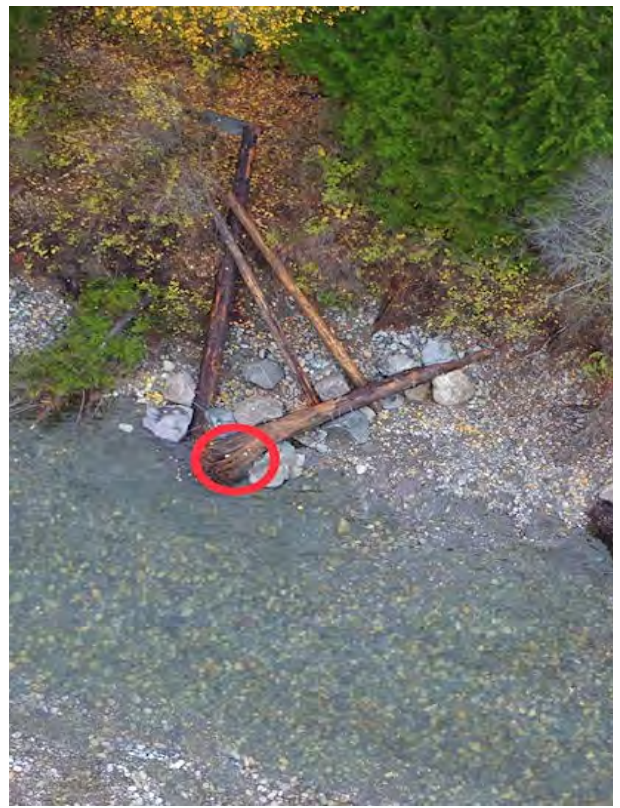
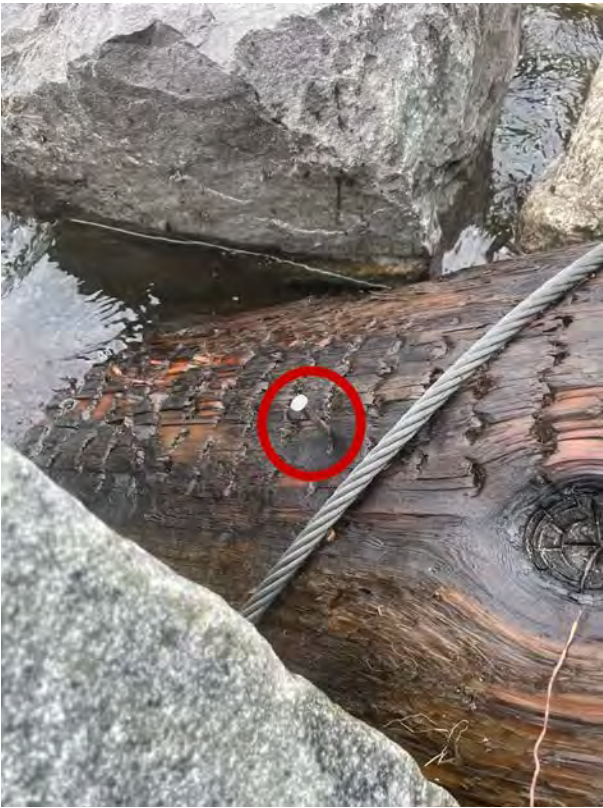
Figure 9. First Triangle. Downstream key log.

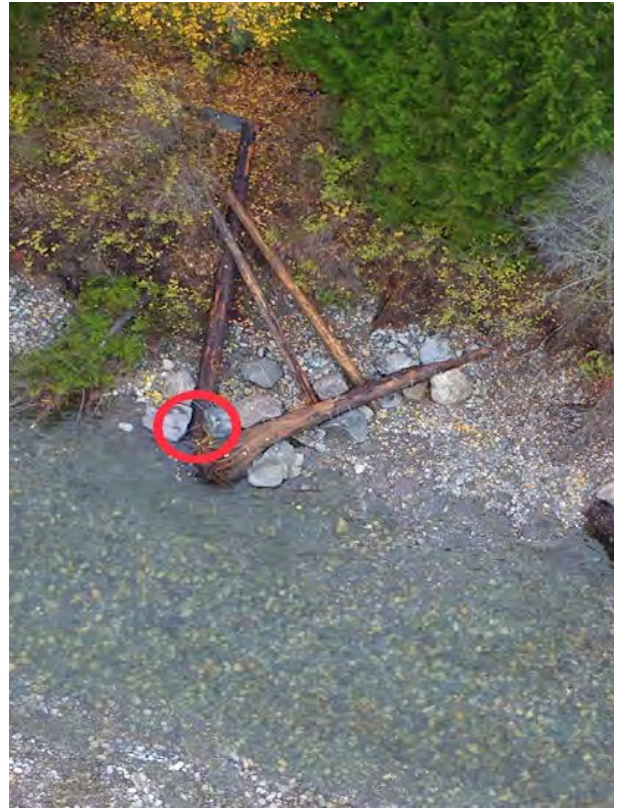
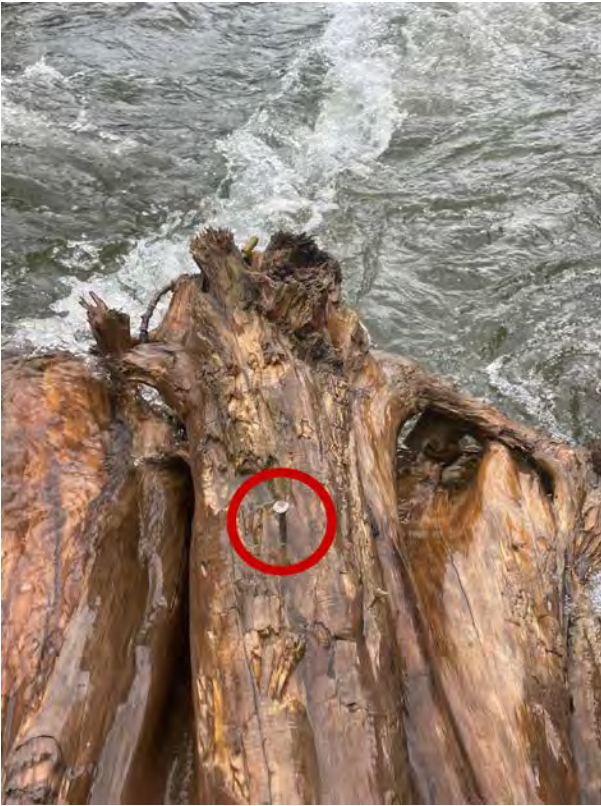
*Figure 10. Second triangle. Upstream key log.*

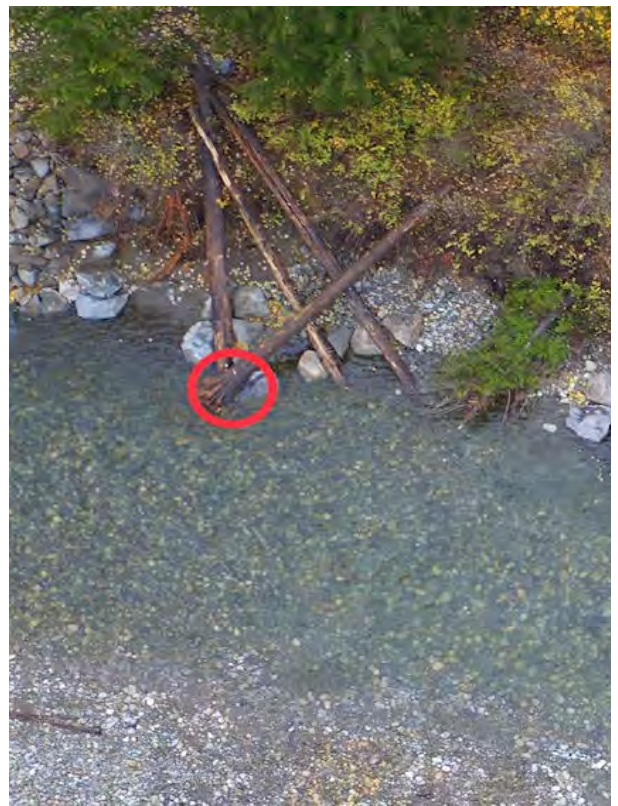
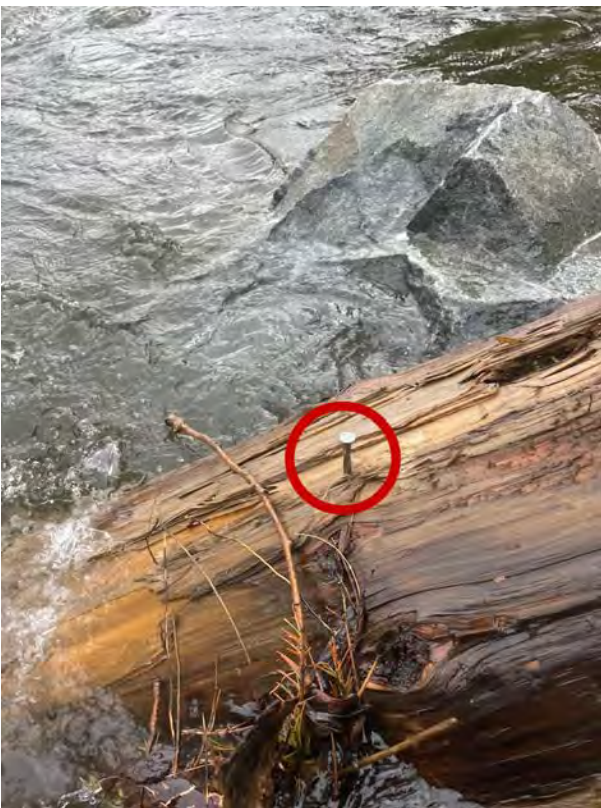
*Figure 11. Second Triangle. Downstream key log.*

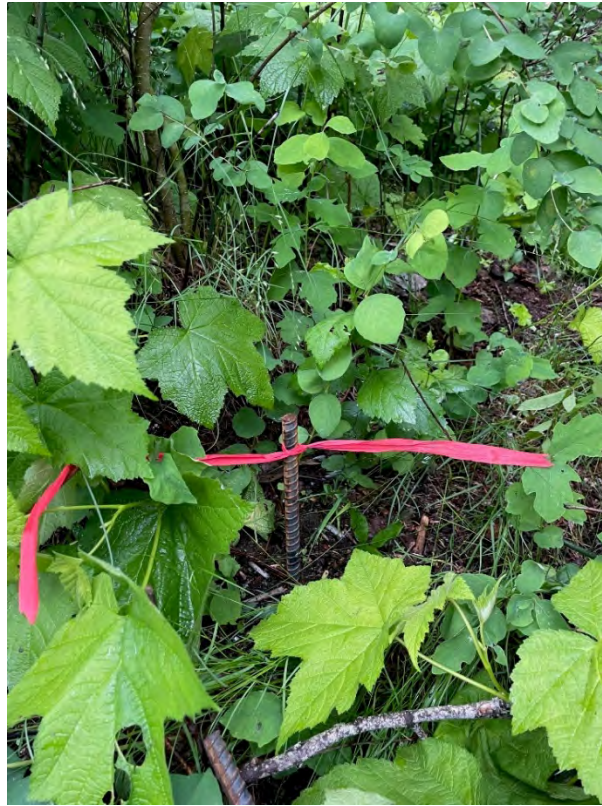
Figure 12. Benchmark for 2 upper triangles. (Not including downstream key log of second triangle. Second triangle downstream key log shares benchmark with First lateral log).

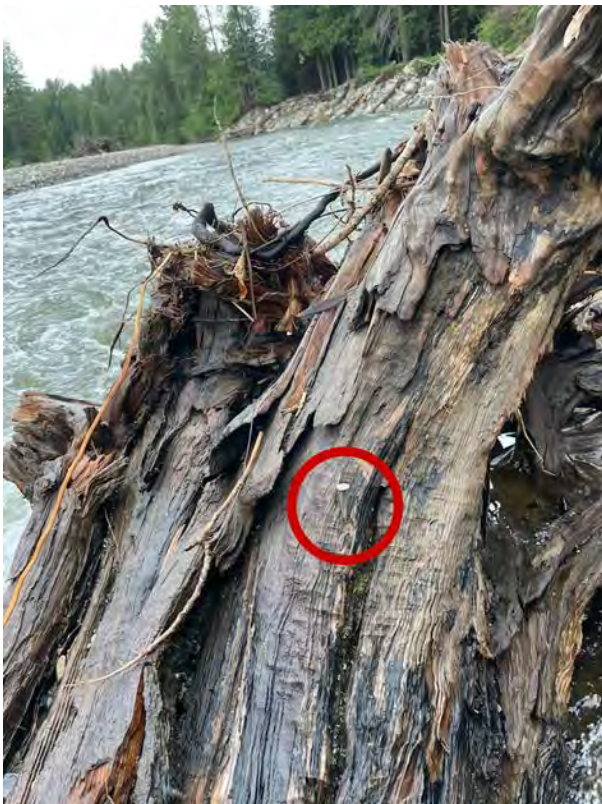
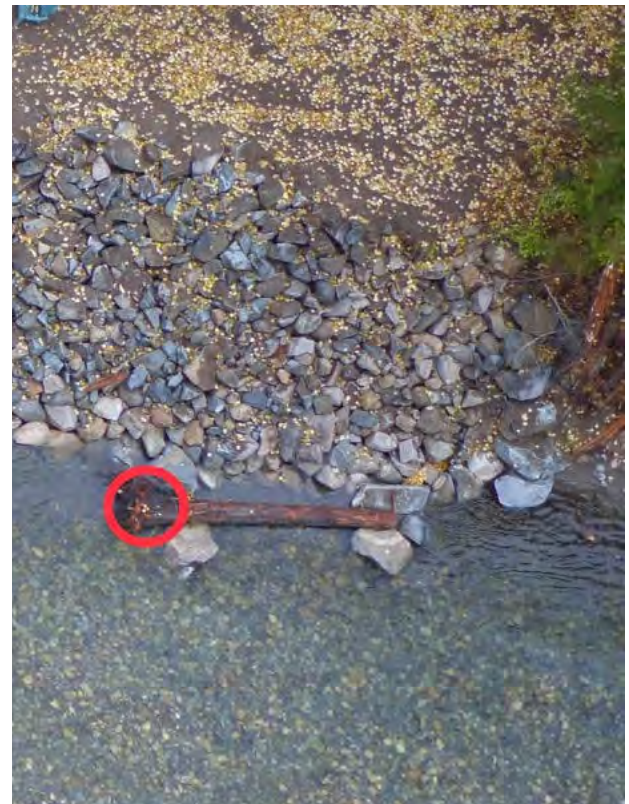
Figure 13. Second Lateral log.

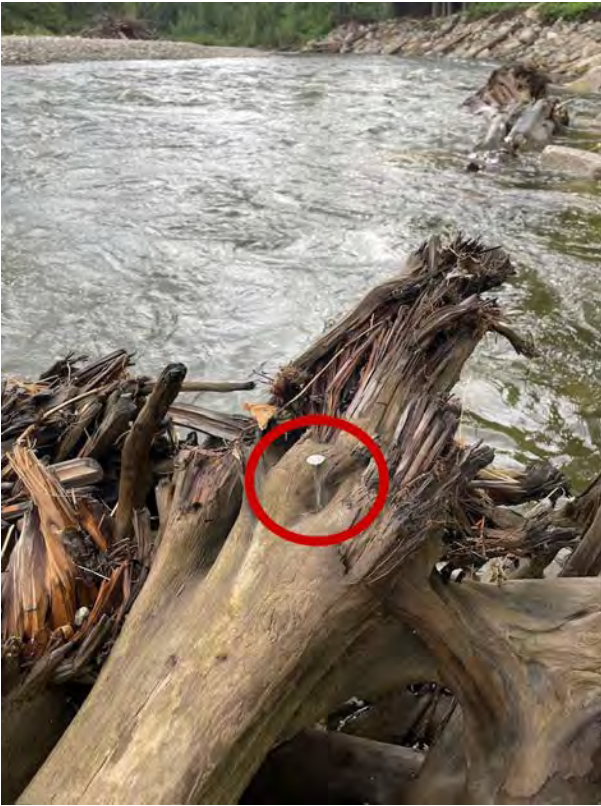
Figure 14. Third Lateral log.

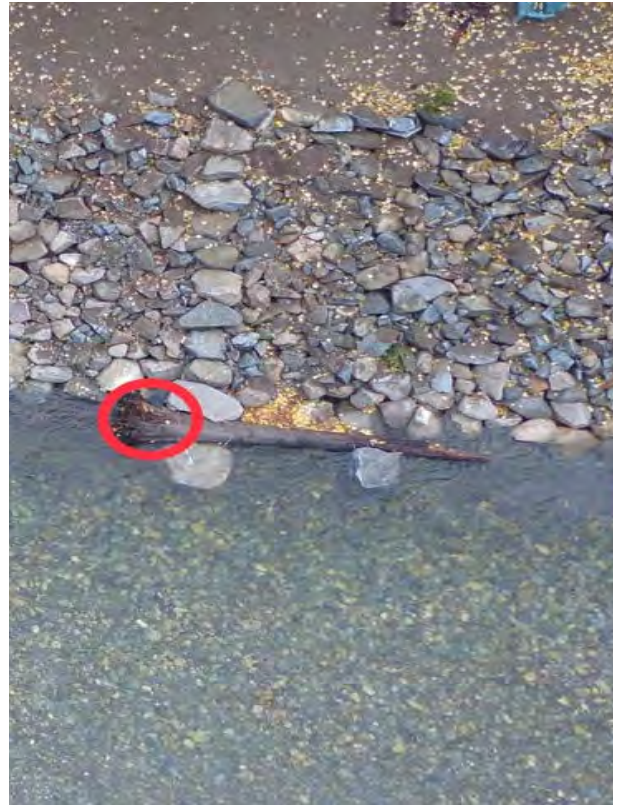
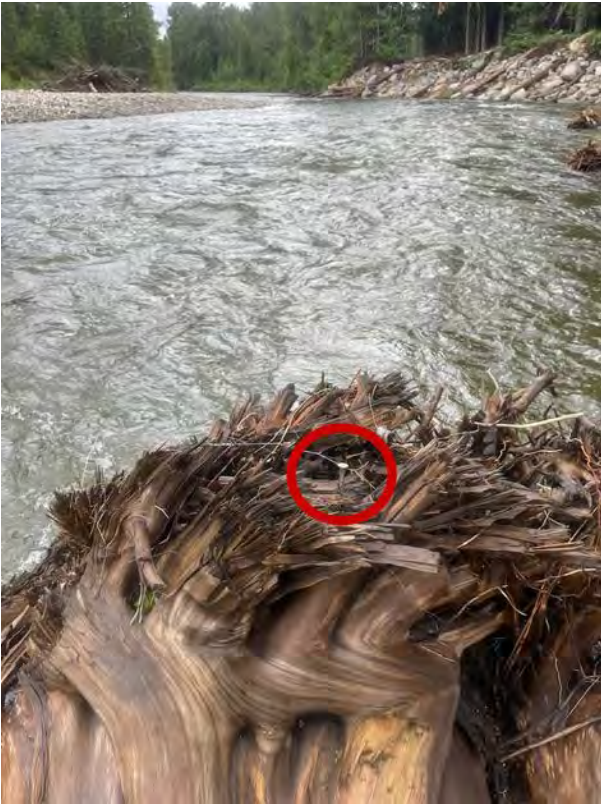
Figure 15. Fourth Lateral log.

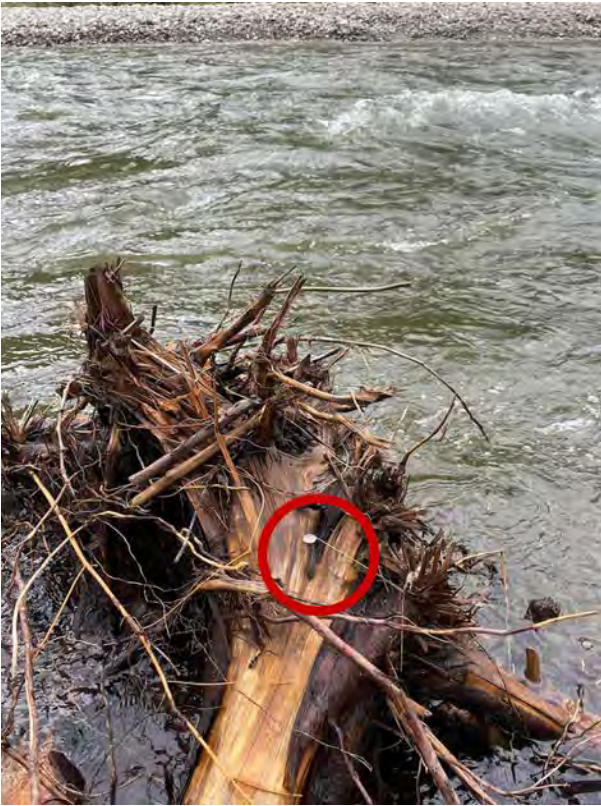
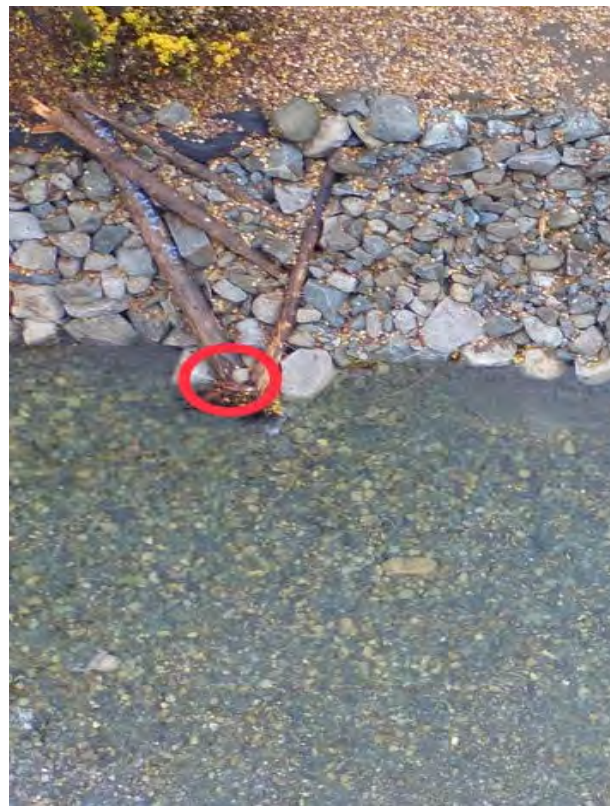
Figure 16. Third triangle. Downstream key log. (Immediately downstream of lateral logs)

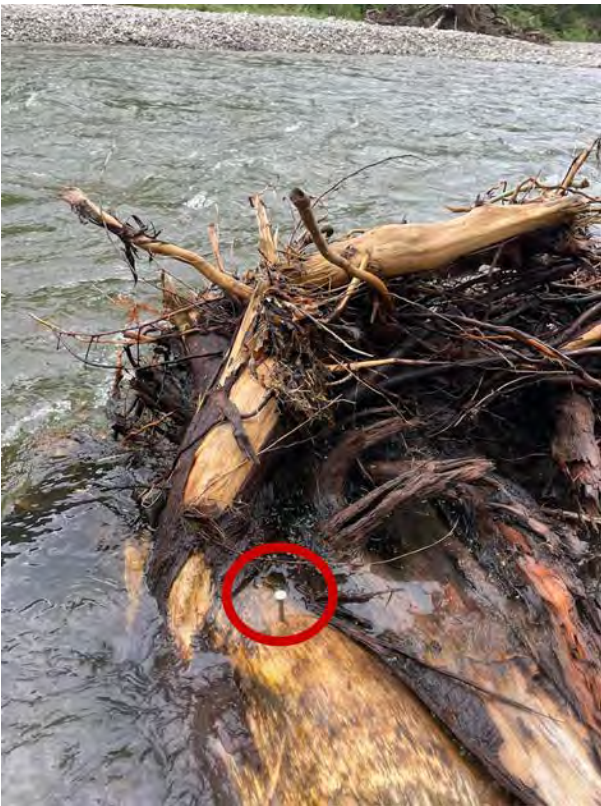
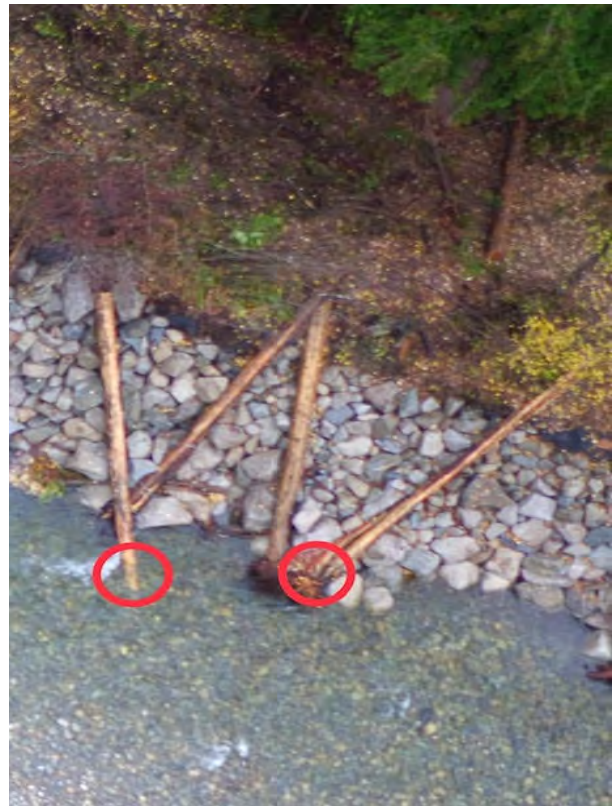
Figure 17. First W structure. Upstream key log.

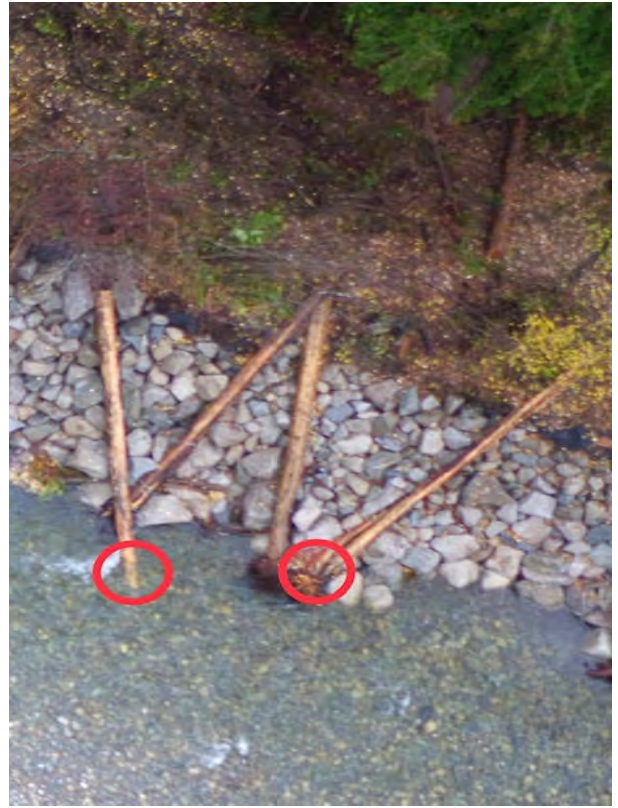
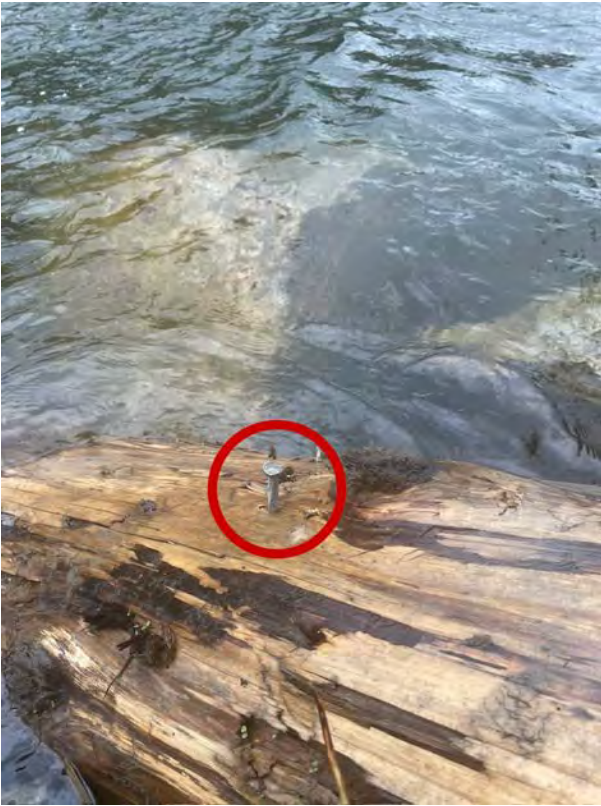
Figure 19. Second W structure. Upstream key log.

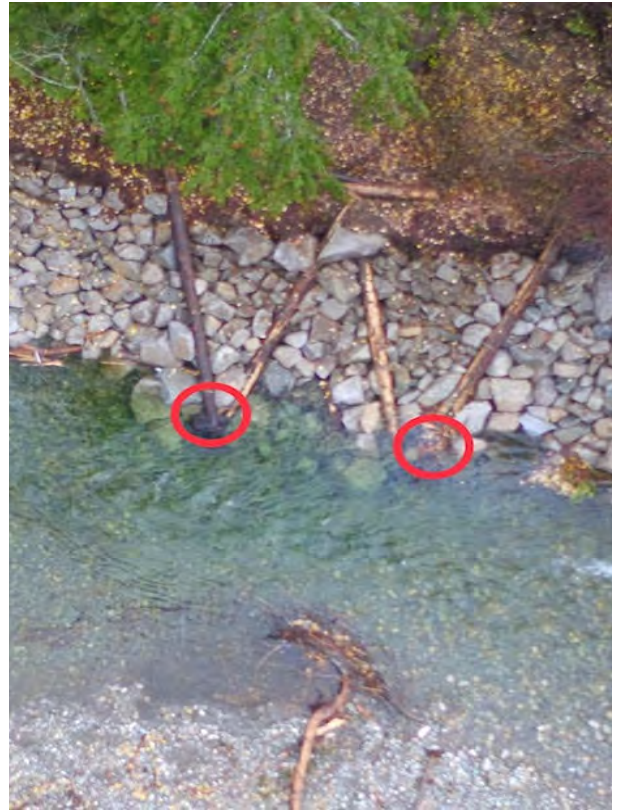
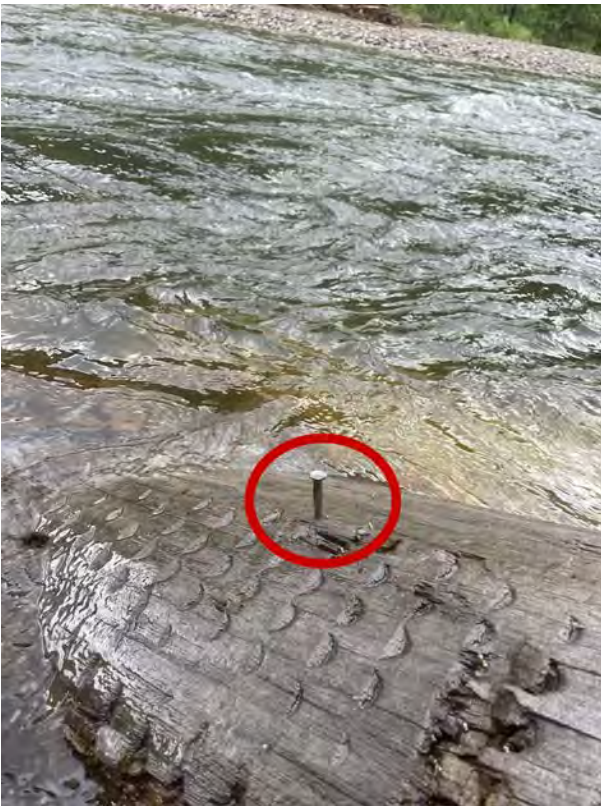
Figure 21. Third W structure. Upstream key log.

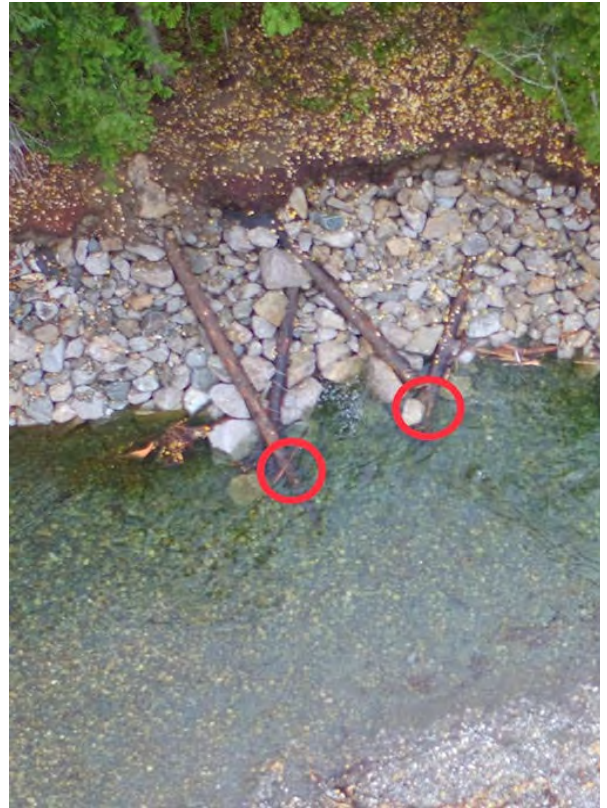
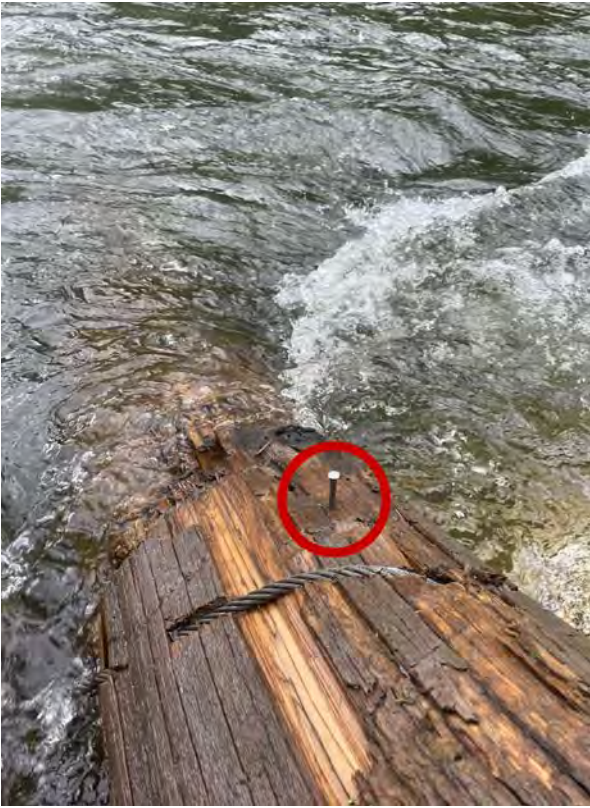
Figure 22. Third W structure. Downstream key log.

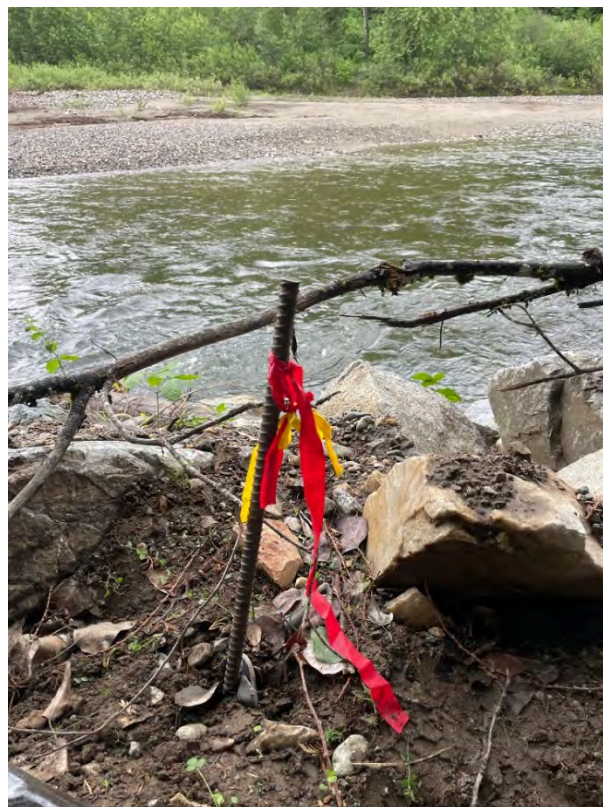
Figure 27. Benchmark for downstream arm of fourth W and fourth triangle (last structure).

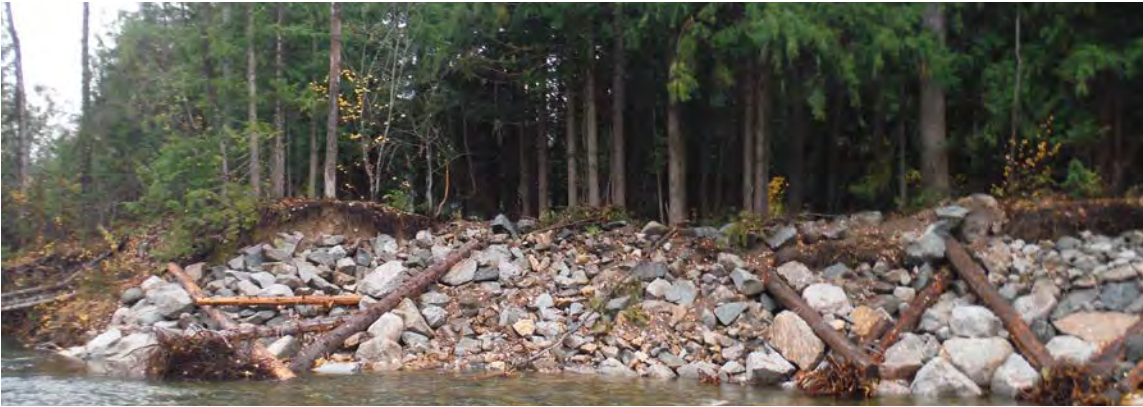
Figure 28

Downstream end of Site A: shows Triangular Structure C/W 2 Ramp logs and a 'W' structure

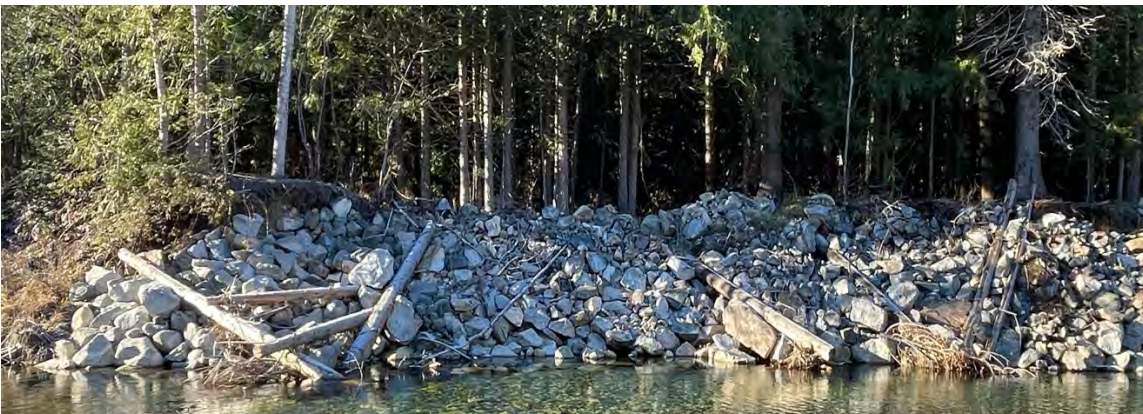
Figure 29

Downstream end of Site A: shows Triangular Structure C/W 2 Ramp logs and a 'W' structure March 24, 2024

The 2024 photos show strong sun activated log bleaching and the addition of post construction additional rock stabilization.

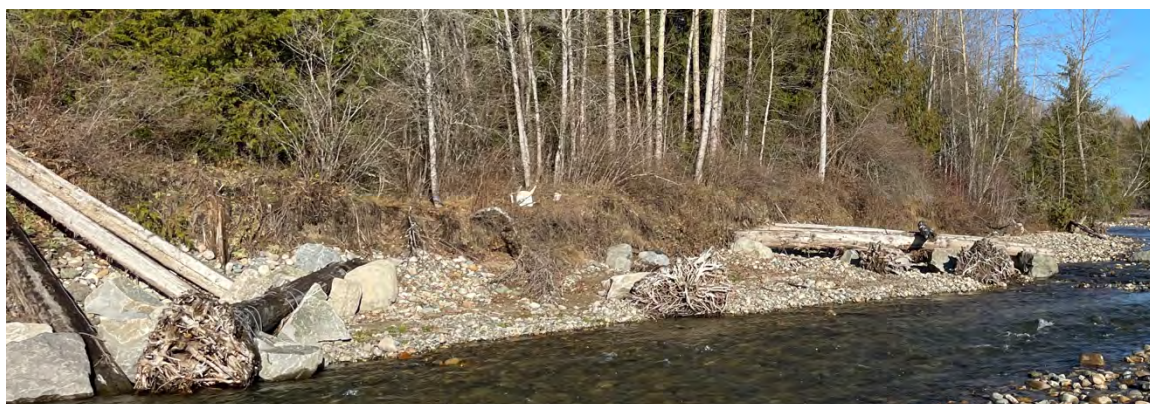
*Figure 31*

Shows upper Triangle above left, a Lateral Log structure and end view of the Debris Catcher. March 24 2024.

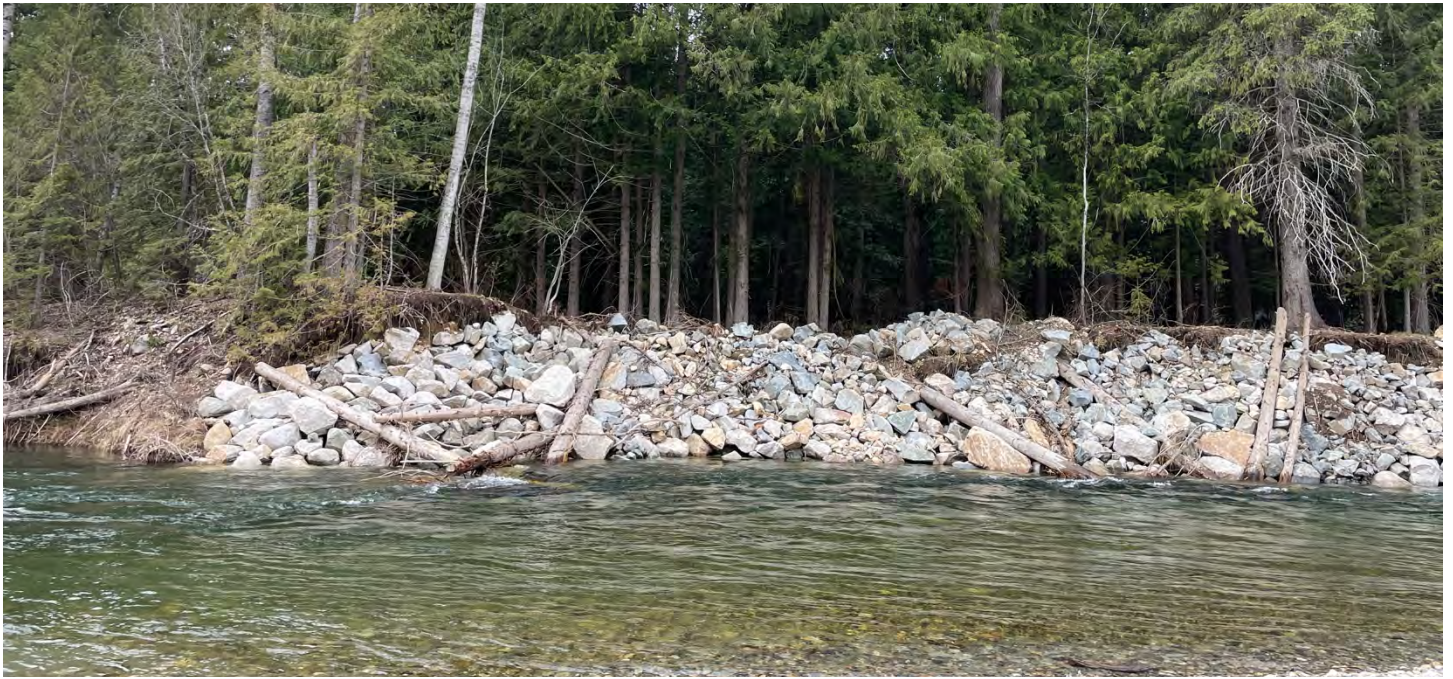
*Figure 32*

Photo 1 Downstream to Upstream. Shows the downstream Triangle and a 'W' structure.

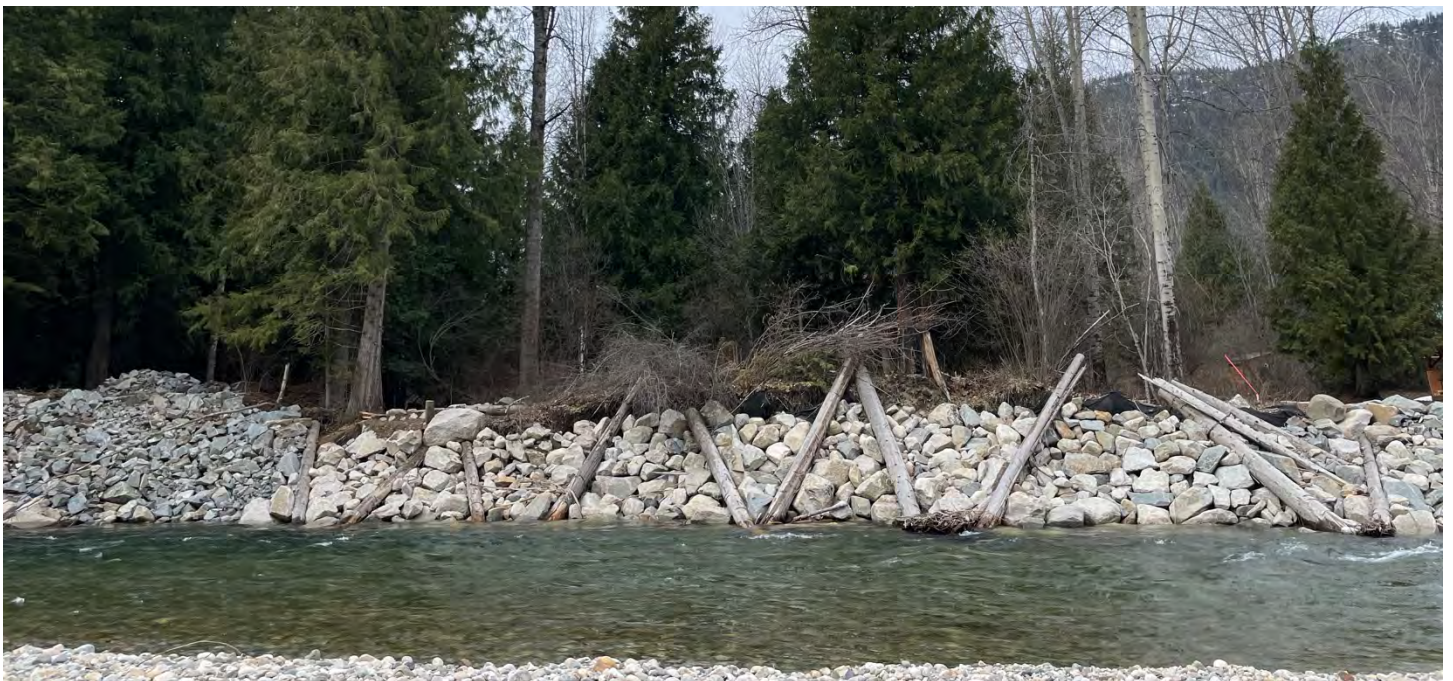
*Figure 33*

Photo 2 Downstream to Upstream. Shows 2 'W' structures and a Triangle structure.

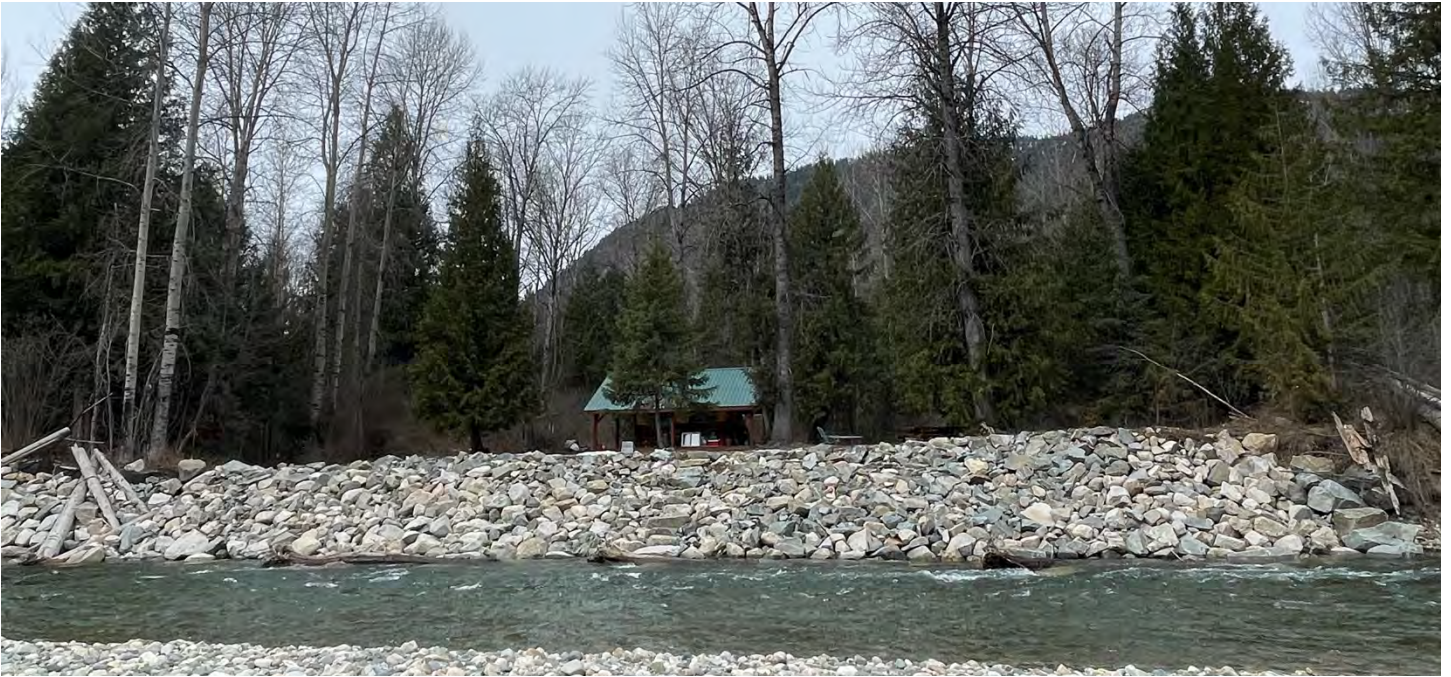
Figure 34

Photo 3 Downstream to Upstream. Shows downstream and upstream Triangle structures and 3 Lateral Log Structures.

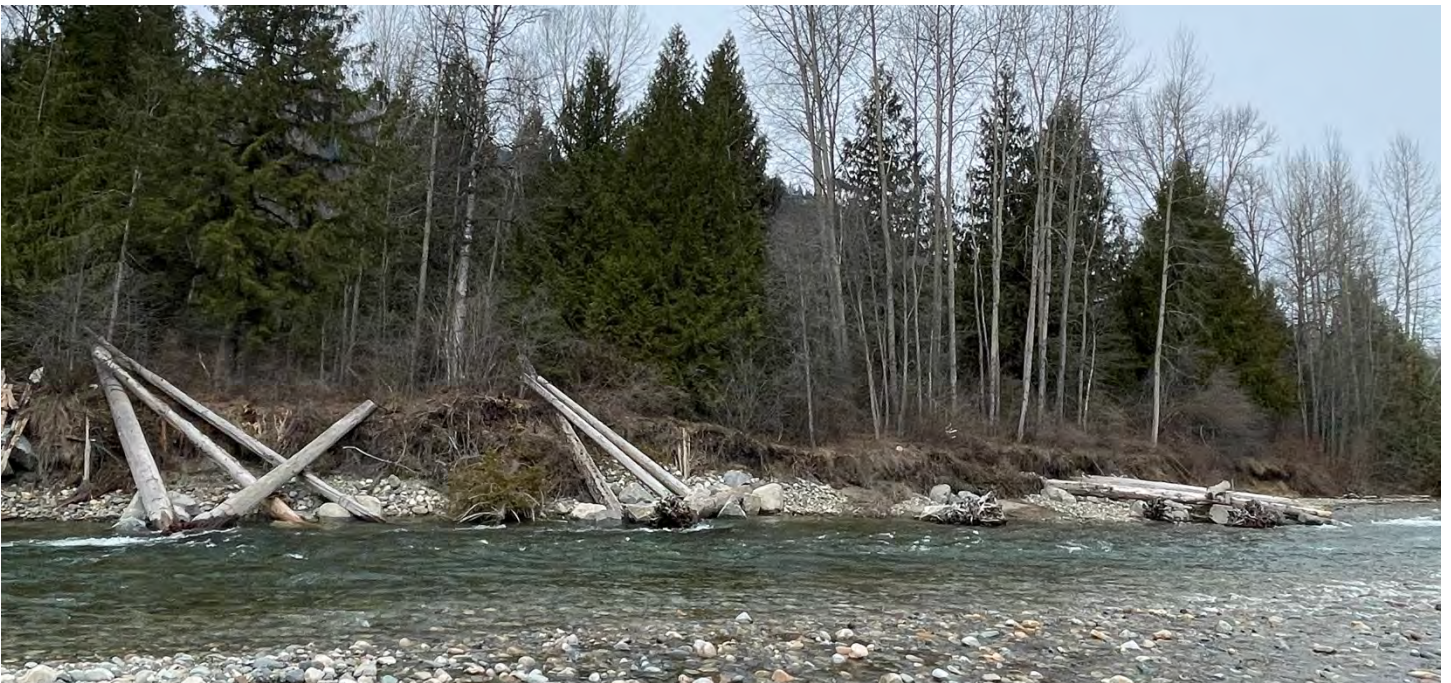
Figure 35

Photo 4 Downstream to Upstream. Shows 2 Triangle Structures a Lateral Log Structure and the Debris Catcher.

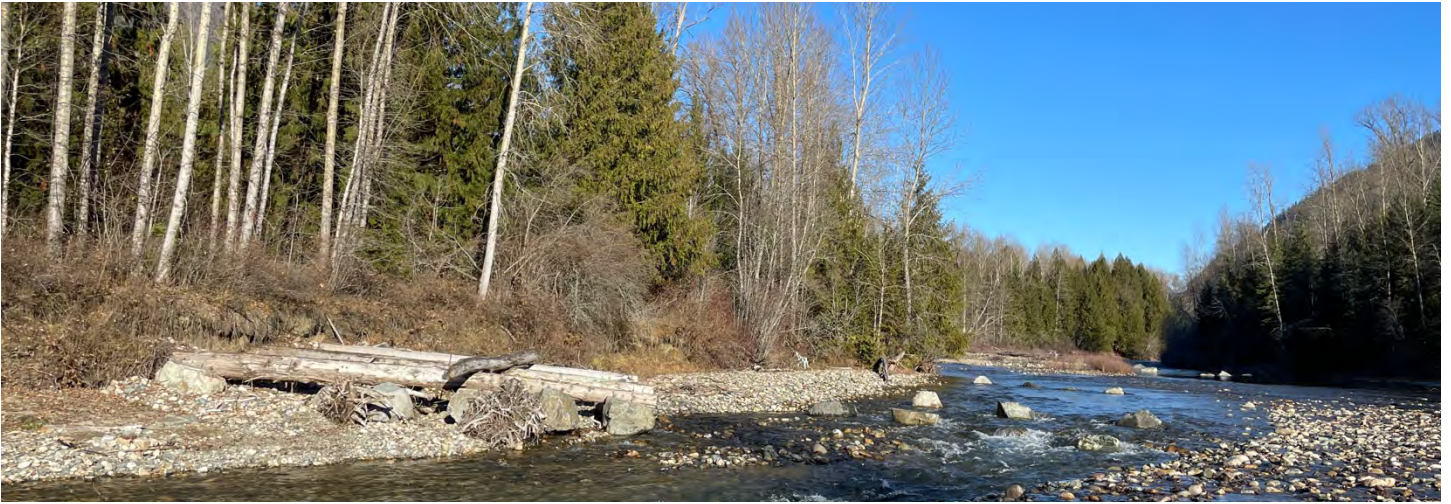
*Figure 36*

Photo 5 Downstream to Upstream. Shows 2 the Debris Catcher looking upstream. Notice the Boulder Clusters instream.

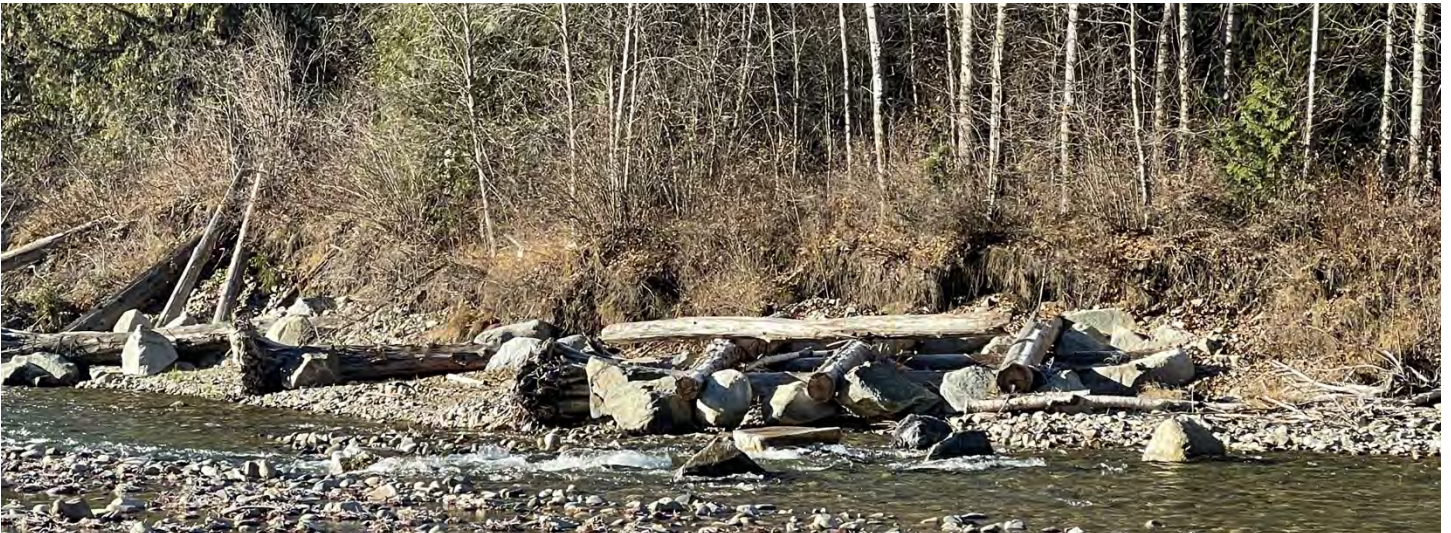
*Figure 37*

Photo 6 Downstream to Upstream shows the Debris Catcher Looking Downstream. Includes placement of the first upstream Lateral Log and the first upstream Triangular structure. Notice the first downstream Boulder Cluster.
