**Project Title: Salmo River Instream Enhancement Program (Phase 2)**

**FWCP Project No: FWCP: COL-F22-F-3438**

# Effectiveness Monitoring and Maintenance Report (EMMR) for Salmo River Watershed Instream Restoration Project (SRWIRP) Phase 2

Project #16,731: Site A – Casey, Site B –Nelson Nordic Ski Club (NNSC): Columbia Basin Trust, Fish and Wildlife Compensation Program Project COL-F22-F-3348

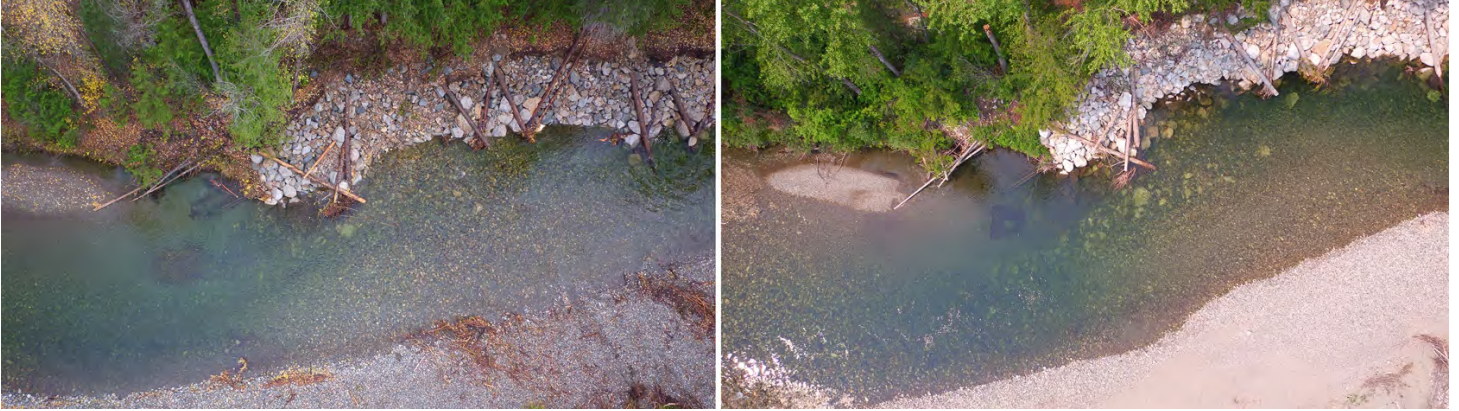
Figure 38

Photo #1 Downstream end of Site A: Captures Lower Triangle with 2 Ramp Logs and 2 'W' Structures.

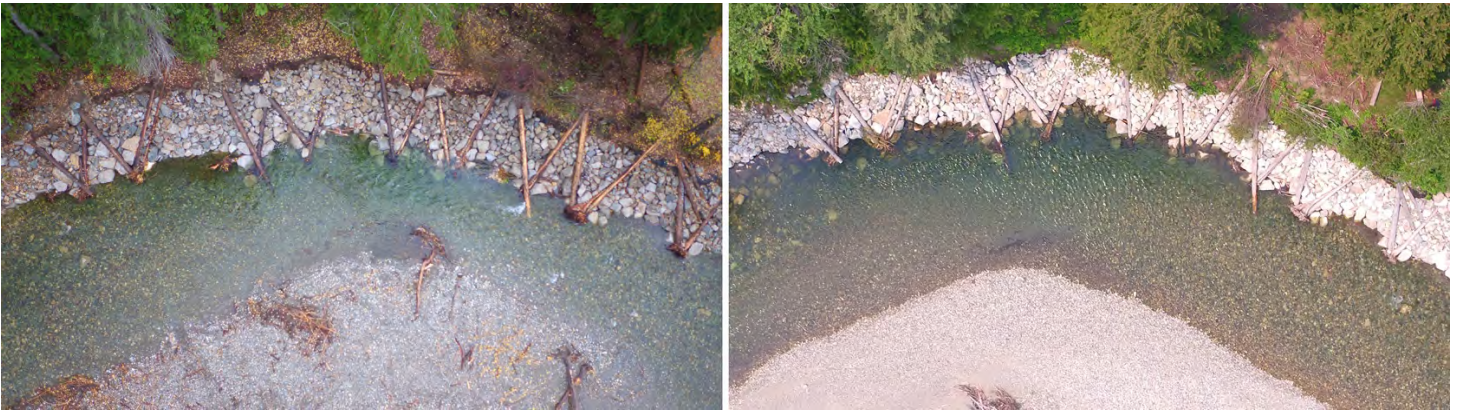
Figure 39

Photo #2, Moving Upstream: Captures 4 'W' Structures and downstream end of 2<sup>nd</sup> Triangle with 1 Ramp Log.

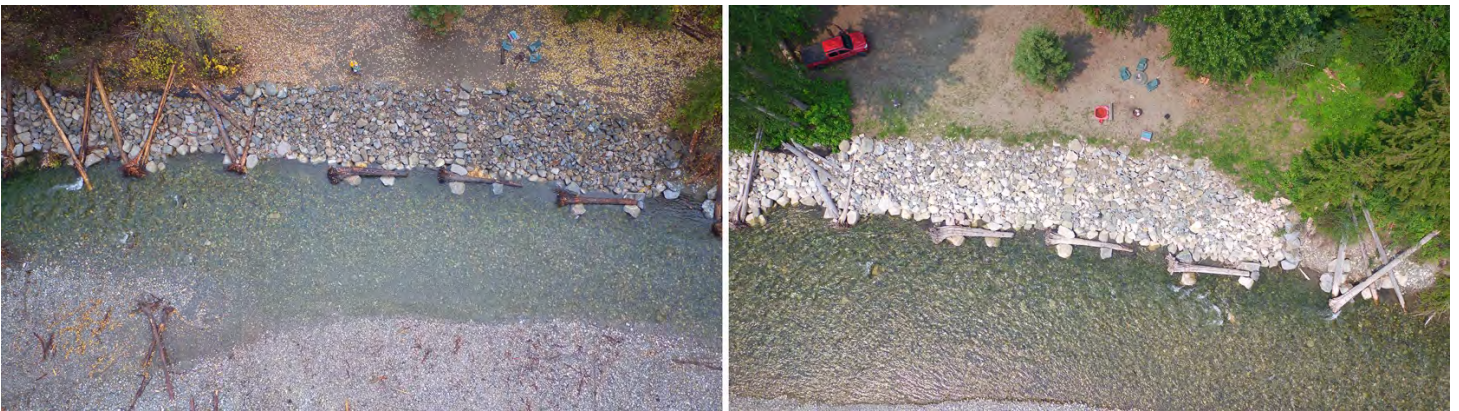
Figure 40

Photo #3, Shows repeat of upstream 'W', 2nd Triangle, c/w 1 Ramp Log, 3 Lateral Log Structures and 3<sup>rd</sup> Triangle c/w 2 Ramp Logs.

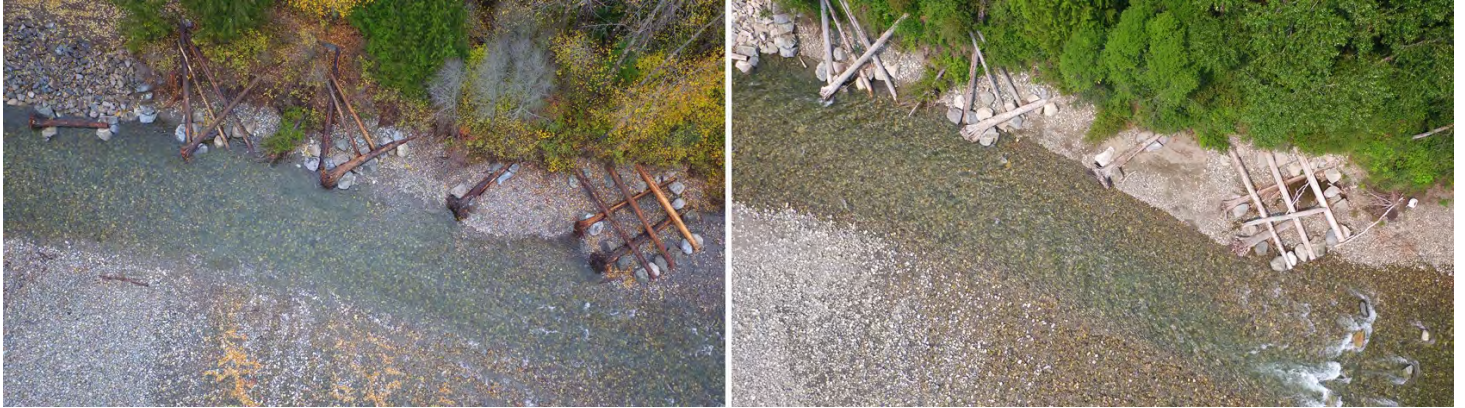
Figure 41

Photo #4, Shows repeat of upper Lateral Log, 2 Triangles c/w 2 ramp Logs, a Lateral Log 'on angle' and the Debris Catcher.

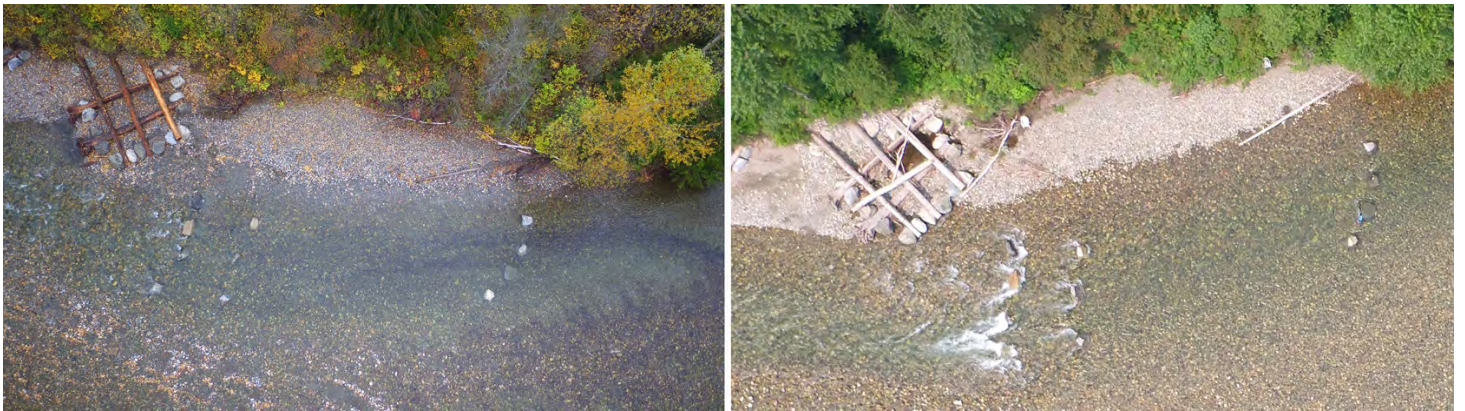
Figure 41

Photo #5 shows repeat of Debris Catcher and the beginning of the upstream of site 'Boulder Clusters'. (3 Clusters)

Review of photos confirm the structures remain stable over 3 high water events, freshet 2023 and 2 additional rain activated high water events. The only readily observable change in structure 'layout' is on the Photo #5, Debris Catcher. It has begun to serve its purpose capturing debris in the upper quadrant and close in on the upstream boulder bar as well as on the structure itself. Just to upstream end of the first downstream W the River has contributed an additional piece of large woody debris. What is apparent is the obvious log bleaching that has occurred since construction.

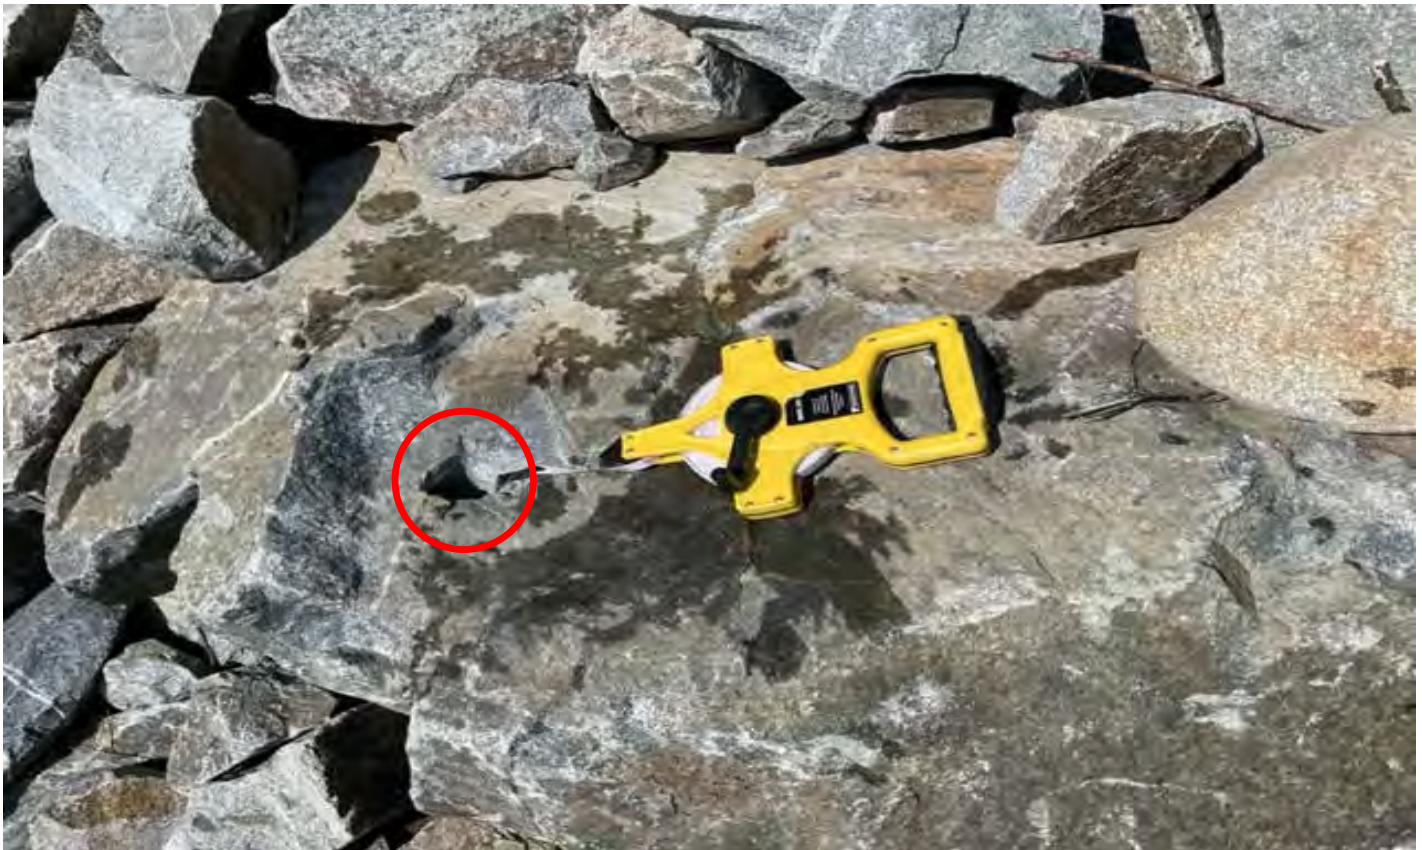
Figure 45. Benchmark. Used same benchmark feature for all structures at NNSC. (Hole in rock)

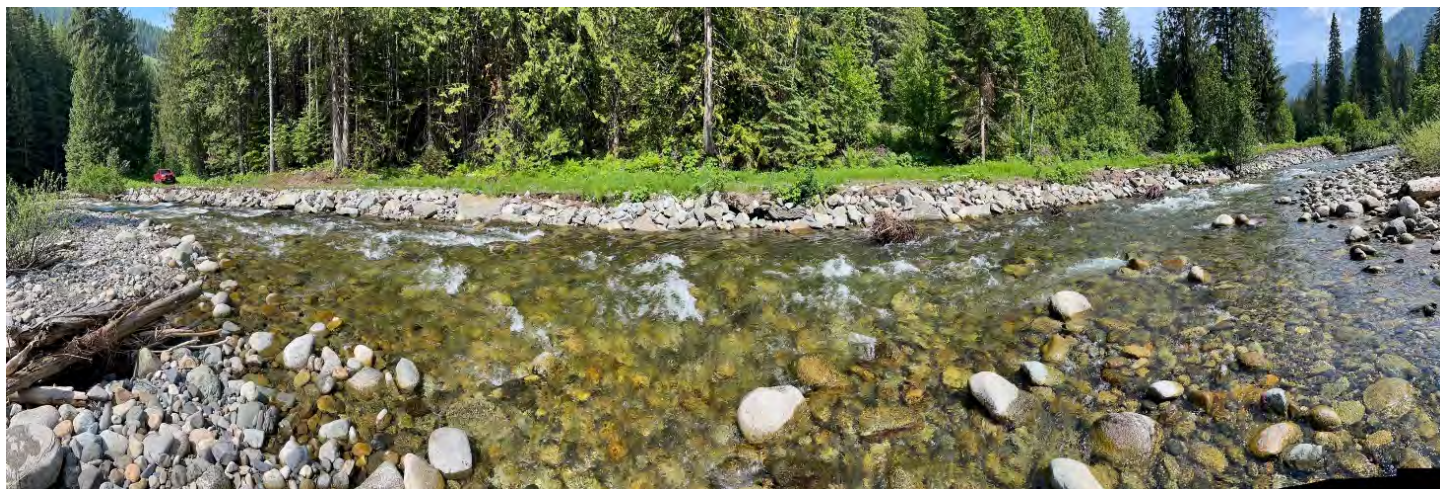
*Figure 47. June 14<sup>th</sup> 2023 Panorama of river right NNSC*

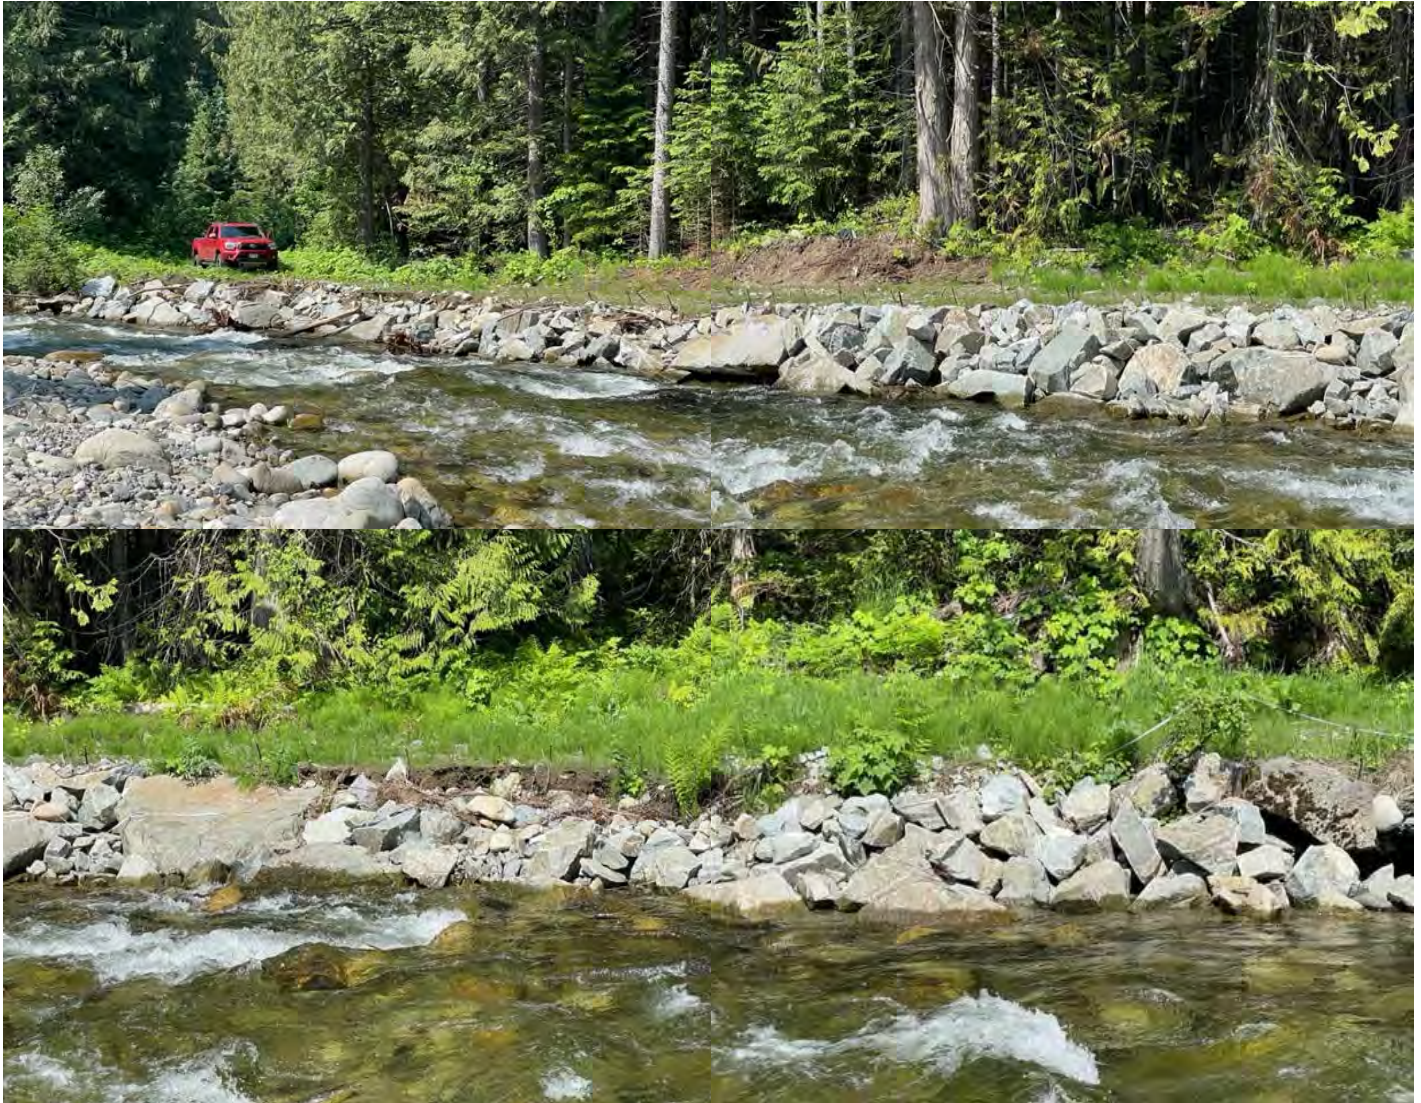
Figure 48. June 14<sup>th</sup> 2023 Succession of photos from downstream to upstream

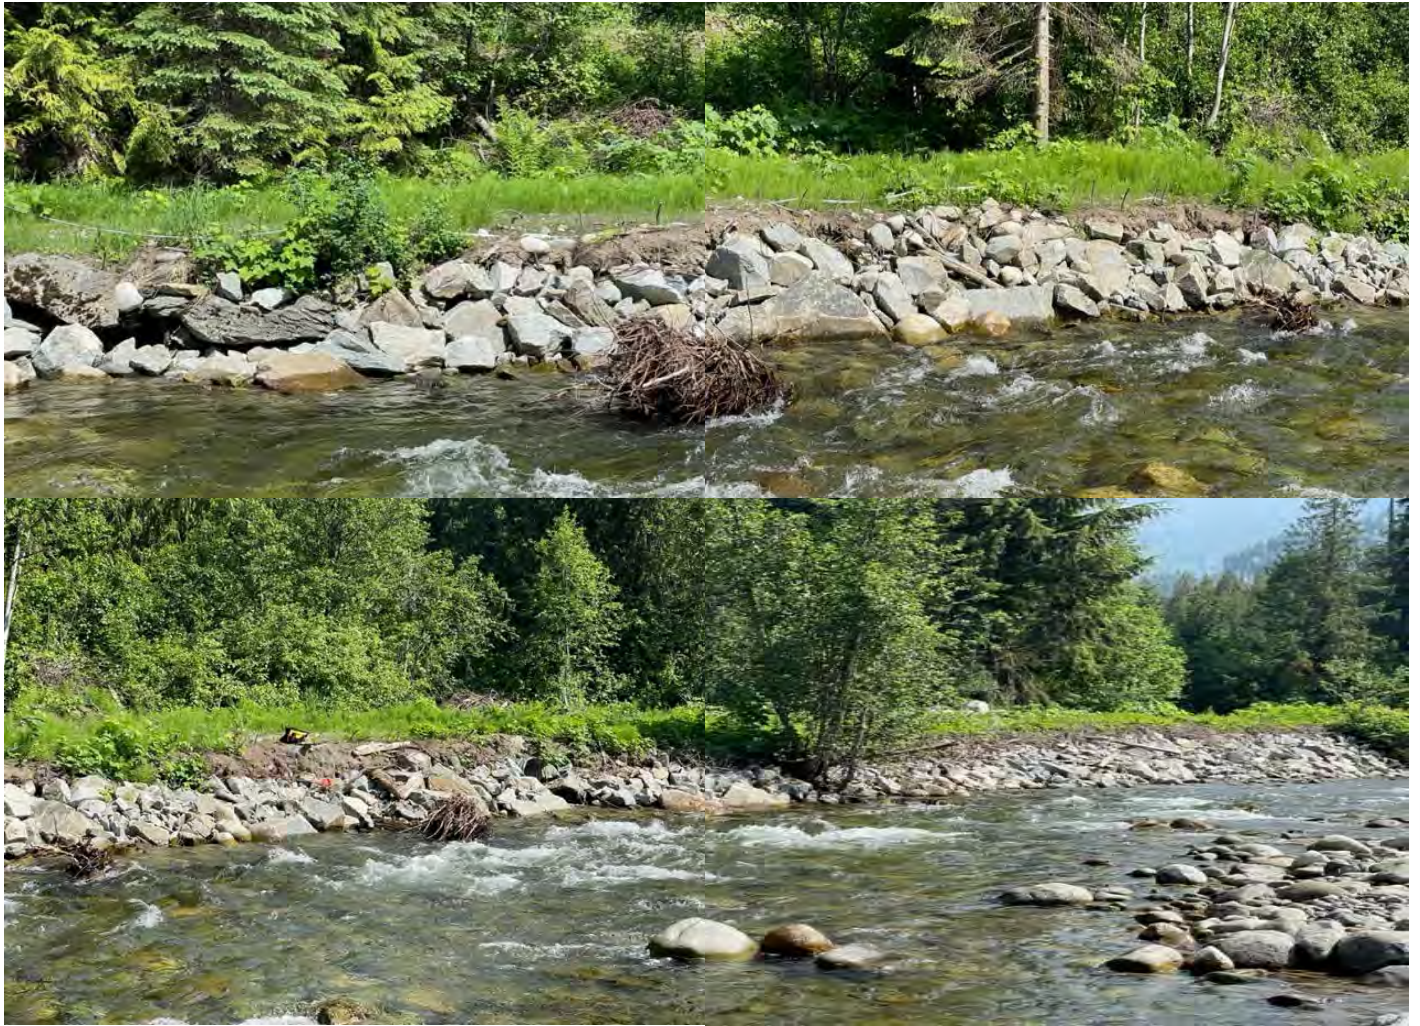
*Figure 49. June 14<sup>th</sup> 2023 Succession of photos from downstream to upstream*

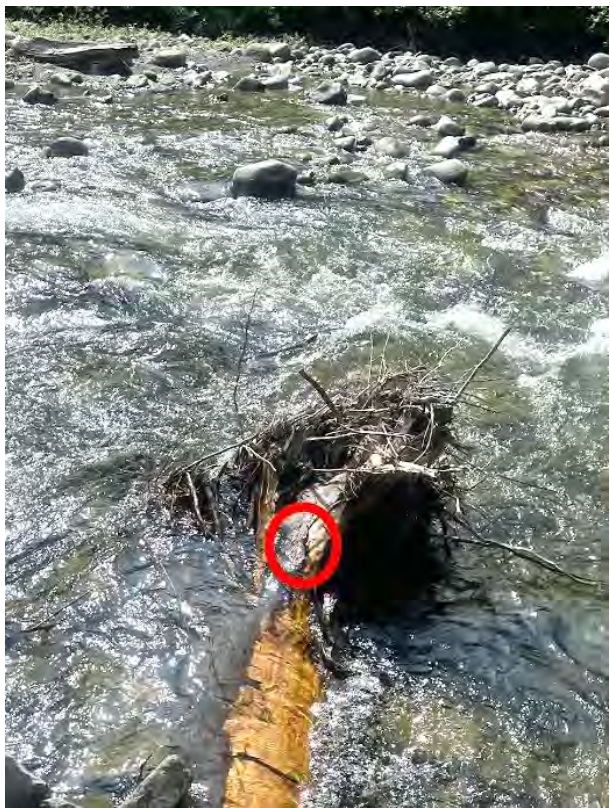
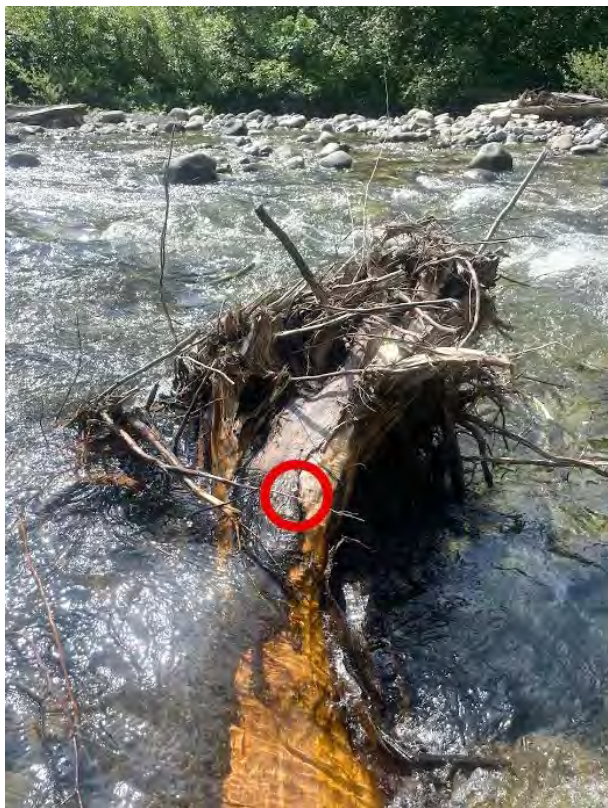
Figure 52. Root Wad 3 (Root Wad 4 was fully submerged at this time)
