**An Inventory of Watershed Conditions
Affecting Risks to Fish Habitat
in the
CARIBOO, COTTONWOOD & HORSEFLY
WATERSHEDS**

VOLUME I
Cariboo River Watershed
(Sections 1 to 5 & 6)

Prepared for
CARIBOO REGION INTERAGENCY MANAGEMENT COMMITTEE
Williams Lake, BC

by
CHAPMAN GEOSCIENCE LTD.
Nanaimo, BC
&
DOBSON ENGINEERING LTD.
Kelowna, BC

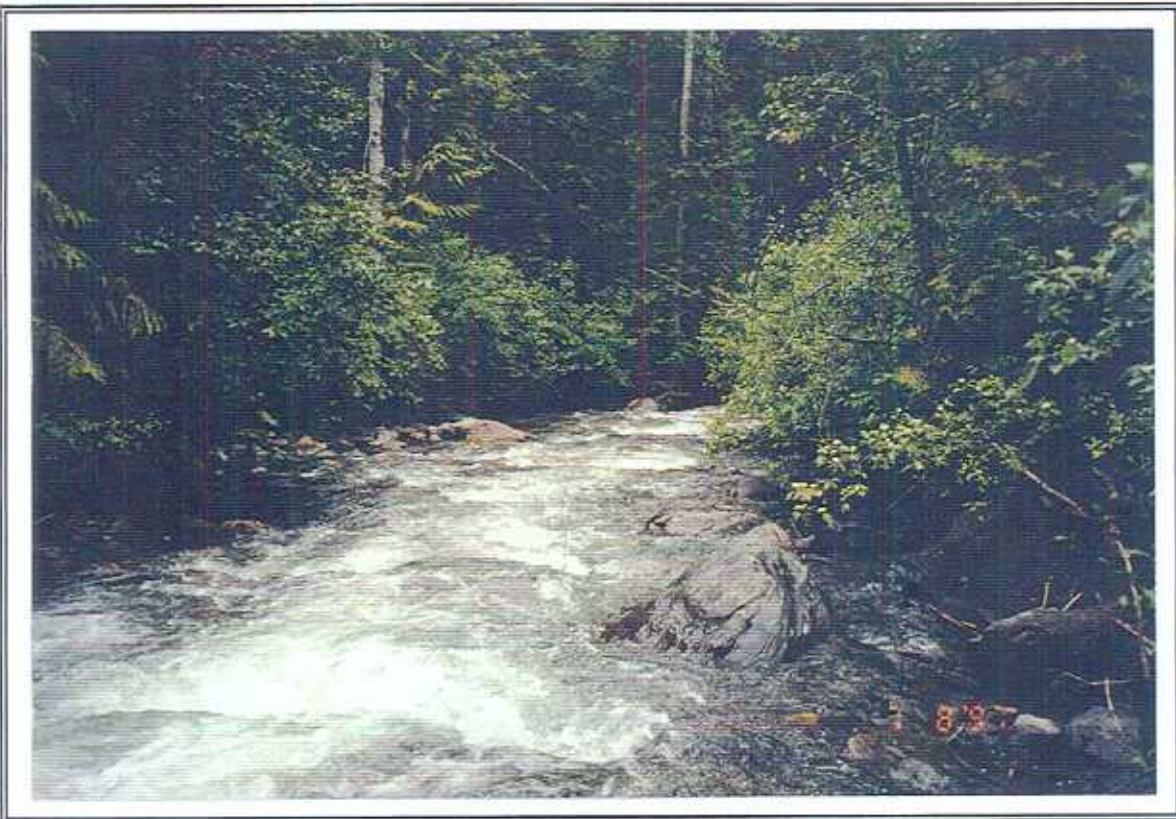
PHOTO SP3. Lower Spanish Creek - downstream [Site S1]

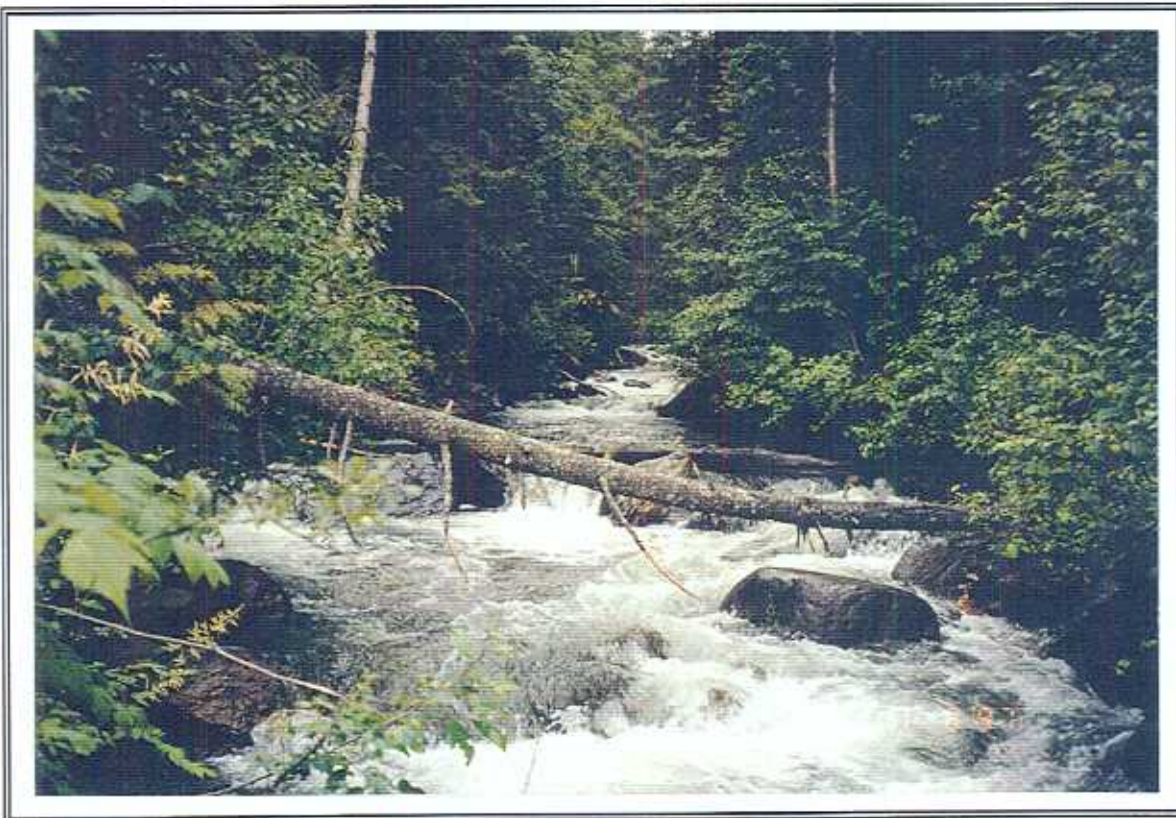
PHOTO SP4. Lower Spanish Creek - upstream [Site S1]

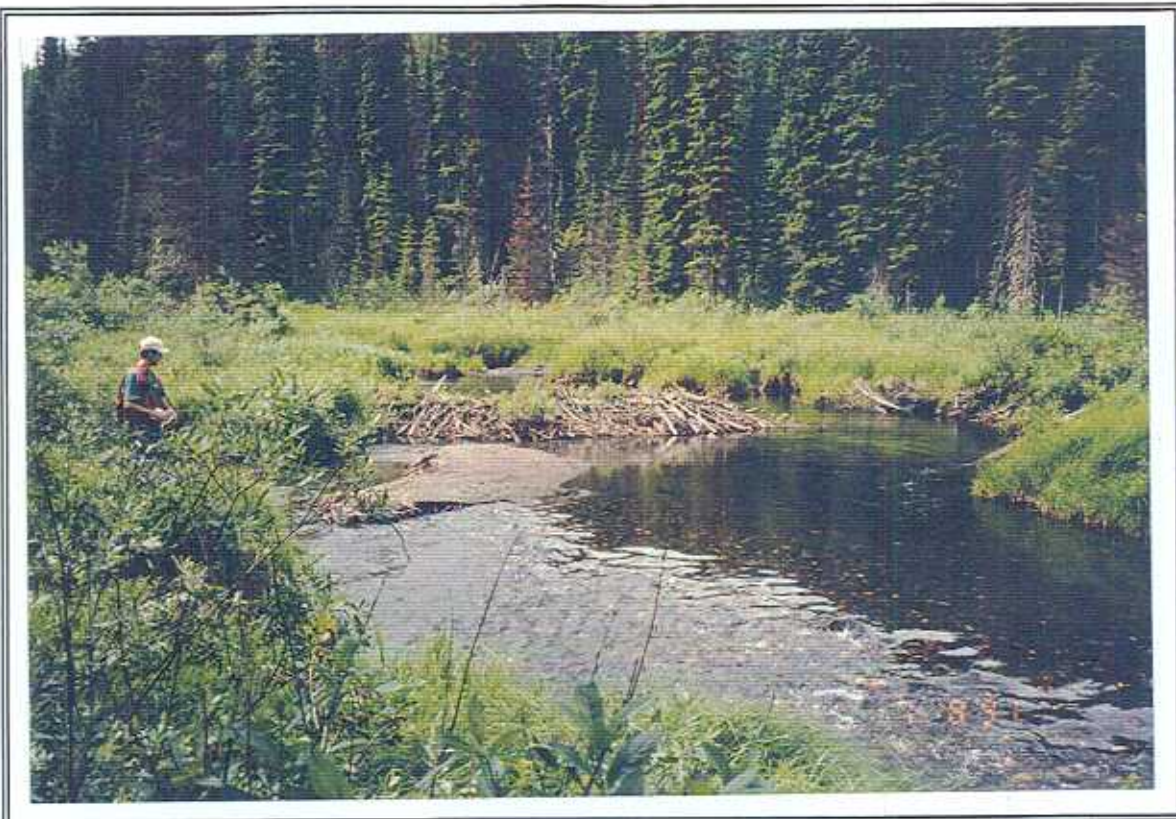
PHOTO SP5. Middle Spanish Creek below Spanish Lake showing broad alluvial floodplain and beaver dam - upstream [Site S2].

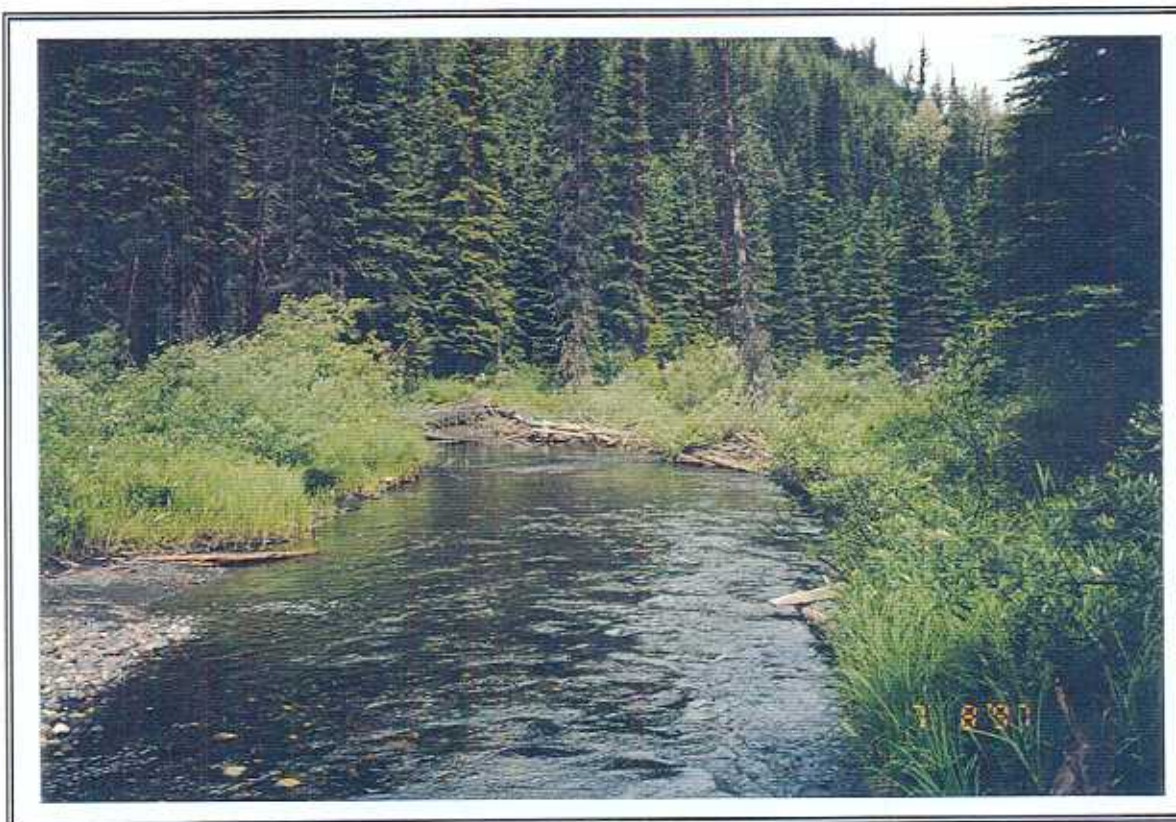
PHOTO SP6. Middle Spanish Creek below Spanish Lake showing low gradient channel - downstream [Site S2].

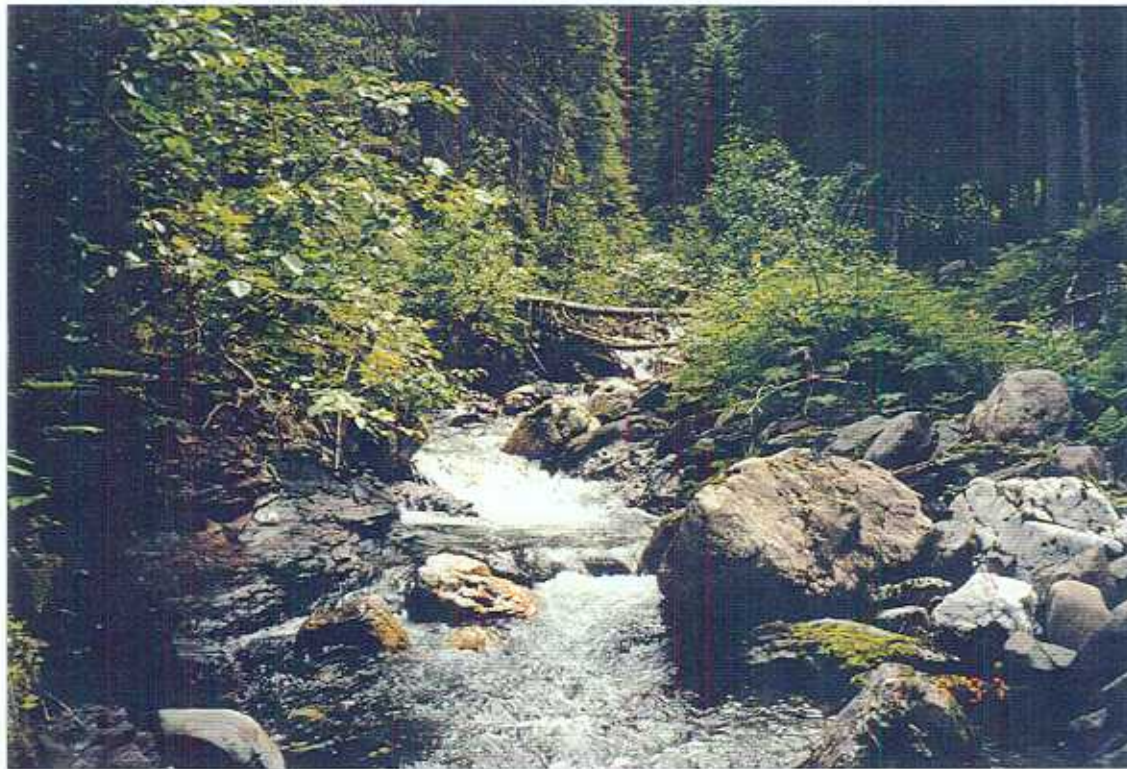
PHOTO SP7. Middle Blackbear Creek showing stable boulder/bedrock channel - upstream [Site S3].

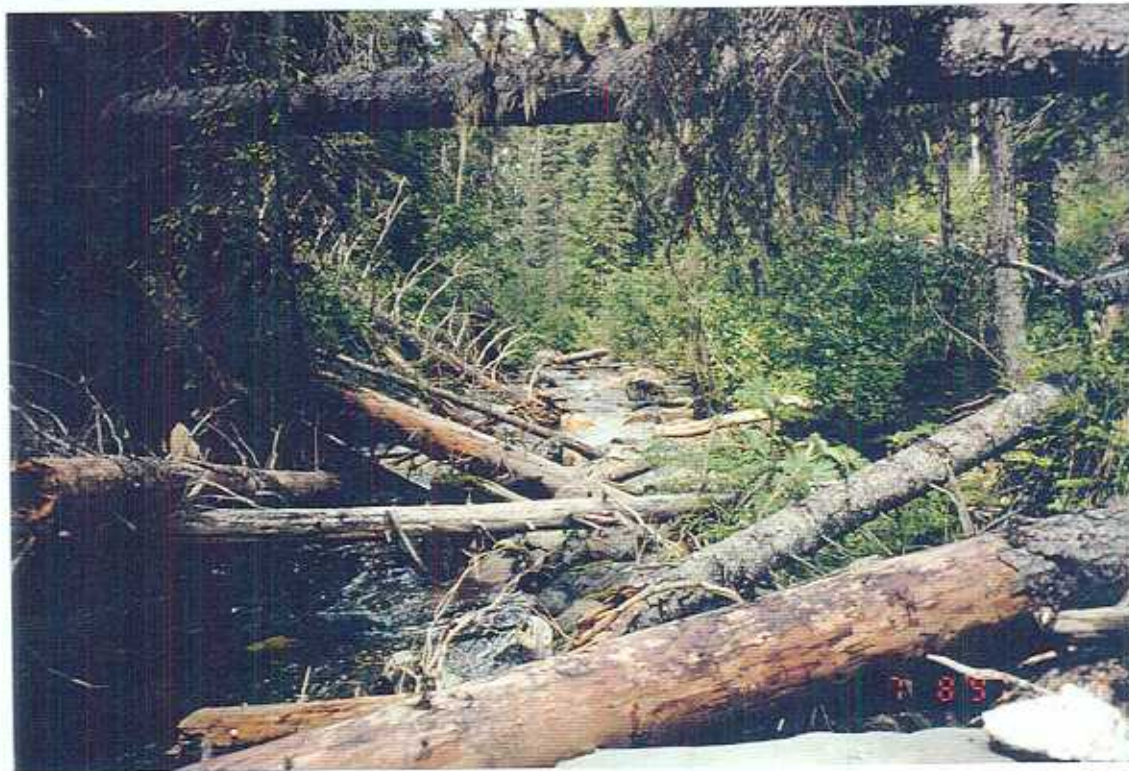
PHOTO SP8. Middle Blackbear Creek showing blowdown from adjacent placer mine site - downstream [Site S3].

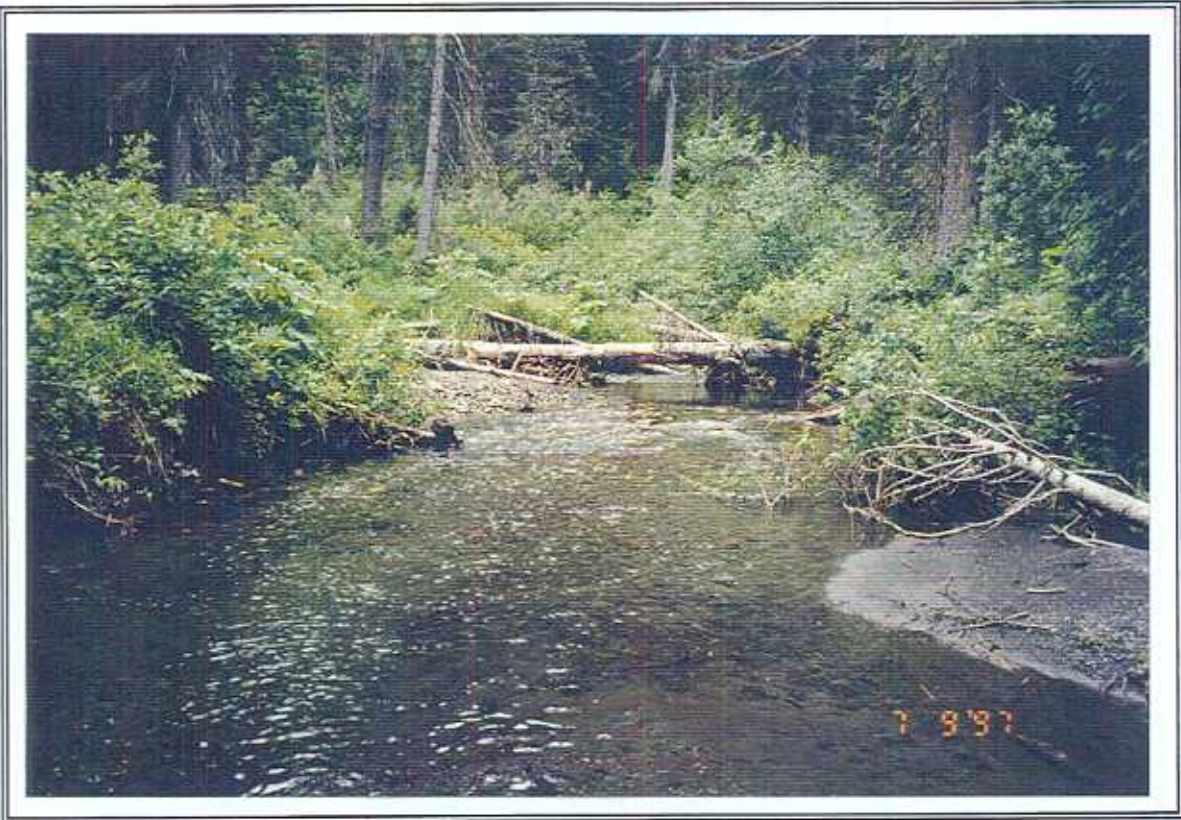
PHOTO SP9. Upper Blackbear Creek - upstream [Site S4].

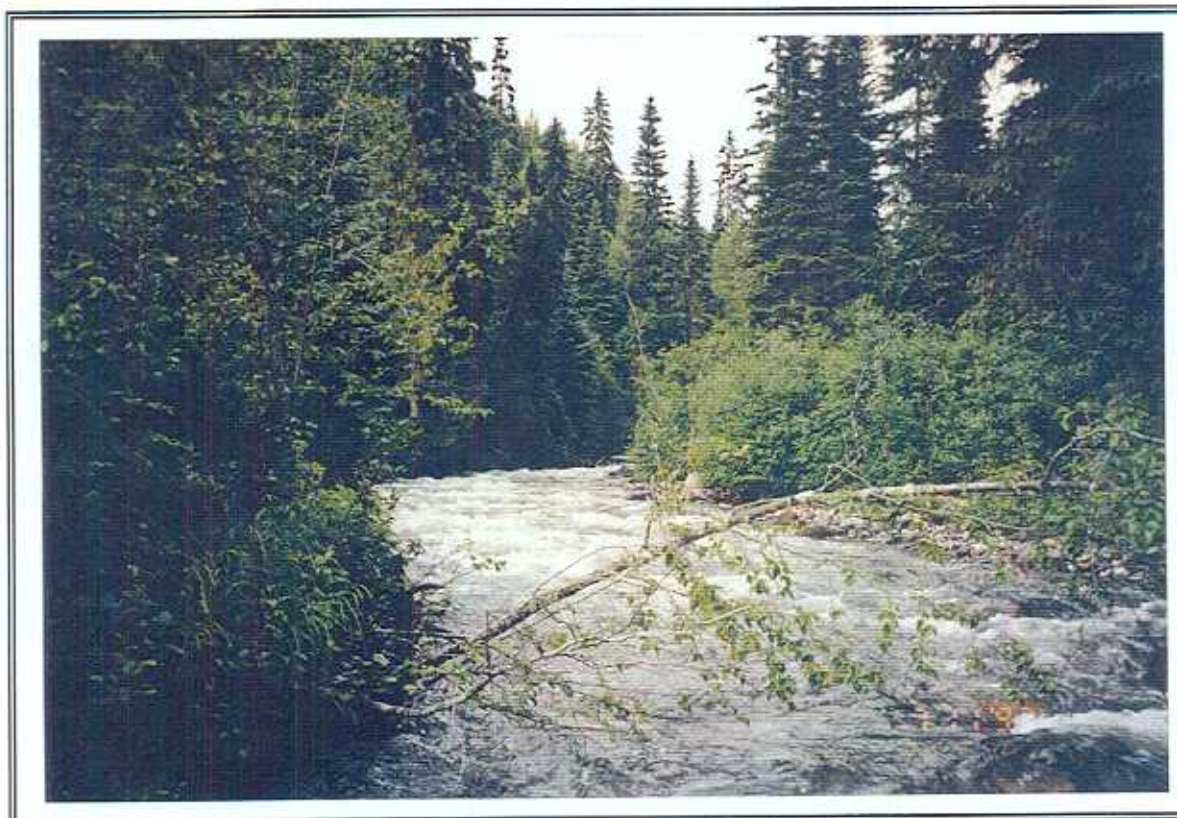
PHOTO S2. Lower Seller Creek - upstream [Site Sel2].

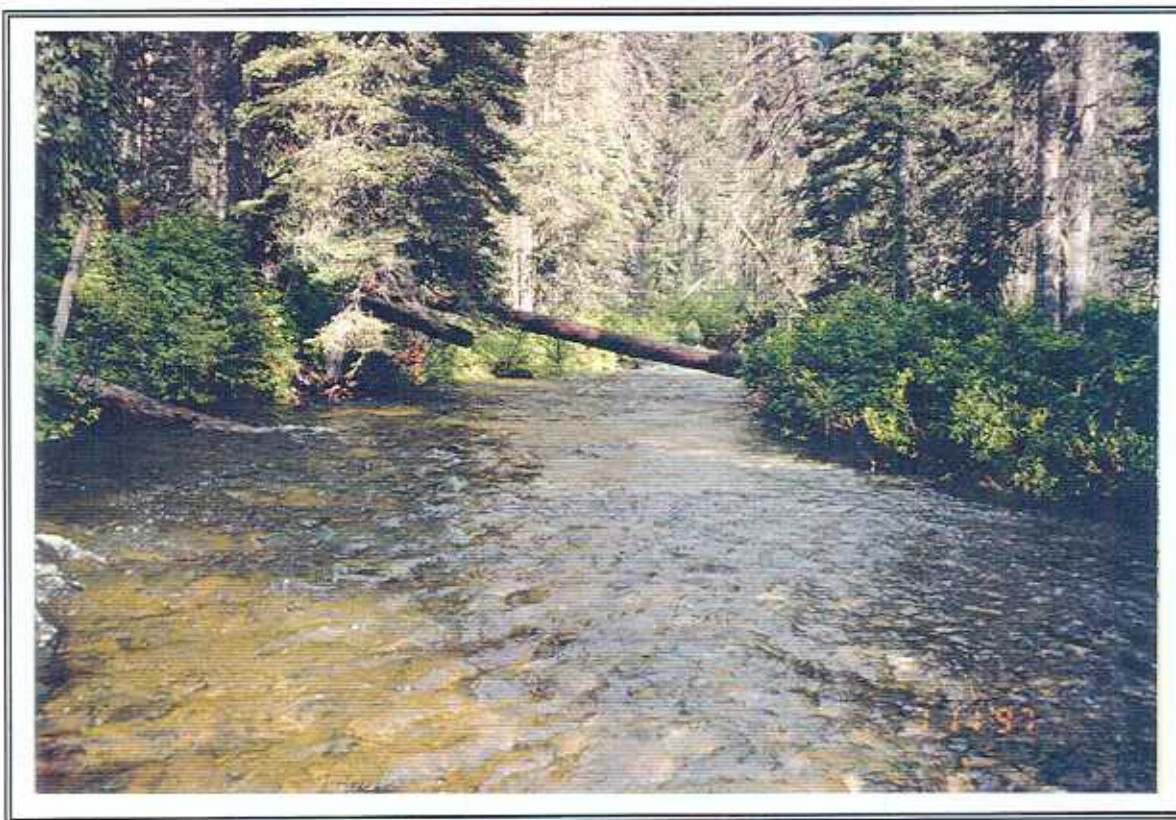
PHOTO S4. Upper Seller Creek with stable old growth riparian zone - upstream [Site Sel4].

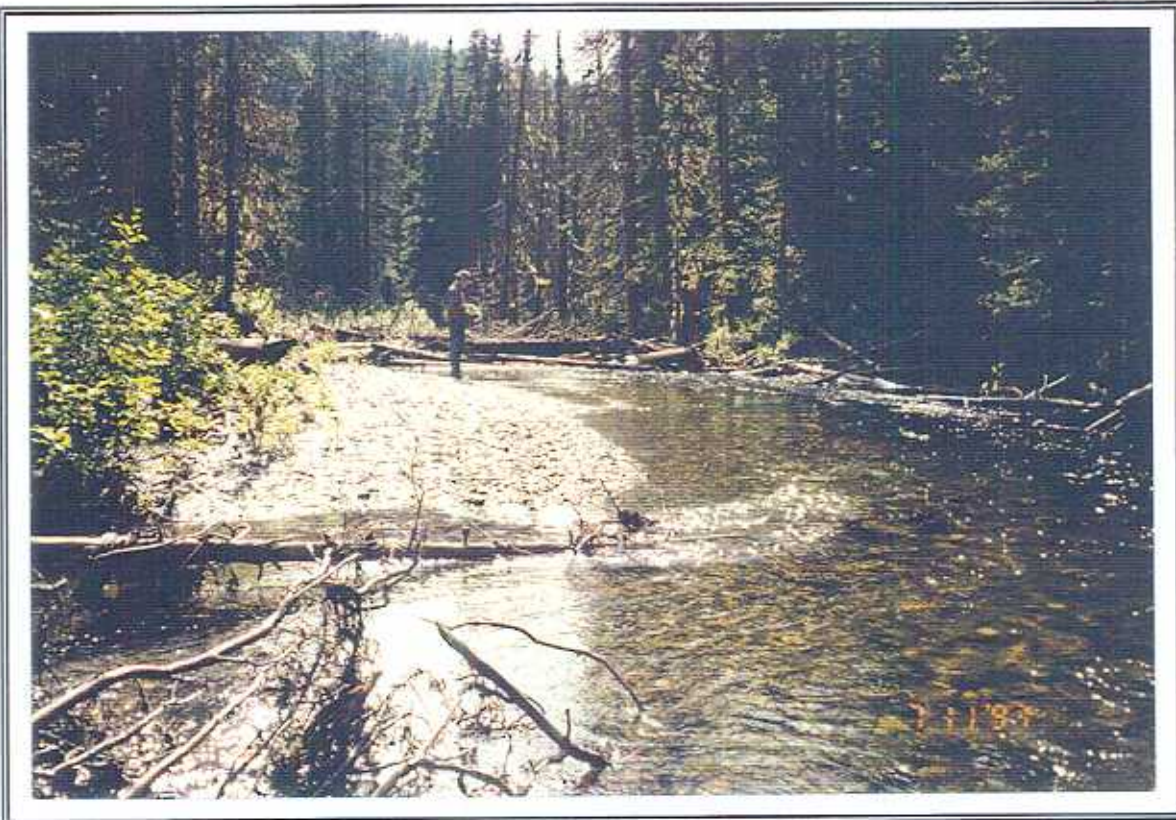
PHOTO S5. Clear flow in undisturbed upper Seller Creek [Site Sel4].

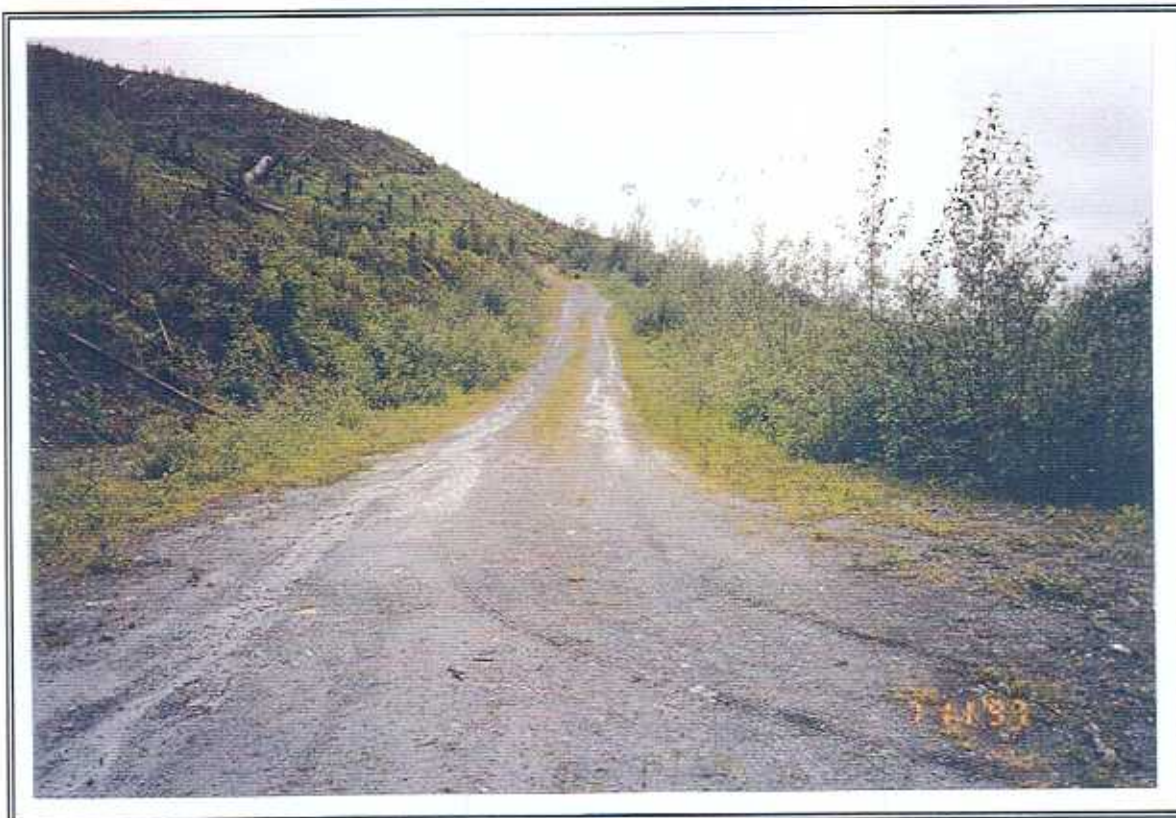
PHOTO S6. Stable road in middle Seller Creek watershed with grass seeding and ditchline vegetation [Site Sel3].

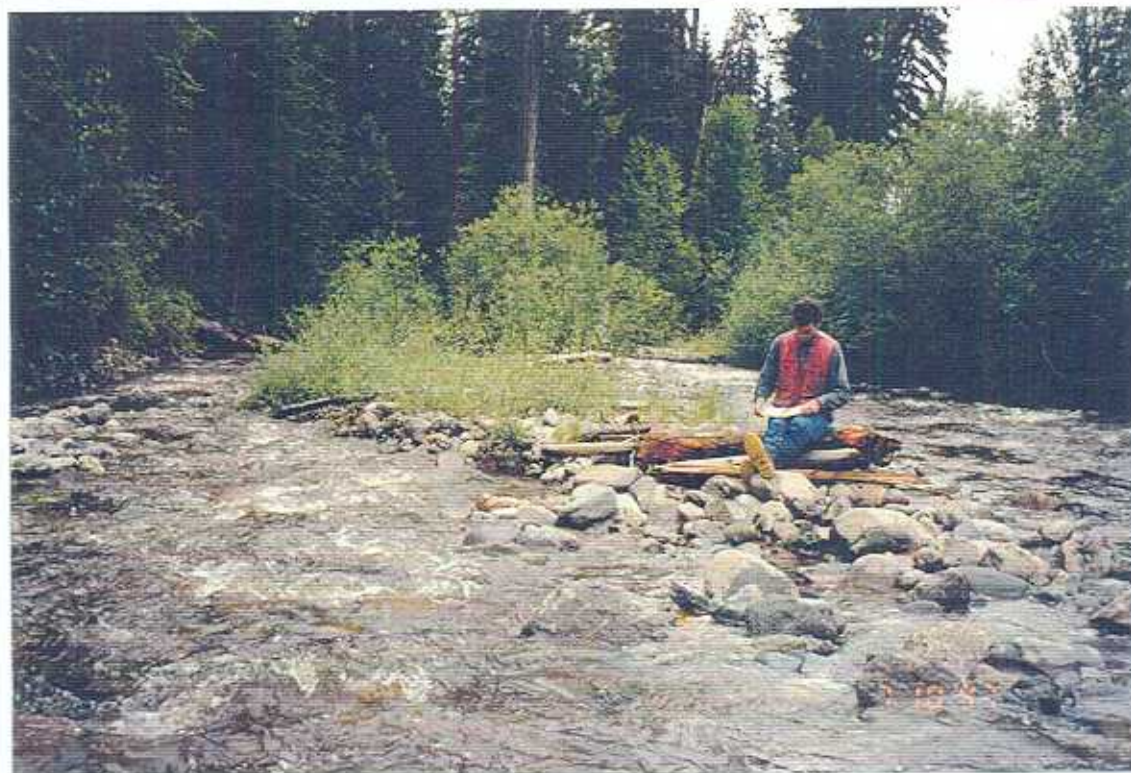
PHOTO R3. Rollie Creek on the alluvial fan - downstream [Site Rol2].

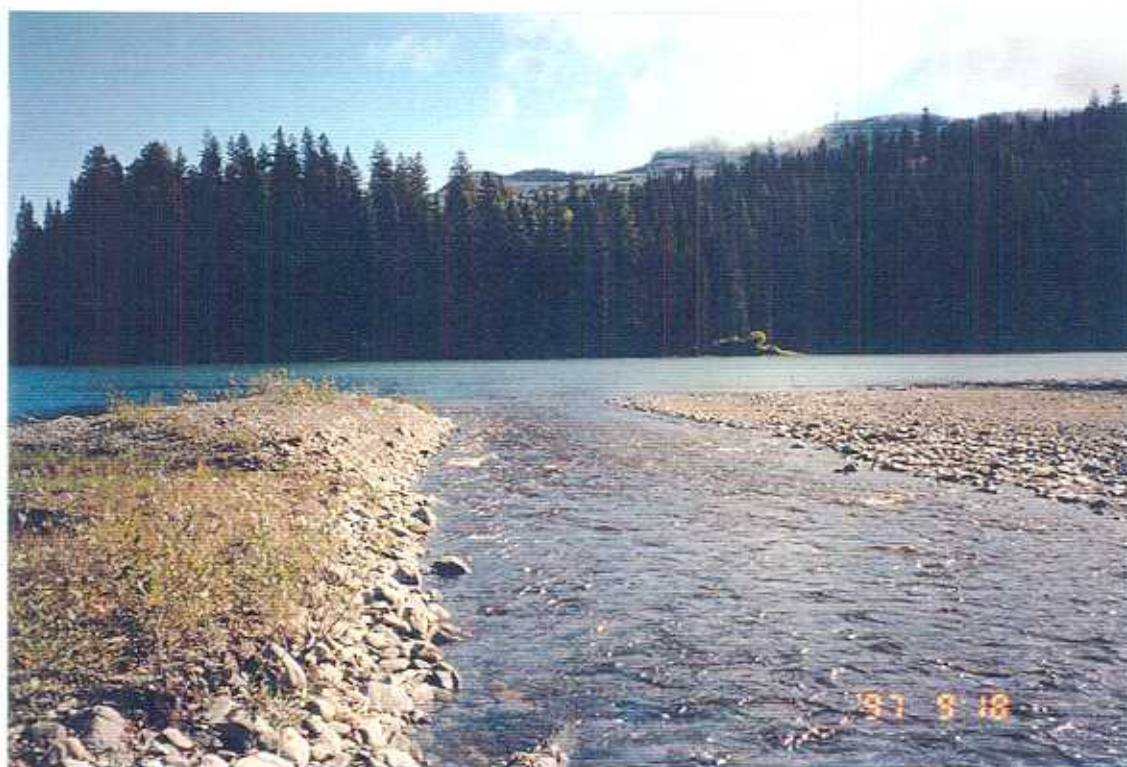
PHOTO R4. Invasive vegetation on old alluvial fan deposit at the mouth of Rollie Creek on Cariboo Lake [Site Rol1].

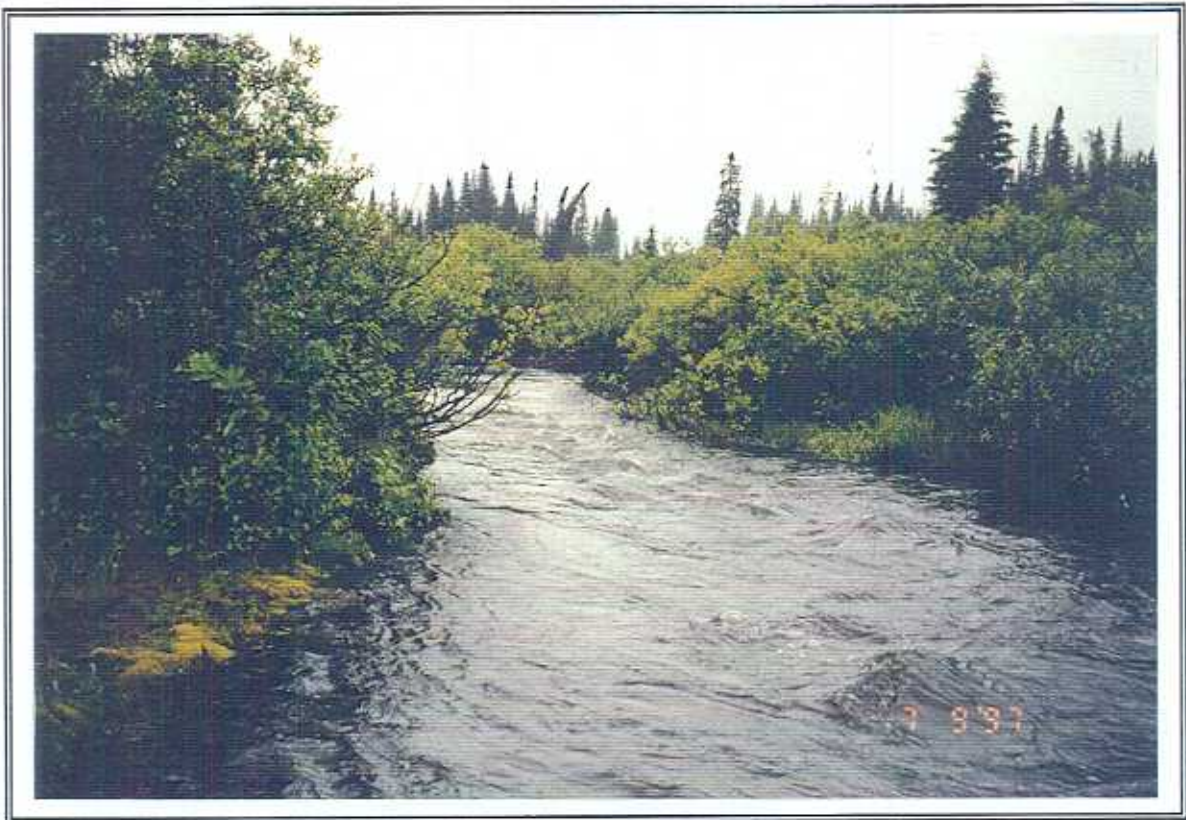
PHOTO R5. Upper low gradient reach of Rollie Creek with stable alder and willow riparian vegetation - upstream [Site Rol4].

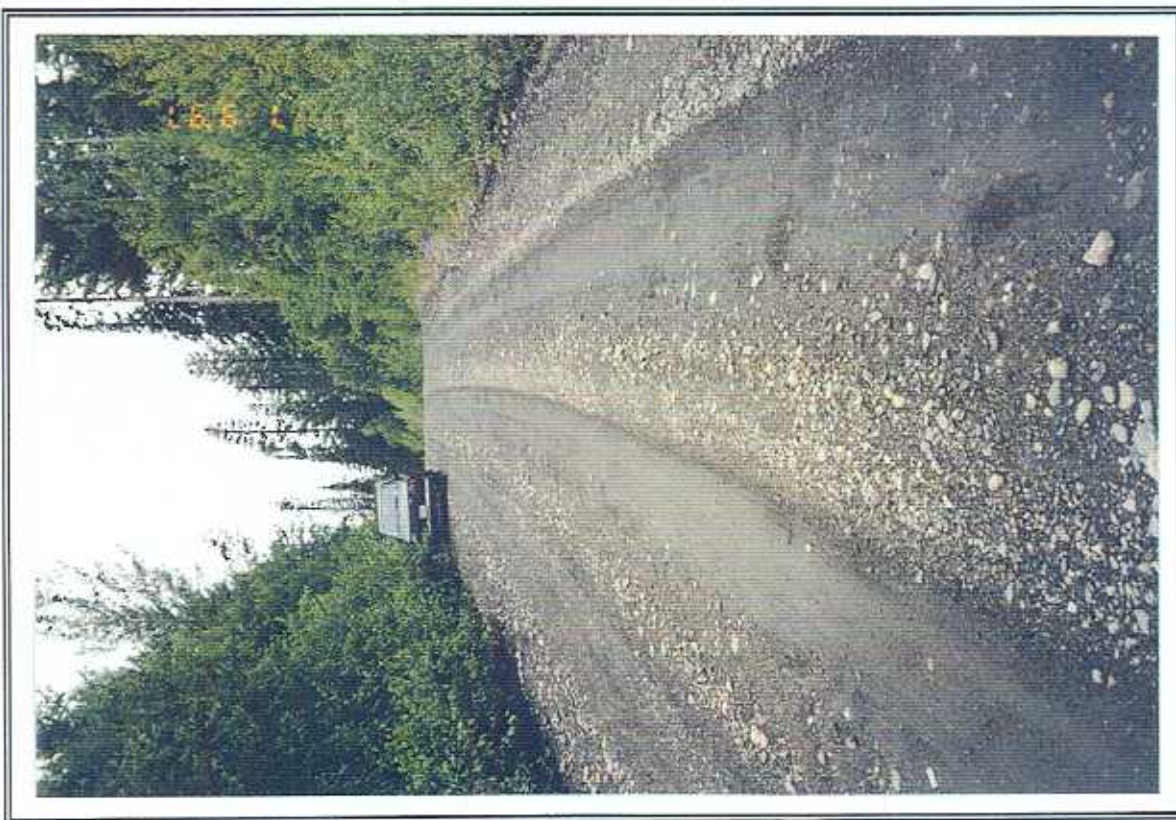
Roads at middle and upper elevations that have been either constructed of, or surfaced with, coarse materials are well-drained and reasonably resistant to surface erosion [Site R10, Figure 5] [Photo R8].

PHOTO R8. Stable coarse surfaced section of the Rollie mainline [Site R10].

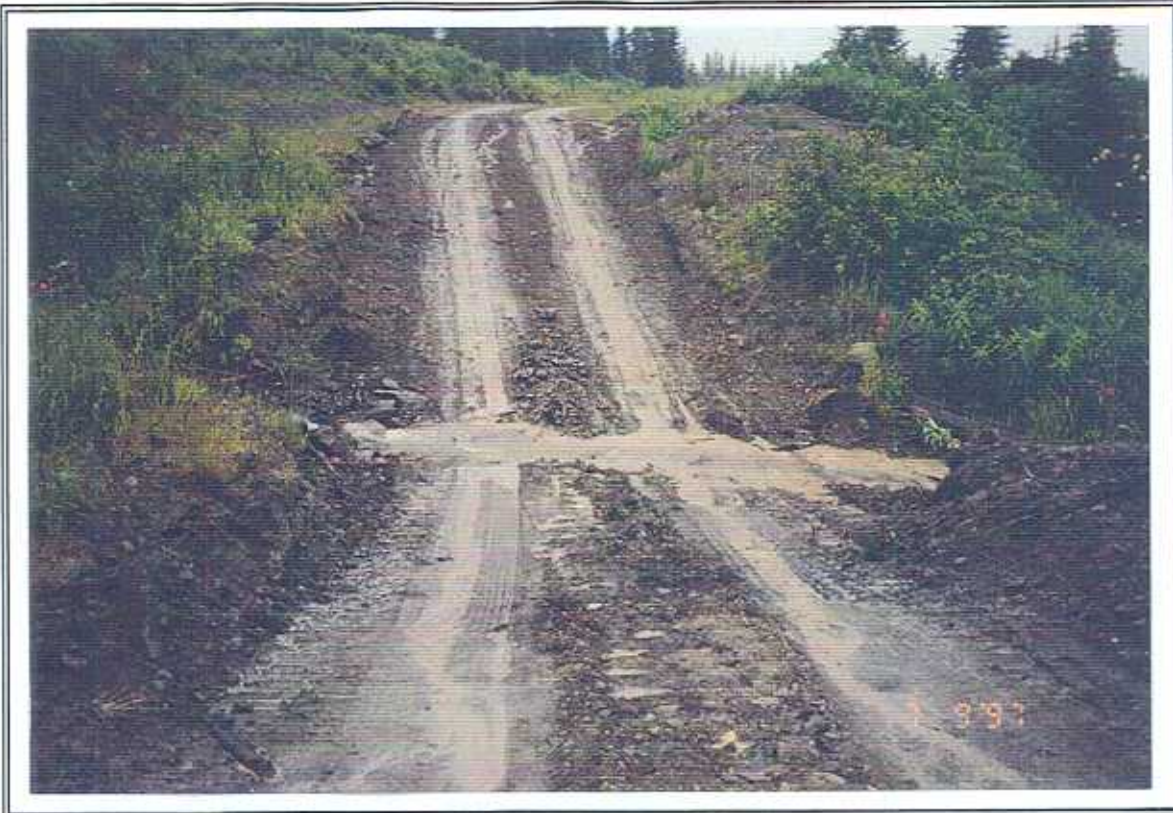
PHOTO R9. Surface erosion and direct input of suspended sediment to the upper Rollie Creek system at an un-armoured ford [Site Rol5].

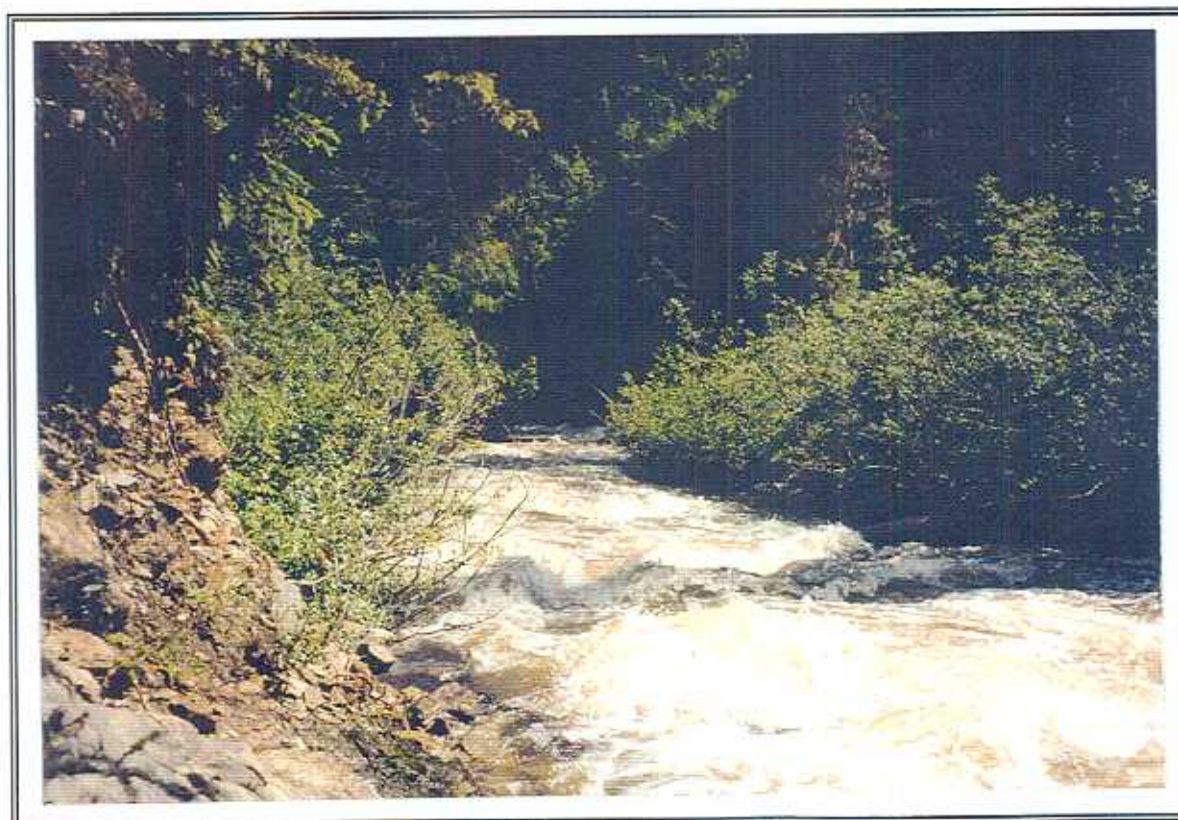
PHOTO K5. Upper Keithley Creek - downstream [Site K5].

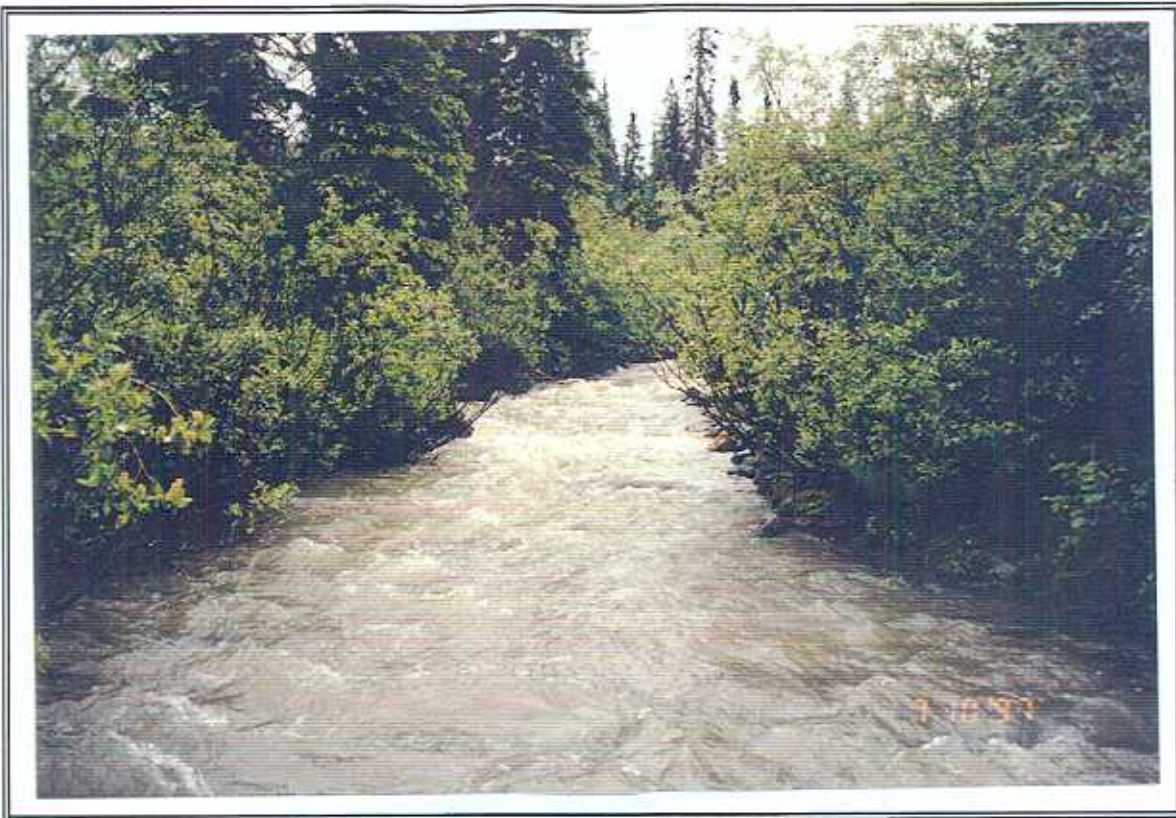
PHOTO K6. French Snowshoe Creek at the confluence with Snowshoe Creek - upstream [Site K8].

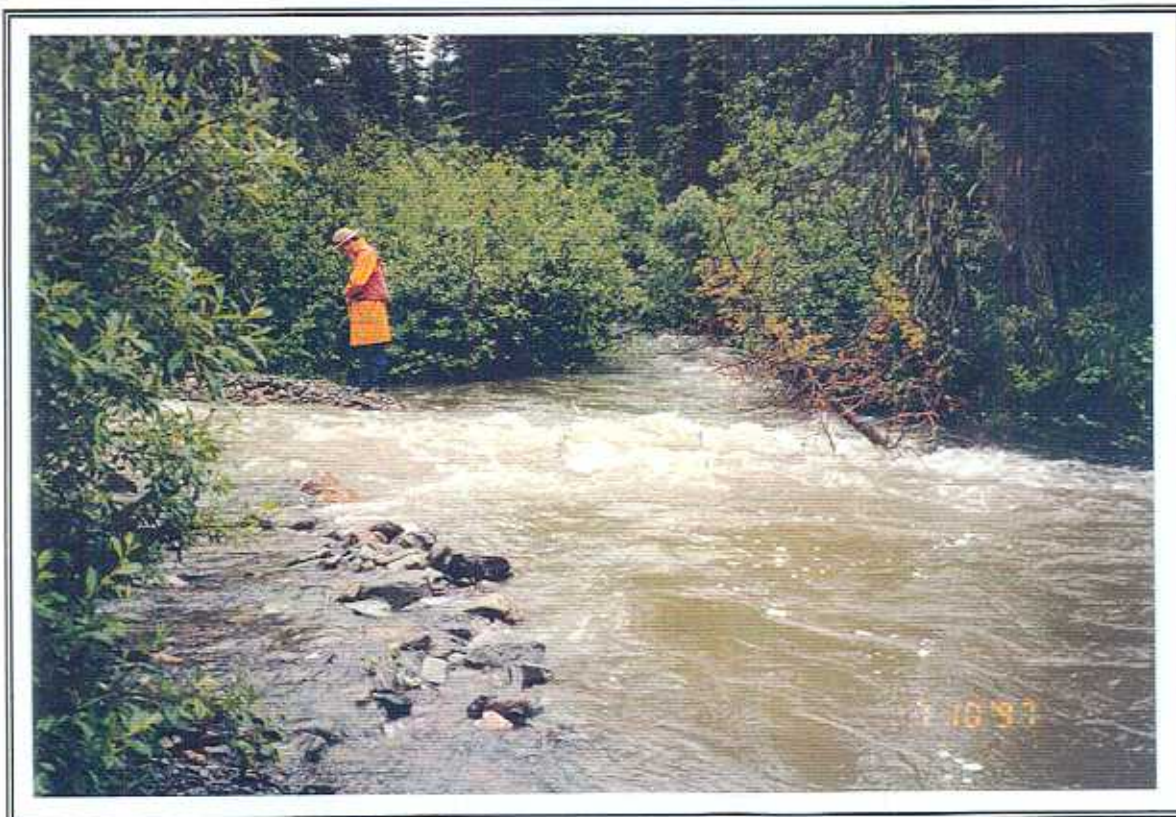
PHOTO K7. Confluence of Little Snowshoe and Snowshoe Creeks showing increased bedload transport in both systems - upstream [Site K9].

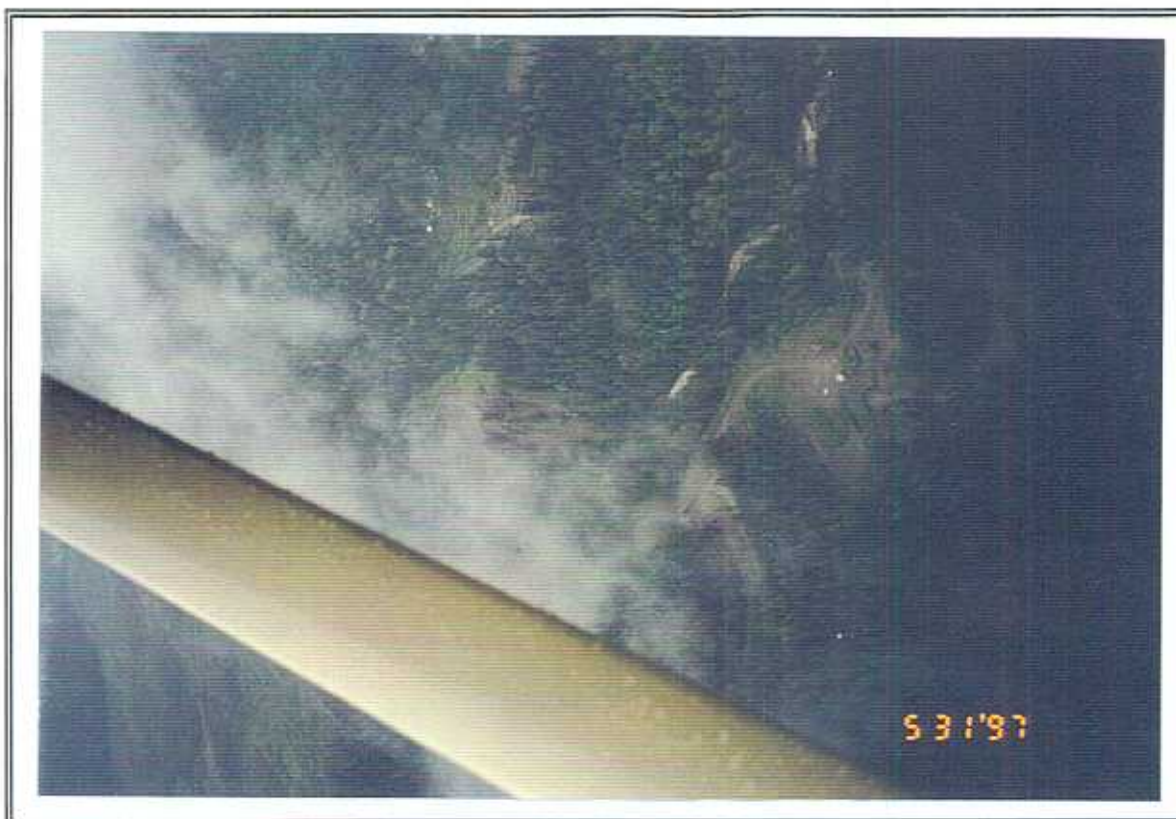
PHOTO H2. Active placer mine site and road sidecast input to Harveys Creek at apex of alluvial fan [Site H1].

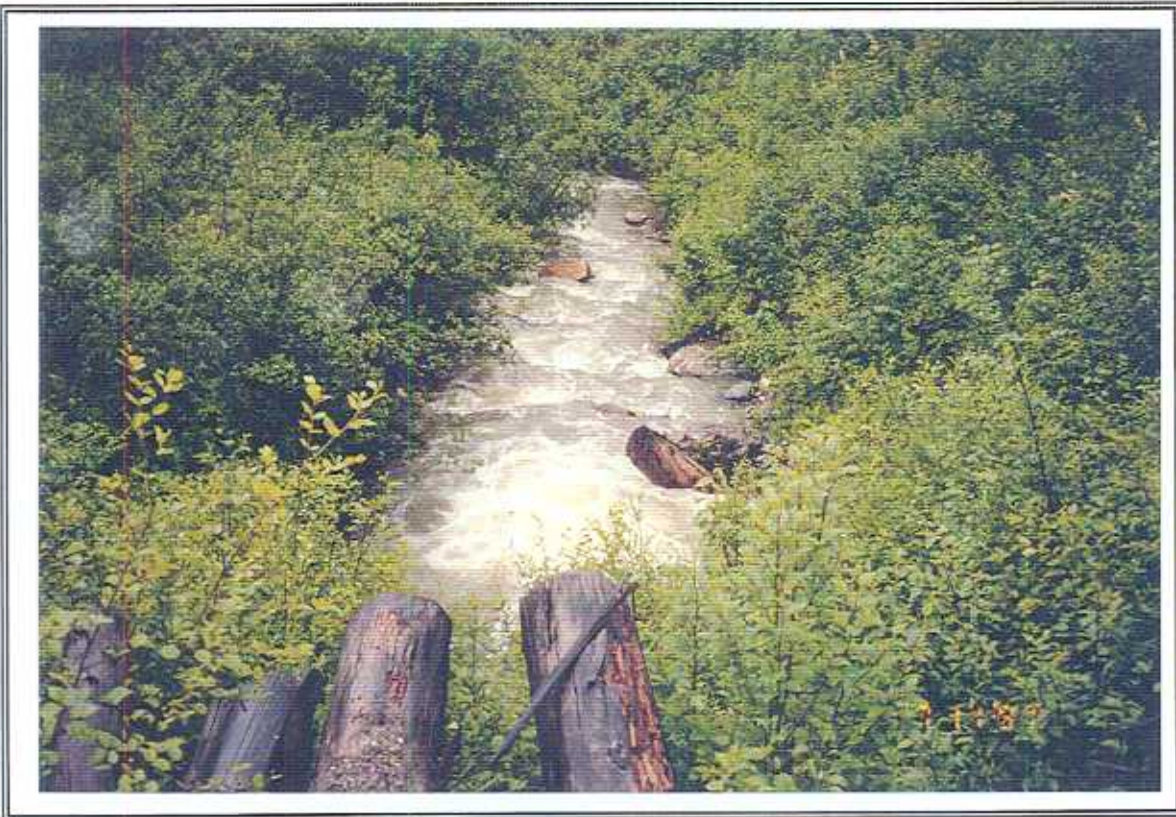
PHOTO H6. Bank instability and erosion resulting from harvesting in the riparian zone on upper Harveys Creek - downstream [Site H3].

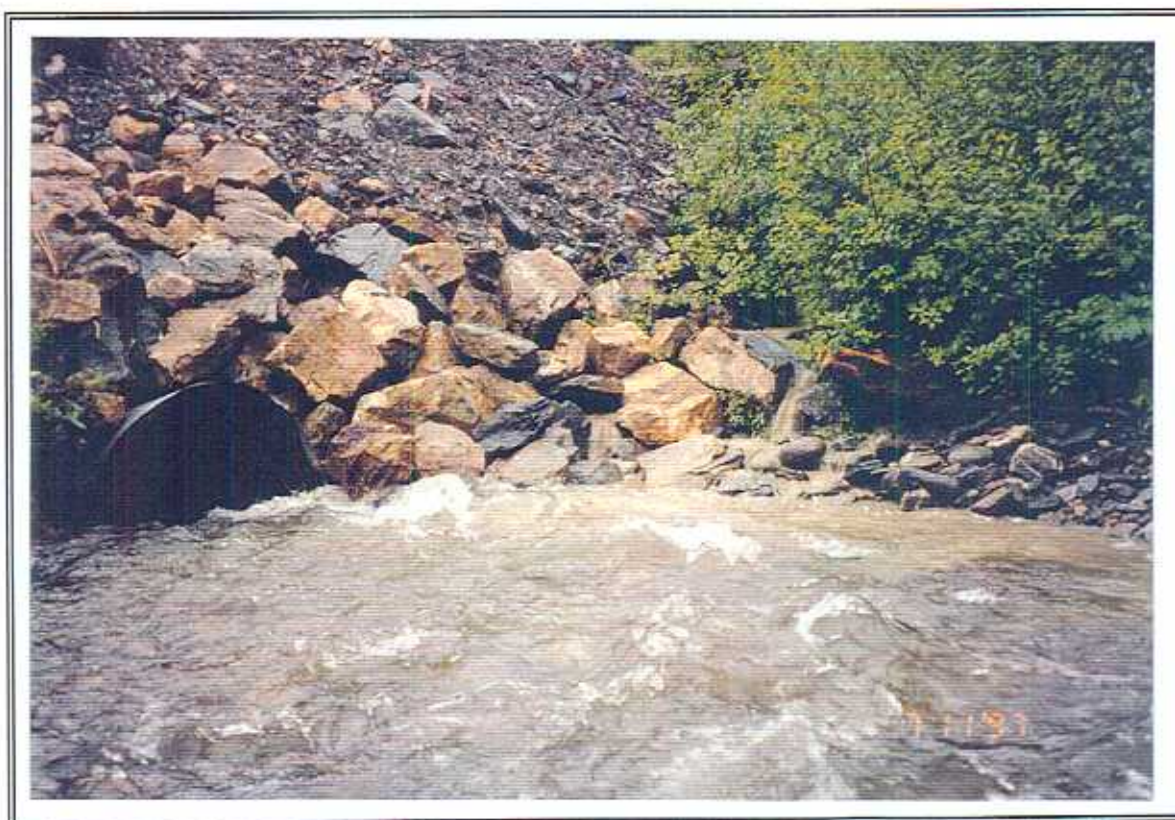
PHOTO H9. Turbid ditch flow into upper Simlock Creek from long uninterrupted ditch line on mainline road [Site H4].

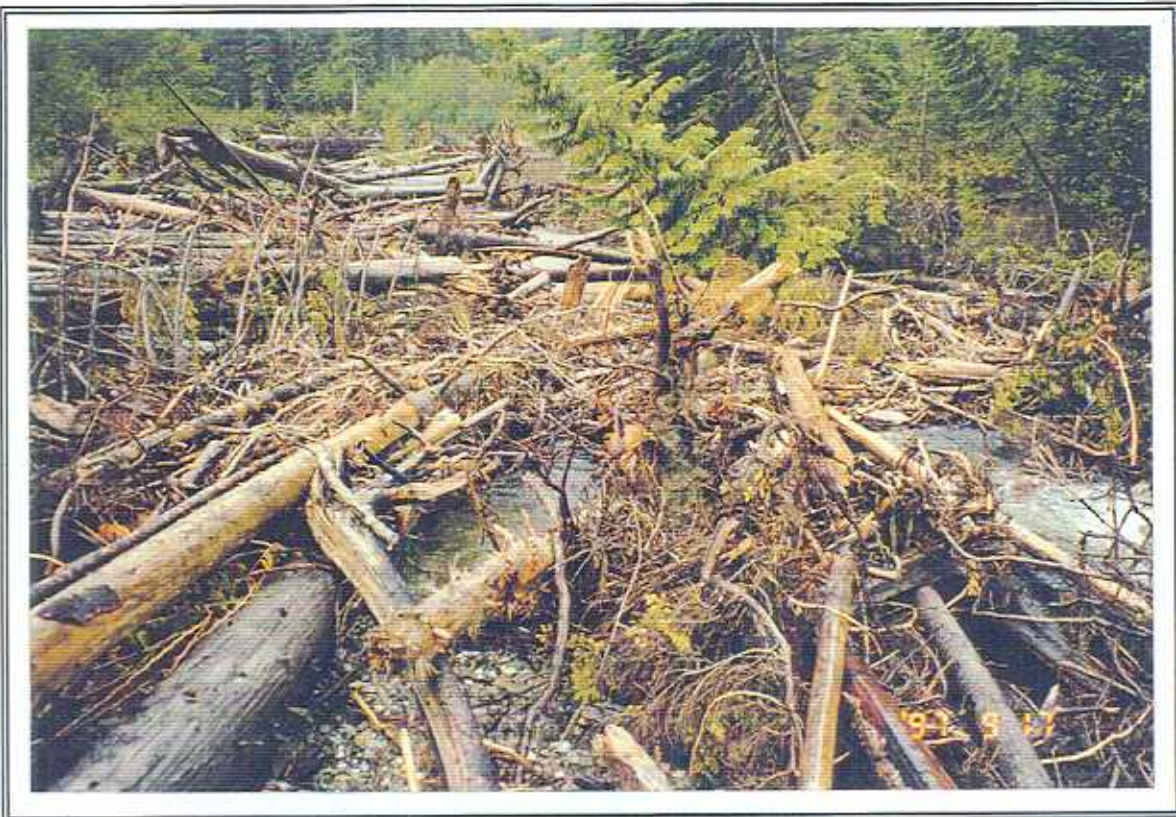
PHOTO L5. Large debris jam on lower Little River above alluvial fan. No evidence of logging related debris. [Site L2].
