**An Inventory of Watershed Conditions
Affecting Risks to Fish Habitat
in the
CARIBOO, COTTONWOOD & HORSEFLY
WATERSHEDS**

VOLUME I
Cariboo River Watershed
(Sections 1 to 5 & 6)

Prepared for
CARIBOO REGION INTERAGENCY MANAGEMENT COMMITTEE
Williams Lake, BC

by
CHAPMAN GEOSCIENCE LTD.
Nanaimo, BC
&
DOBSON ENGINEERING LTD.
Kelowna, BC

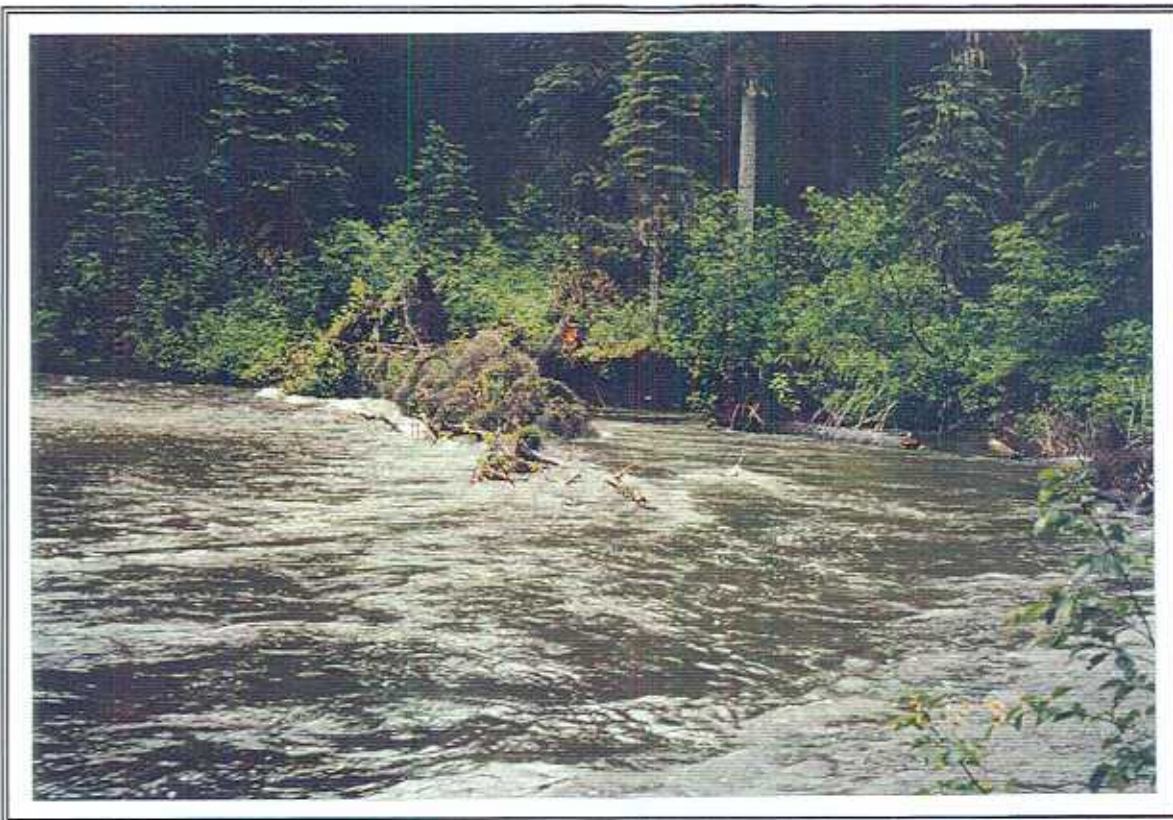
PHOTO L9. Fresh bank erosion and large woody debris input to the lower Little River - downstream [Site L6].

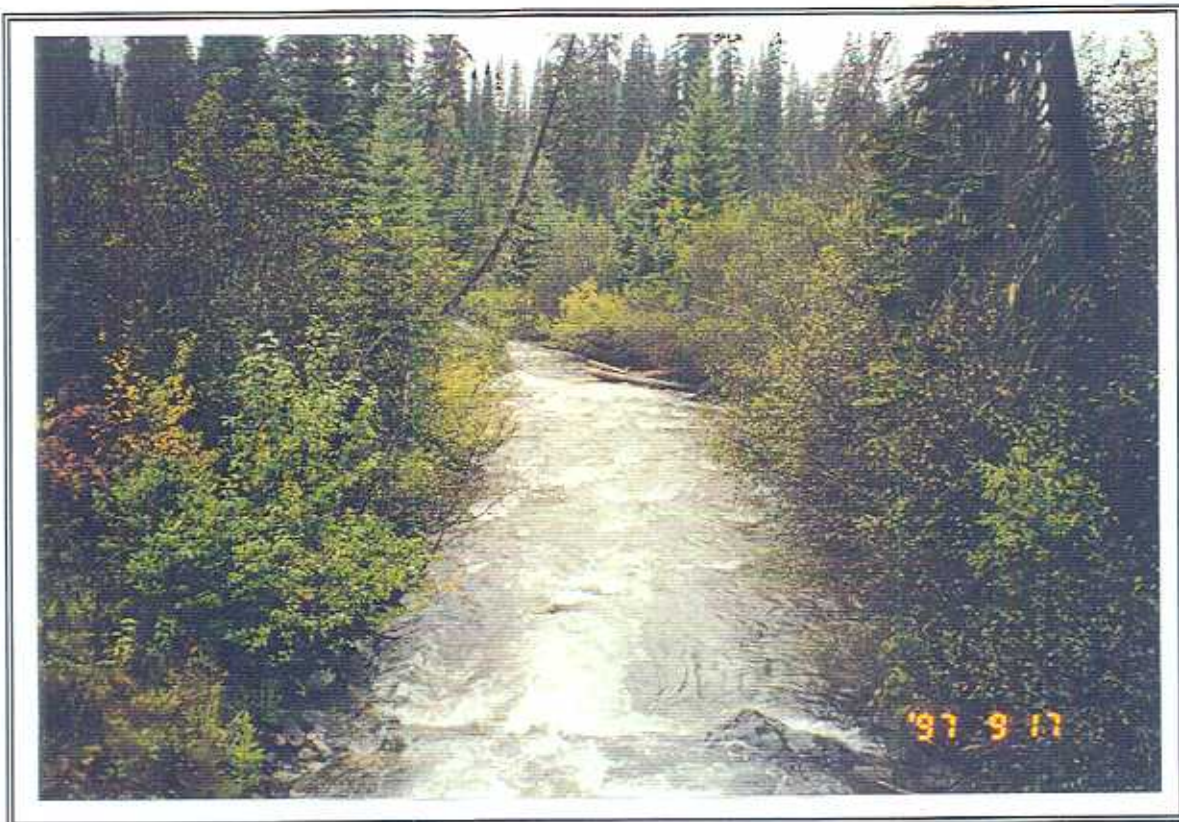
PHOTO L11. Middle Little River channel with stable channel bed and banks - downstream [Site L9].

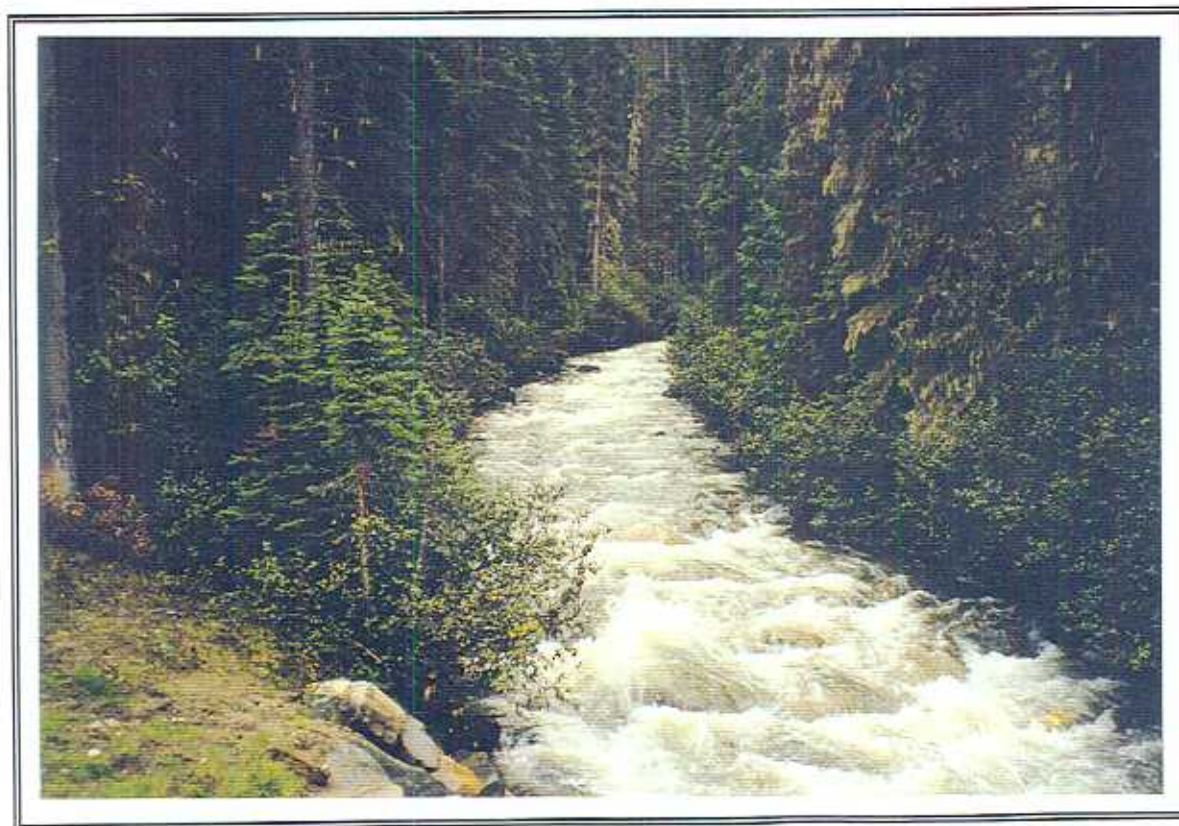
PHOTO L12. Lower Ishkloo Creek with stable old growth riparian zone - upstream [Site L8].

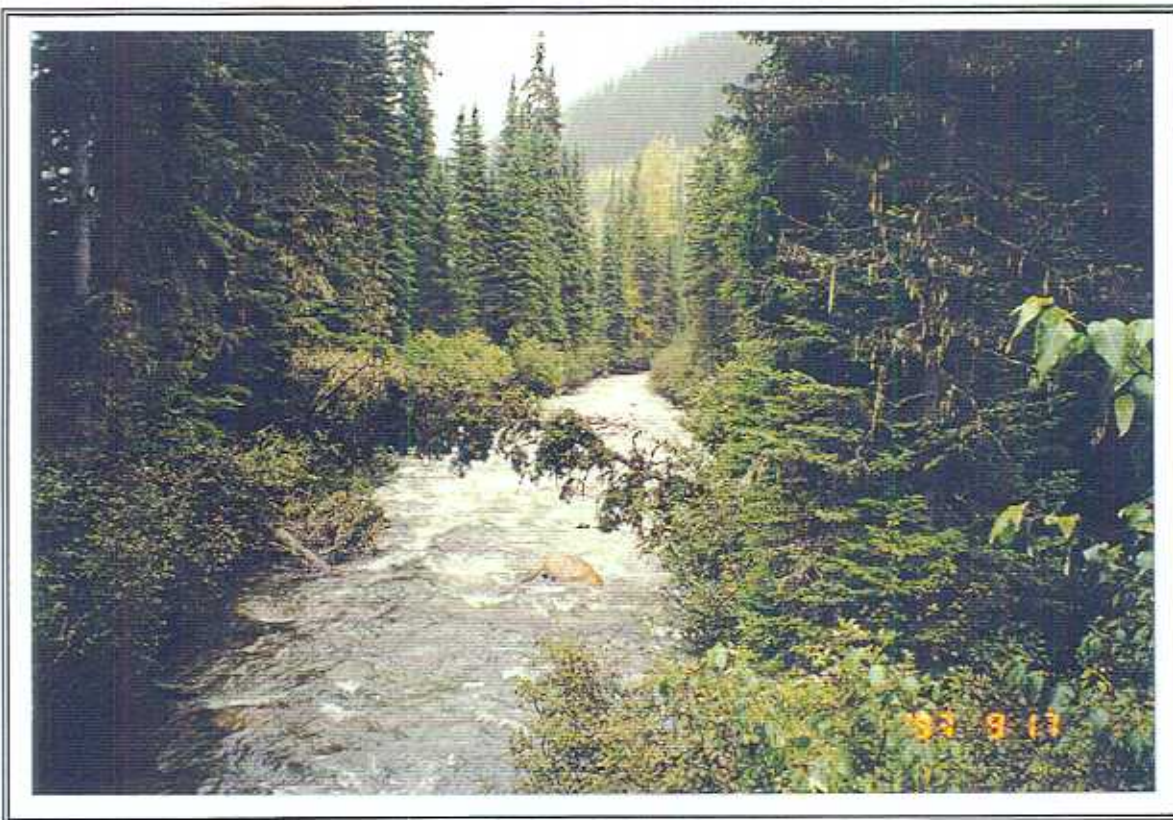
PHOTO L13. Lower Ishkloo Creek with stable boulder channel - downstream [Site L8].

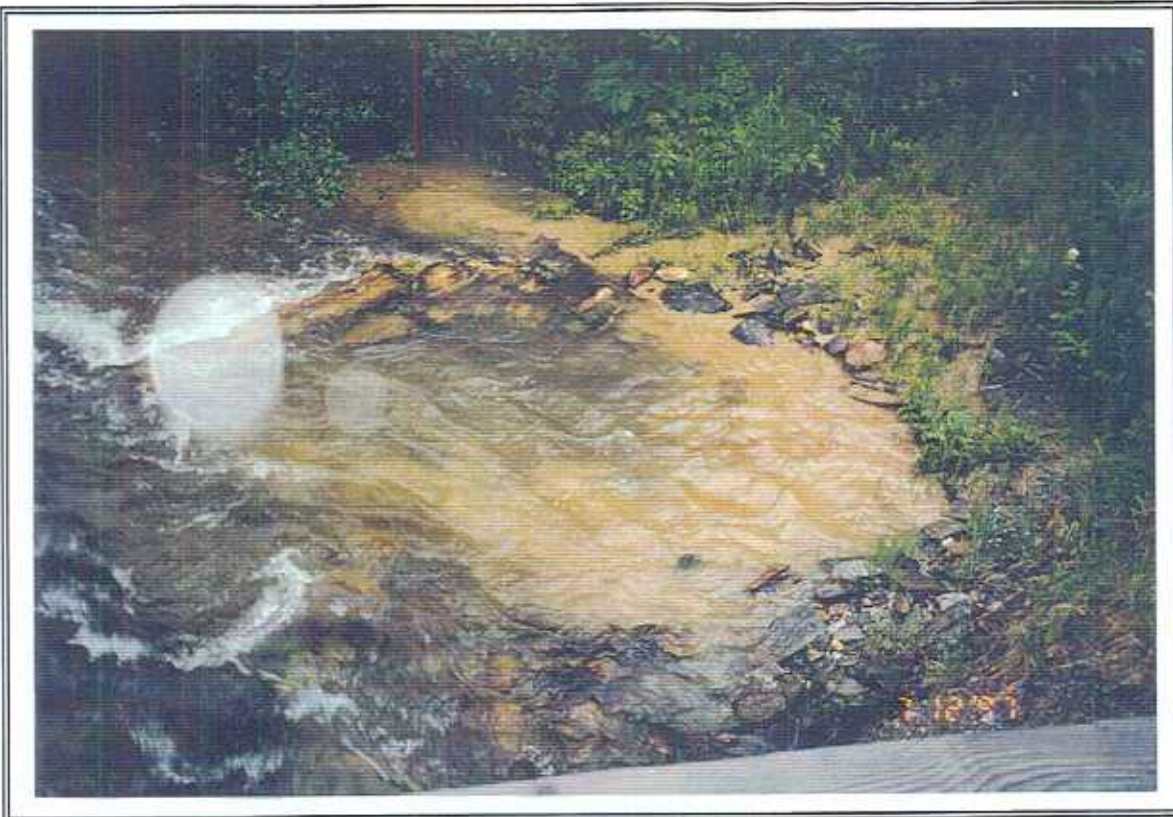
PHOTO L14. Running surface erosion from fine textured road leading into the Ishkloo Creek drainage [Site L10].

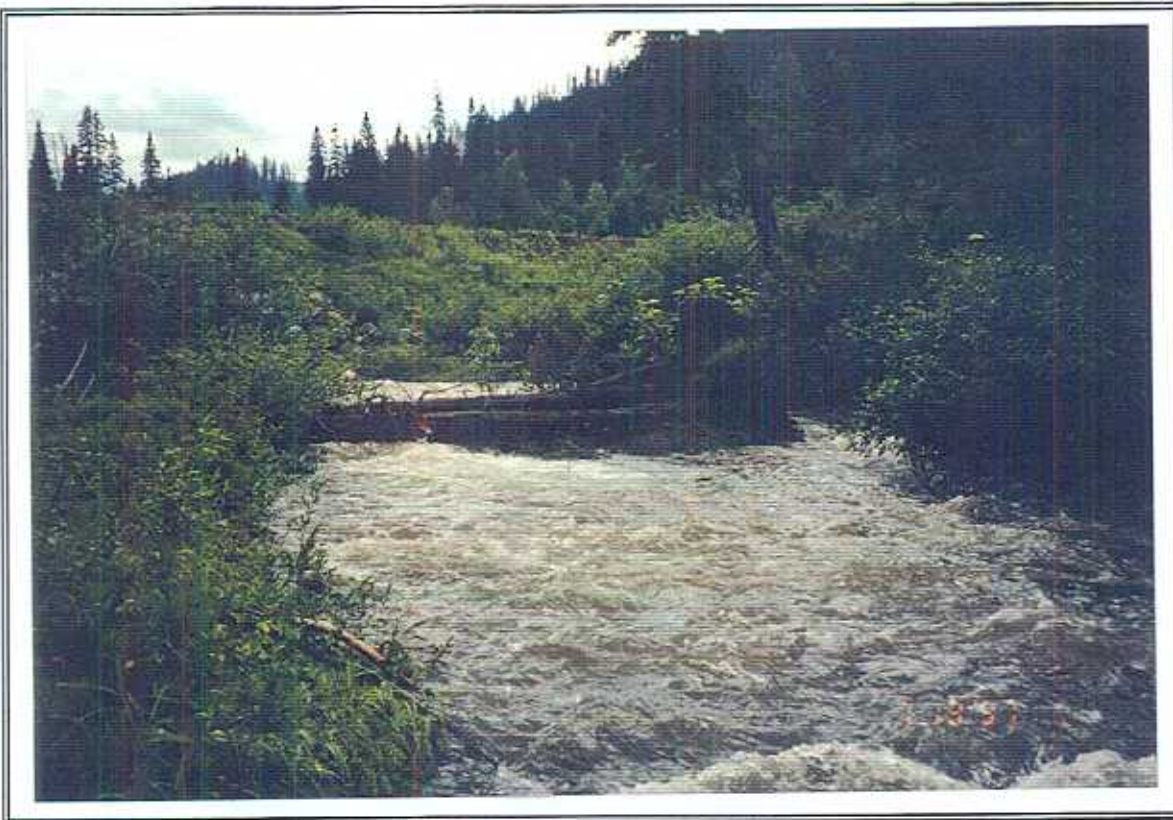
PHOTO CN3. Multiple channels and channel widening on the Cunningham Creek alluvial fan - downstream [Site C1].

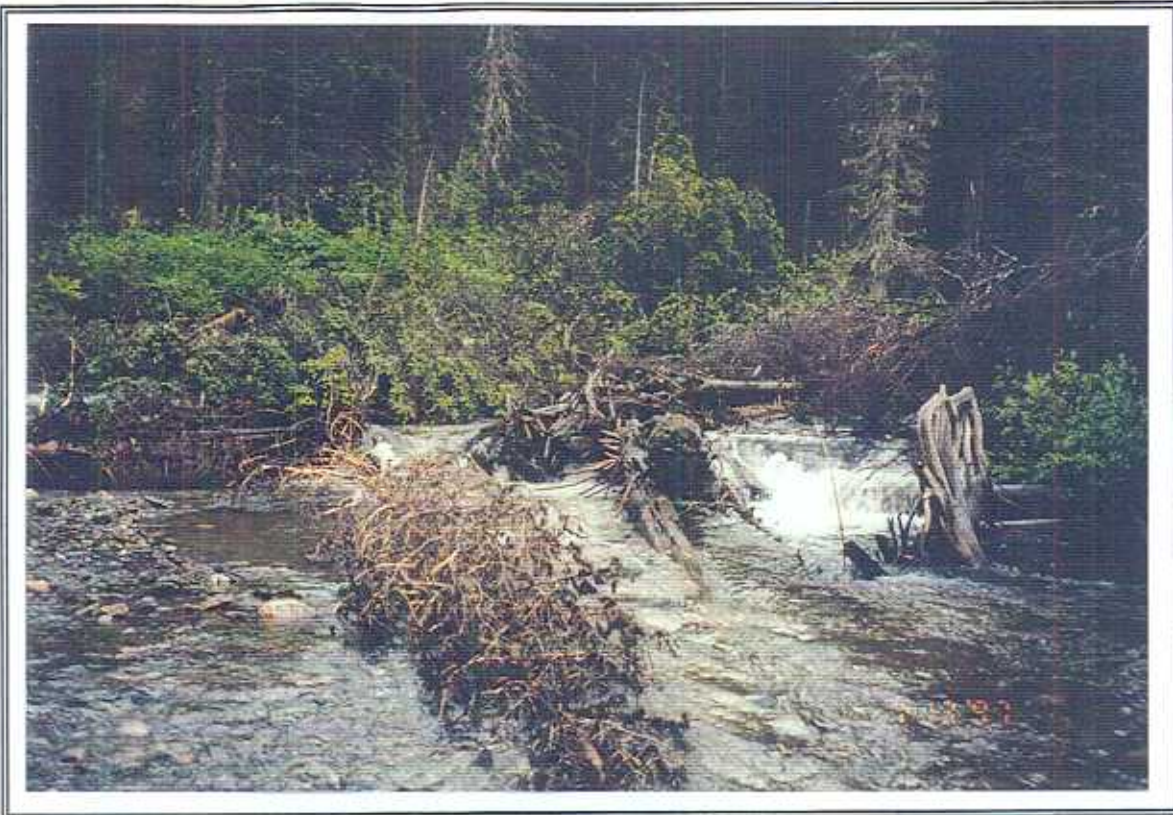
PHOTO CN5. Increased large and small woody debris from pre-FPC harvesting in the riparian zone of Tisdale Creek - downstream [Site C3].

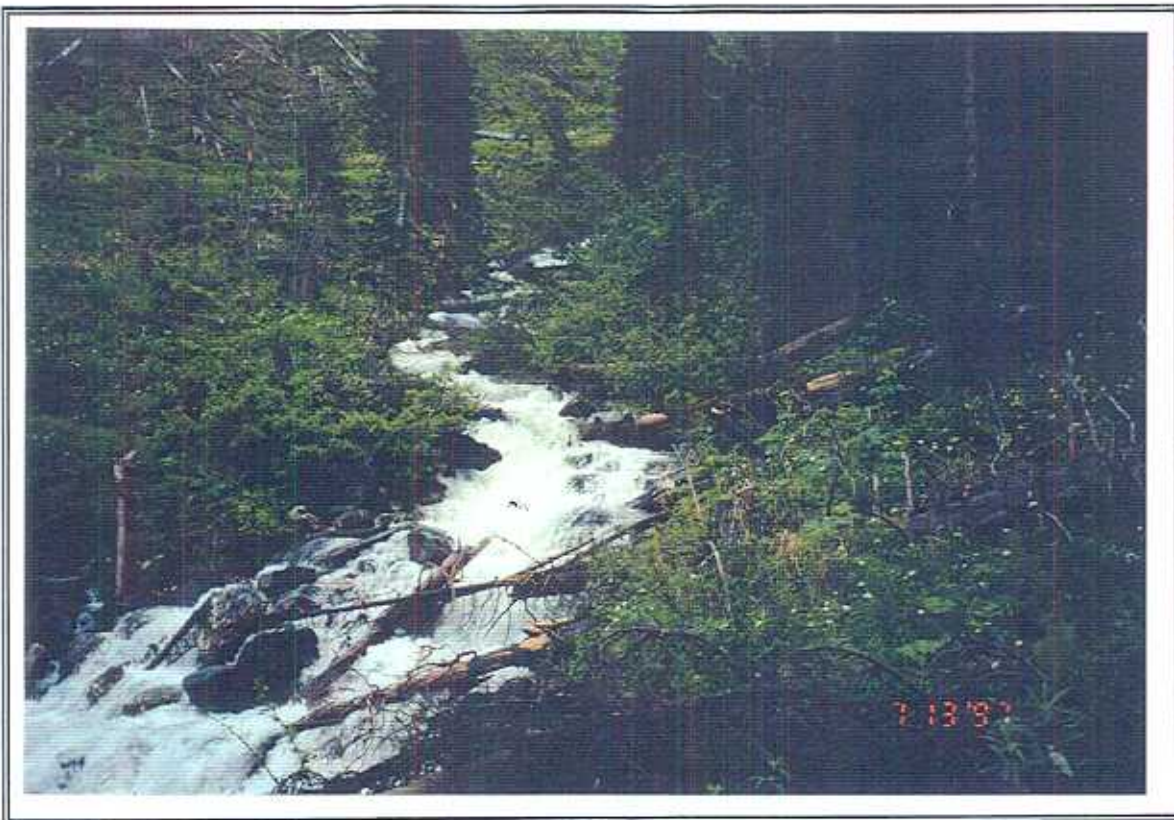
PHOTO CN7. Bank erosion in placer mined floodplain materials in upper Cunninham Creek - downstream [Site C8].

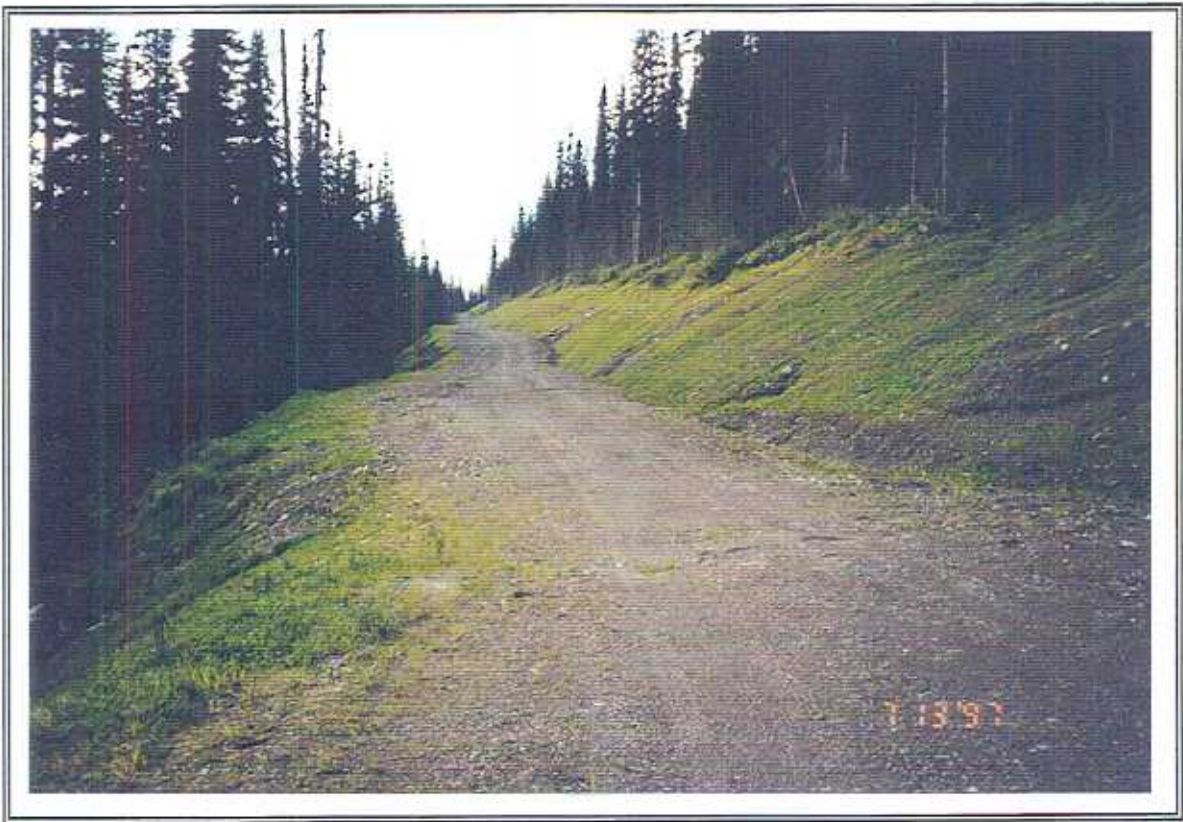
PHOTO CN9. Ruts in fine textured pre-FPC road surface in the middle watershed [Site C4].

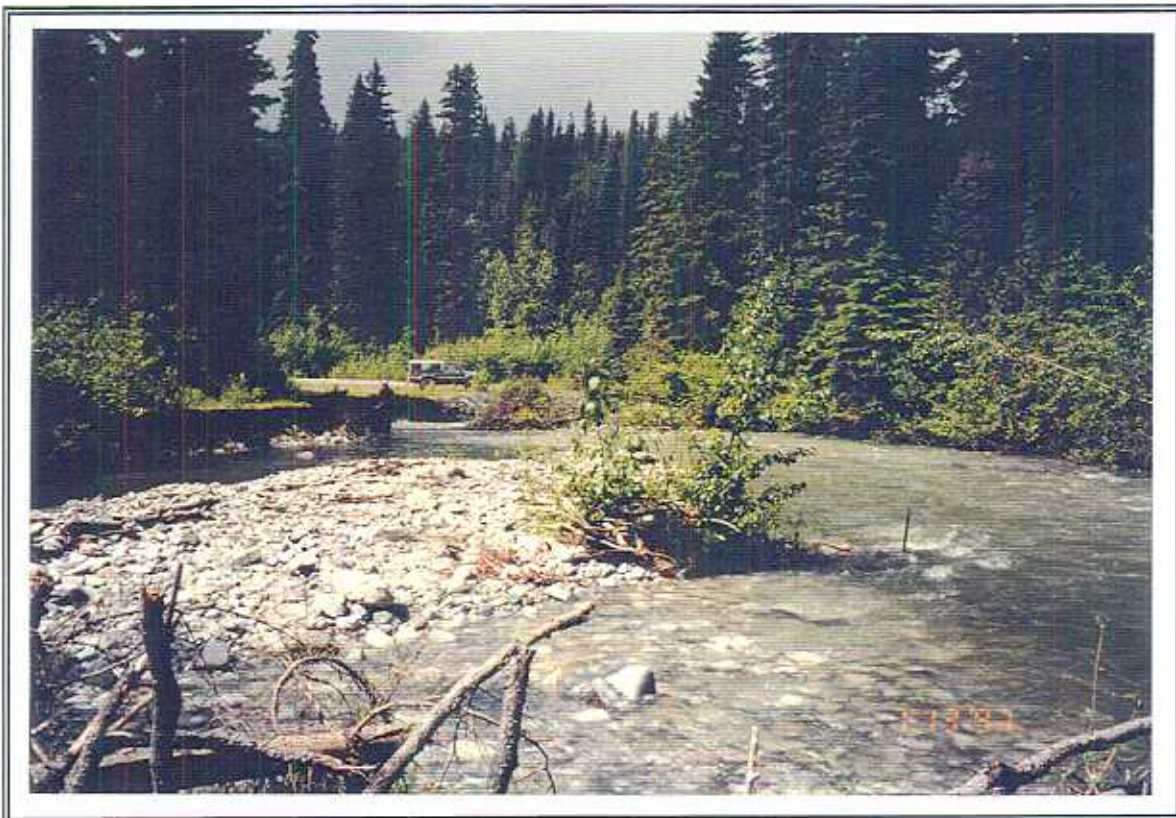
PHOTO KB1. Recent channel disturbance on the Kimball Creek alluvial fan - upstream [Site Kim1].

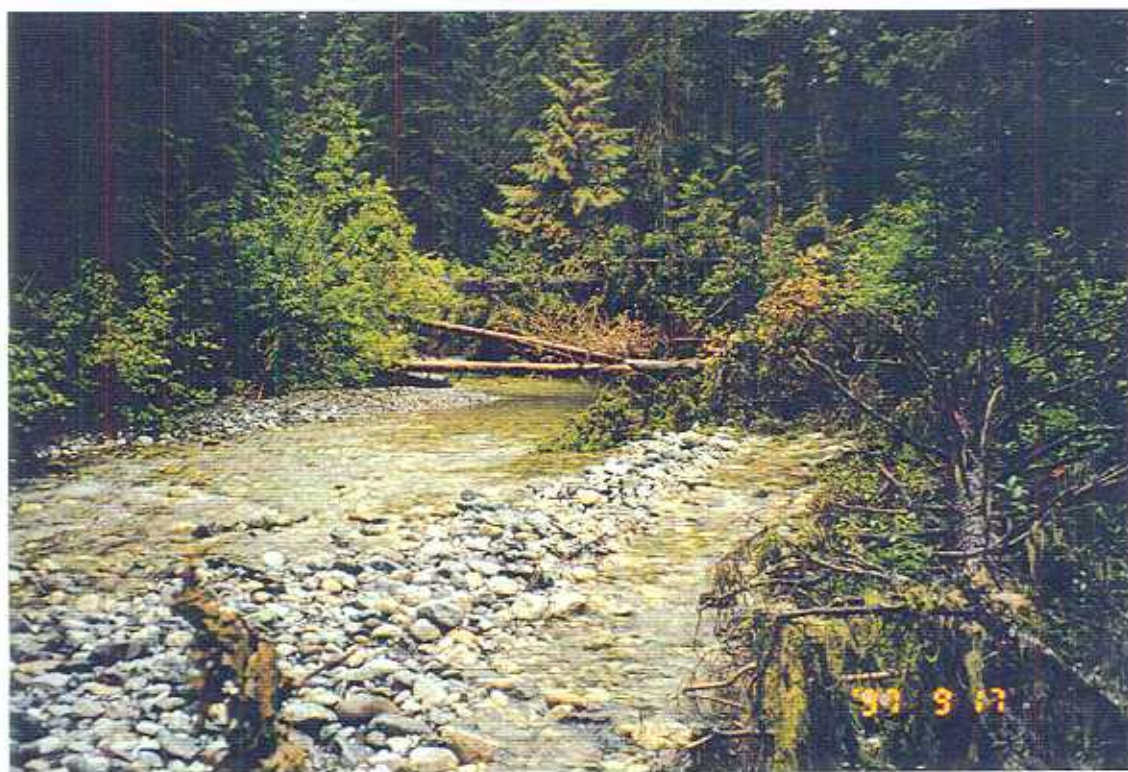
PHOTO KB3. Bank erosion and large increase in woody debris input to lower Kimball Creek [Site Kim1].

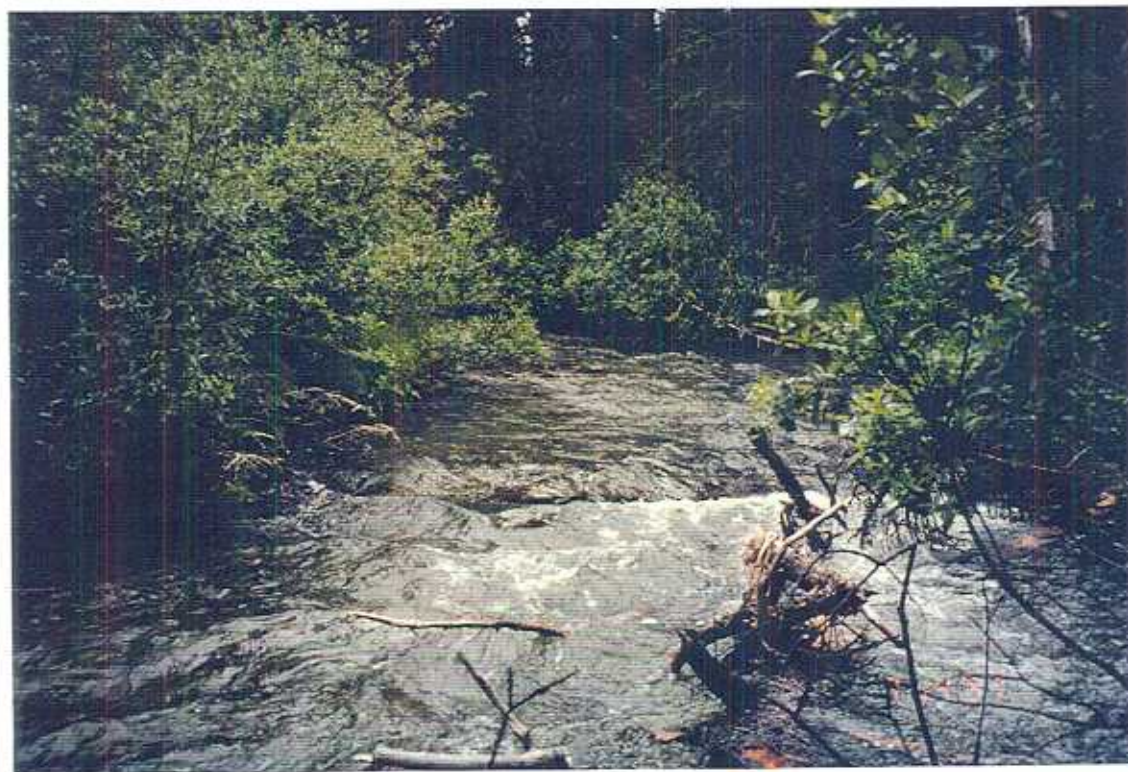
PHOTO KB4. Woody debris input from old growth riparian zone on lower Kimball Creek [Site Kim1].

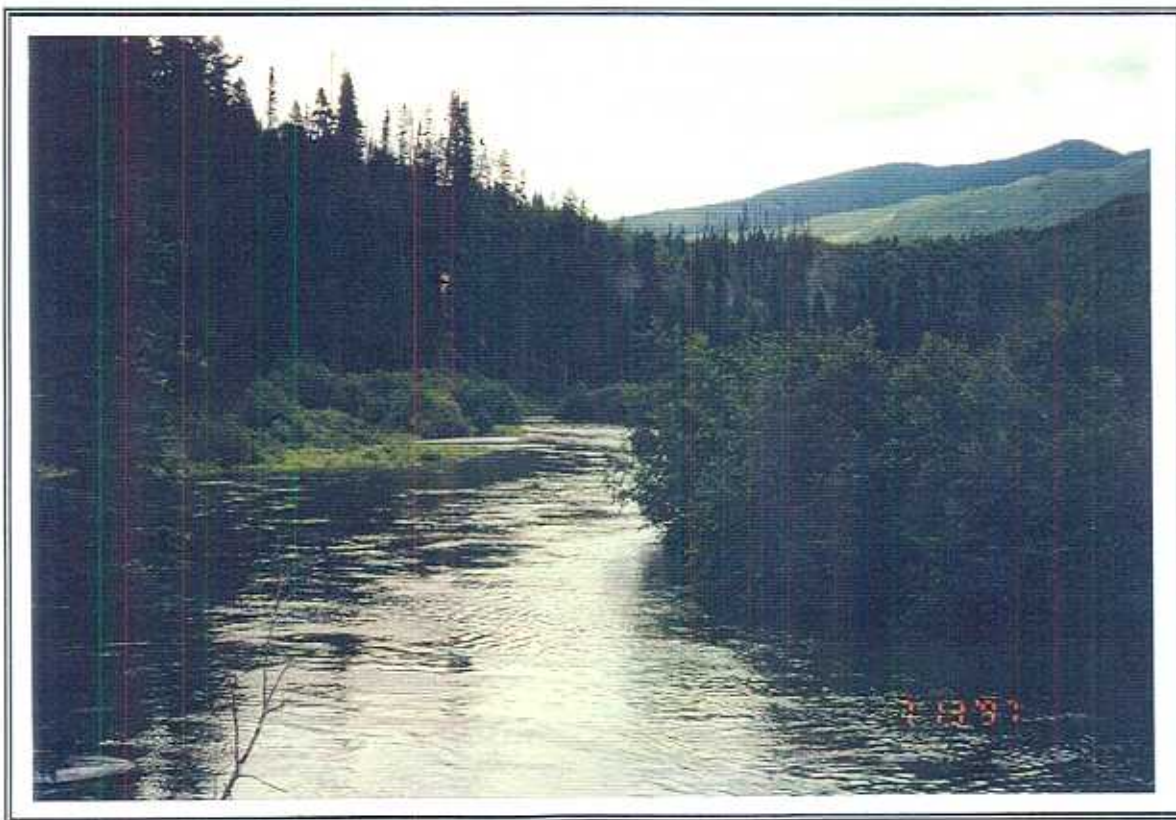
PHOTO M1. Extensive riparian harvesting along the lower mainstem channel of the Matthew River [Site M1].

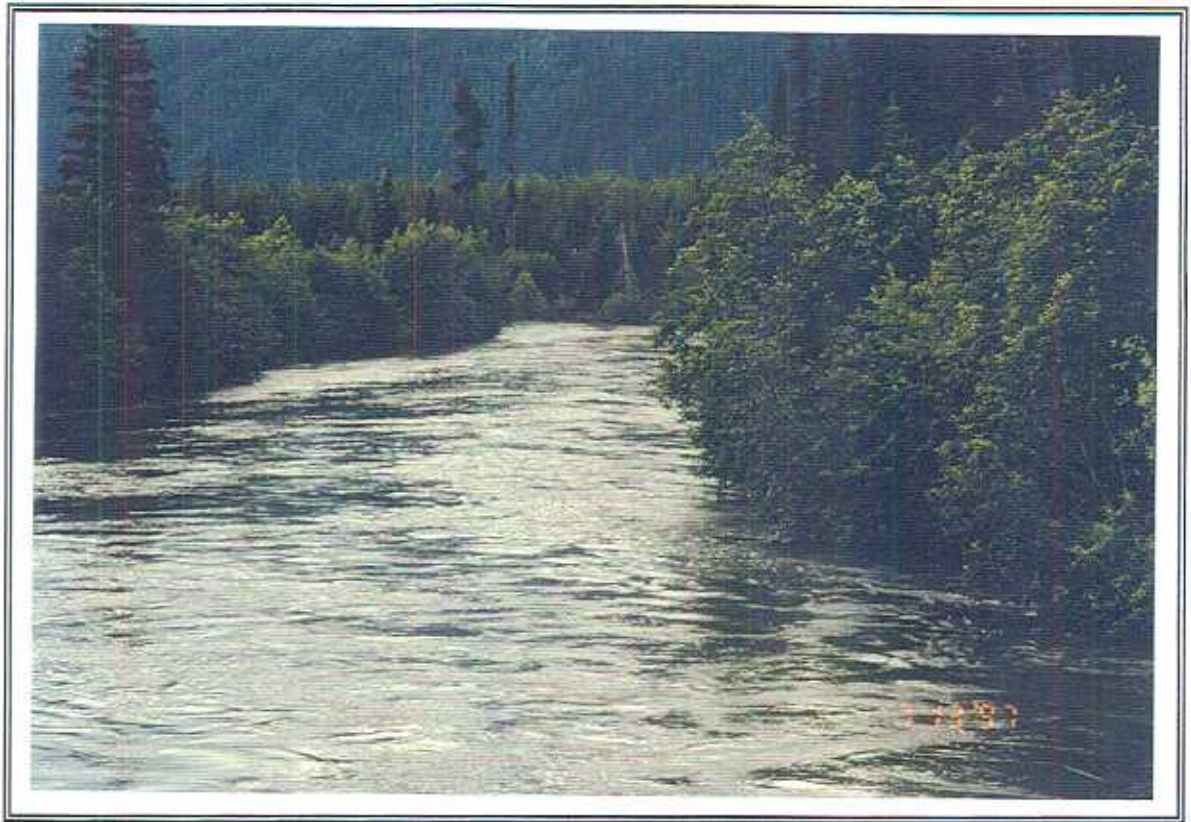
PHOTO M2. Low gradient reach of the lower Matthew River showing alder and willow regeneration on the banks - upstream [Site M1].

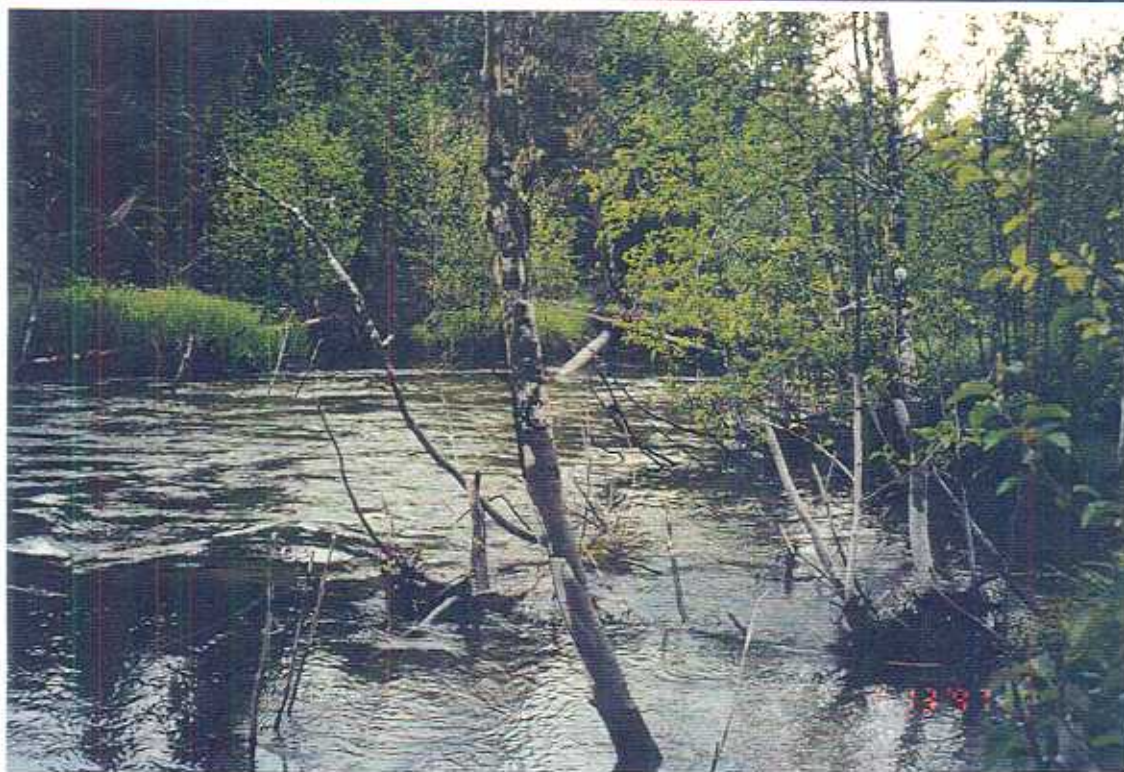
PHOTO M4. Lower Connection Creek with a large woody debris increase from blowdown in the riparian zone - upstream [Site M4].

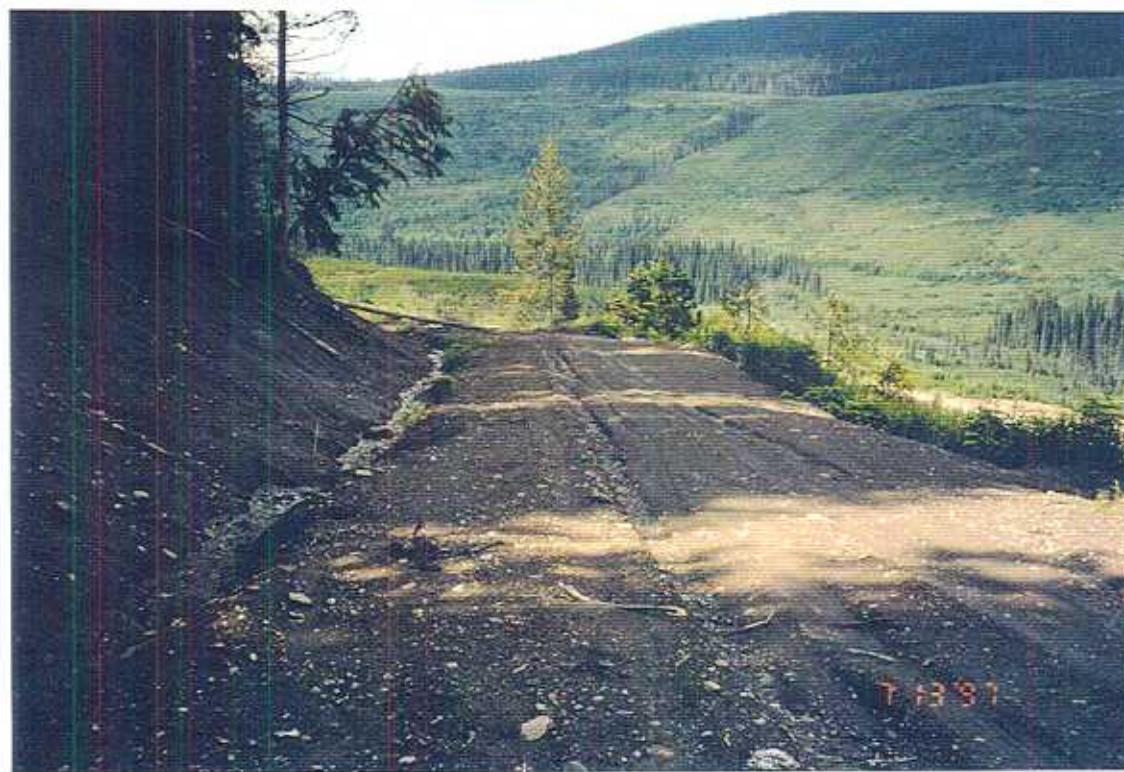
PHOTO M5. Low gradient reach on lower Connection Reach showing stable banks - downstream [Site M4].
